## Technical Due Diligence Condition Survey Report

Prince of Wales Theatre, Church  
Street, Cannock WS11 1DE

April 2026

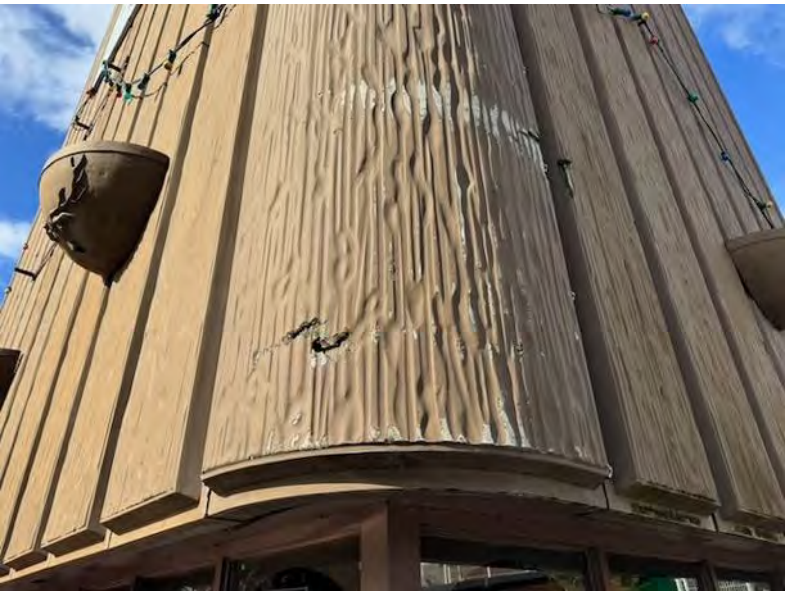
| 3. | The glass reinforced plastic (GRP) cladding is solar degraded and localised impact damage is evident to the low level areas and corners. | |

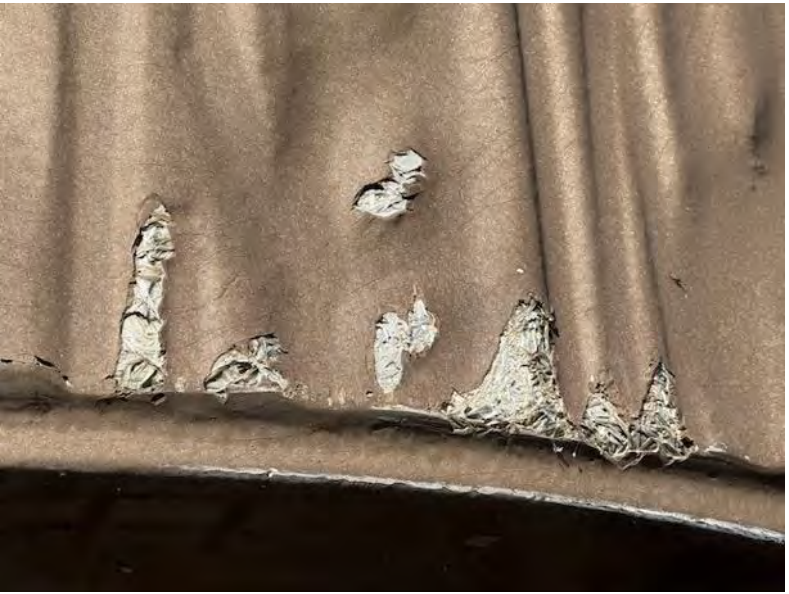
| 4. | The coating to the GRP cladding is failing. | |

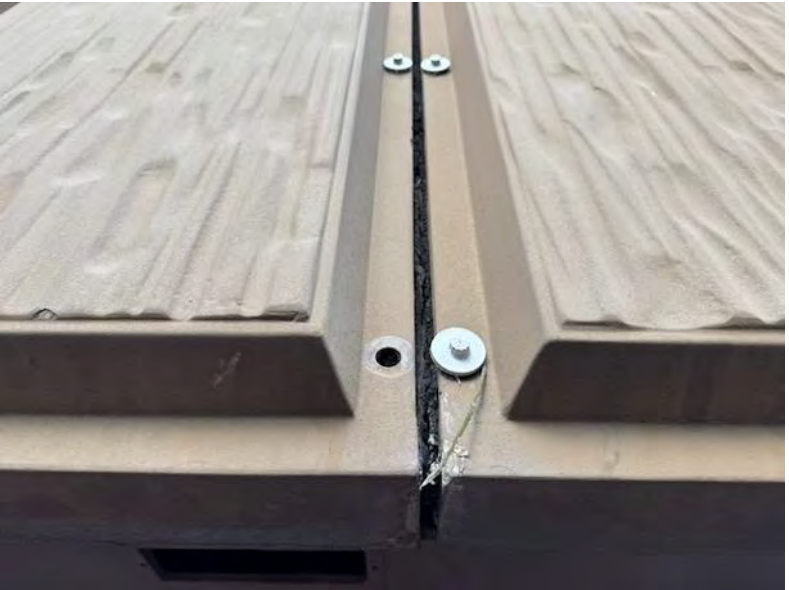
| 5. | The sealant between the cladding panels is degraded and split and the fixings and cover caps are in poor condition. Localised fixings are missing. | |

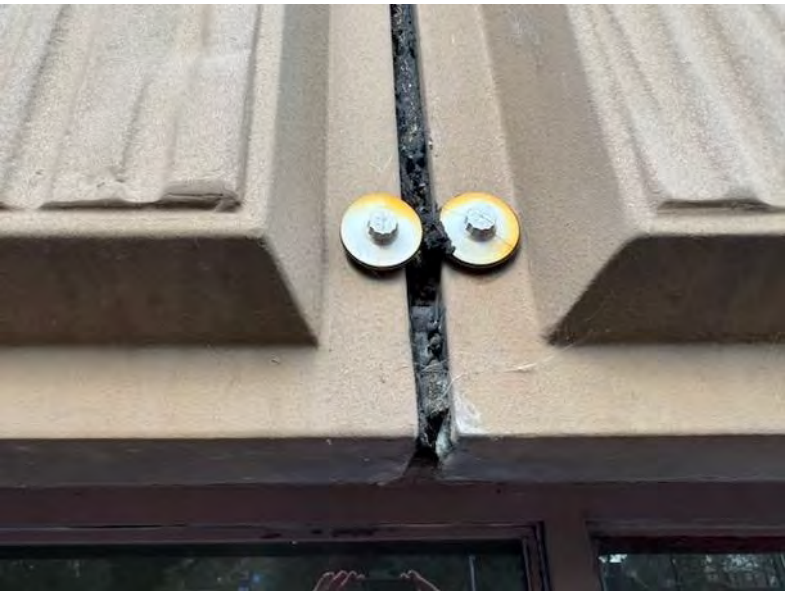
| 6. | The cover caps are rust stained suggesting the underlying fixings are corroding. | |

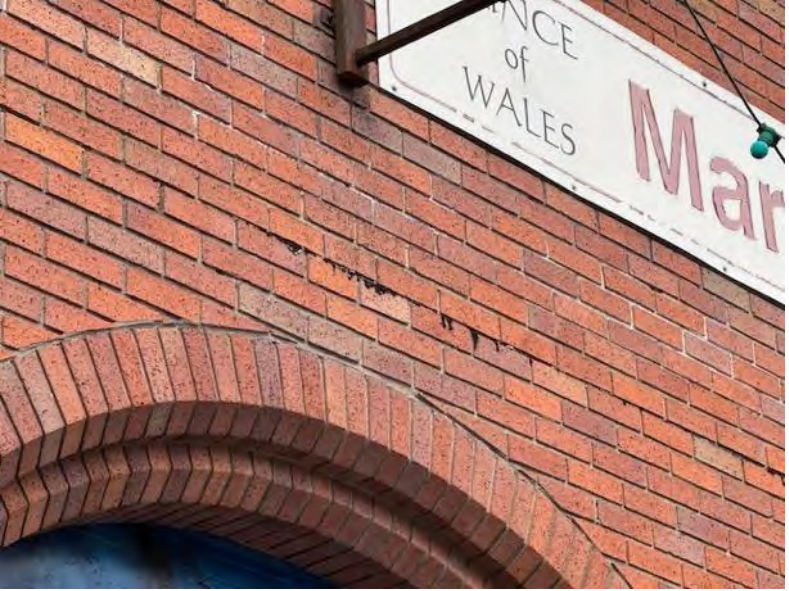
| <p>16.</p> | <p>The movement joint compound has bled slightly to the elevation between the ground and first floor. This remains relatively isolated.</p> | |

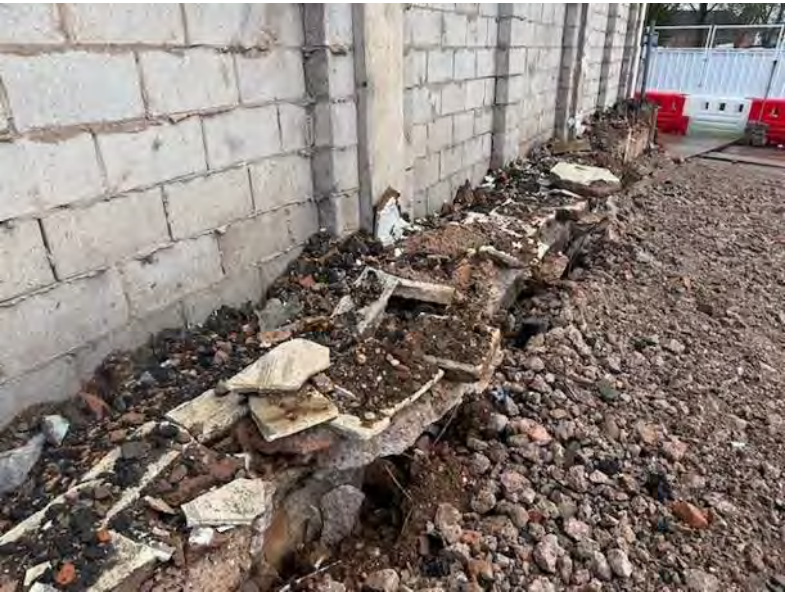
| 22. | Remnants of the floor and substructure to the former adjoining premises remain at low level. | A photograph showing the remnants of a floor and substructure at a low level, adjacent to a concrete wall. The ground is covered in rubble, including broken concrete slabs and debris. A concrete wall is visible on the left, and a gravel area is on the right. |

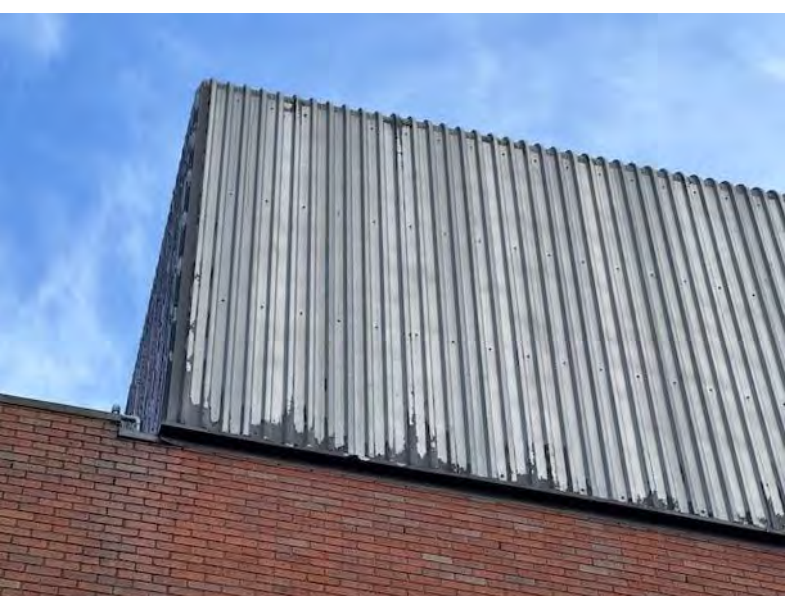
| 24. | The coating to the cladding has entirely failed exposing the metal substrate. | A photograph showing the profiled metal cladding with a failed coating, exposing the metal substrate. The cladding is silver, and the brickwork below is red. The building is viewed from a low angle, looking up. |

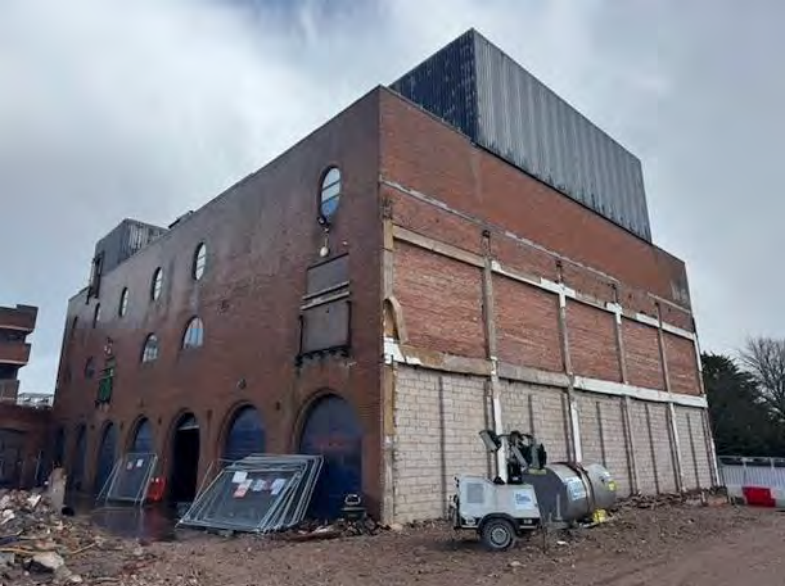
| <p>25.</p> | <p>Geneal view of the west (rear) elevation.</p> <p>Significant rainwater run off and soiling is visible to the high level brickwork</p> | |

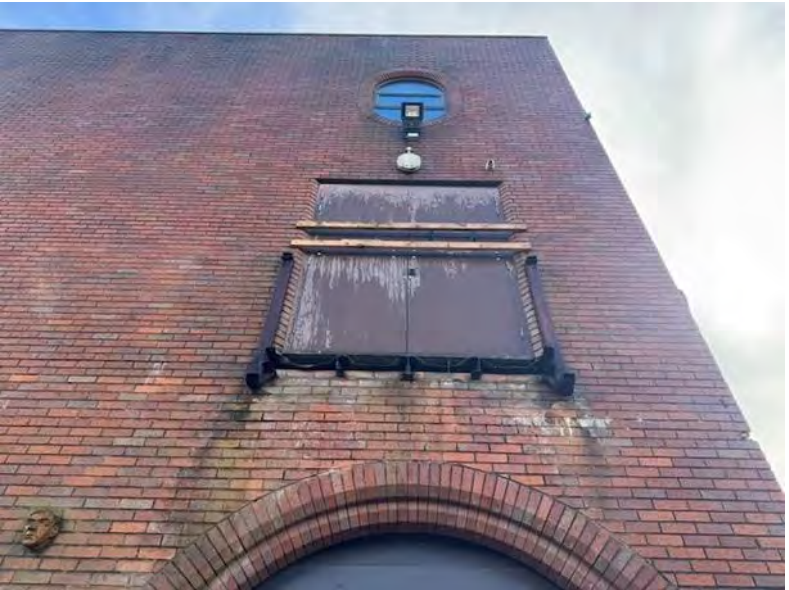
| <p>26.</p> | <p>The removal of adjacent link bridges and structures as part of the adjacent demolition works has left former door openings exposed.</p> | |

| | Risk |
|---|---|
| 10 The completion of adjacent demolition works to adjoining buildings and the removal of former link bridges has necessitated the need for more significant repairs to the elevations. This briefly includes recladding of the exposed south elevation, the making good of redundant apertures and reinstatement of safe means of escape to the west elevation. | ■ |

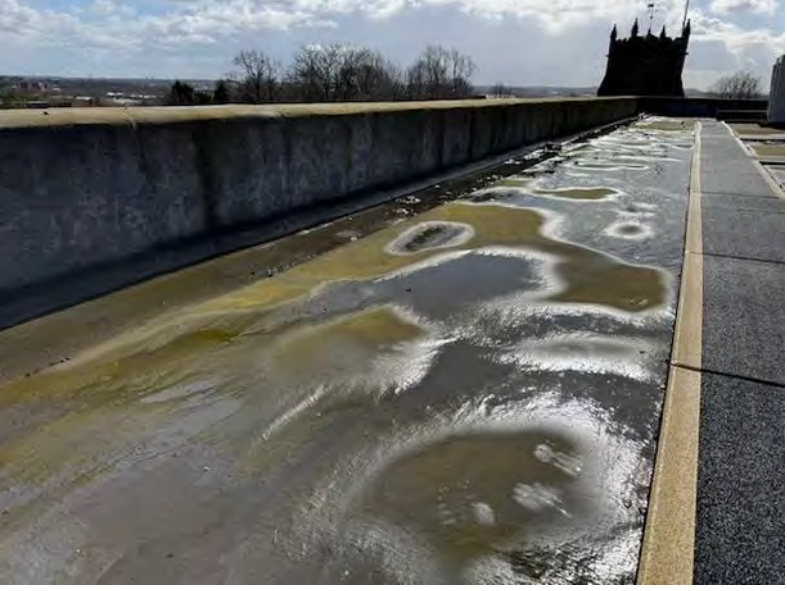
| 41. | <p>Core sampling is required to determine the exact makeup of the roof coverings, however these appear to comprise of felt overlaid with a liquid resin waterproofing. We expect a carrier board or a layer of former asphalt roof coverings may also be present below these areas.</p> <p>Several areas of blistering and undulation are visible to the roof coverings.</p> | |

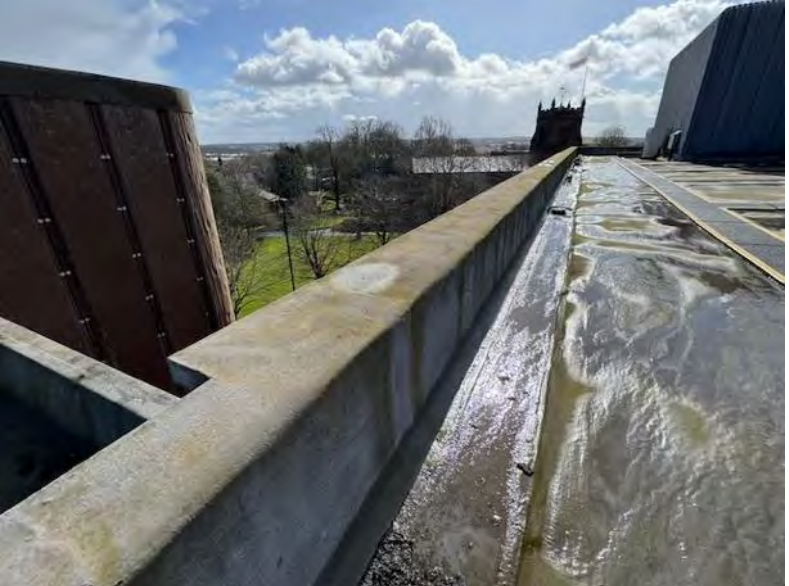
| <p>42.</p> | <p>View of the parapet gutter along the east elevation. The gutter was generally free flowing with only localised areas of silt and vegetation noted.</p> <p>More significant accumulations of silt, vegetation and waste materials were identified to the west parapet gutter.</p> <p>Note: Edge protection and safe means of access to the roof areas is inadequate and missing entirely to significant part of the roofs.</p> | |

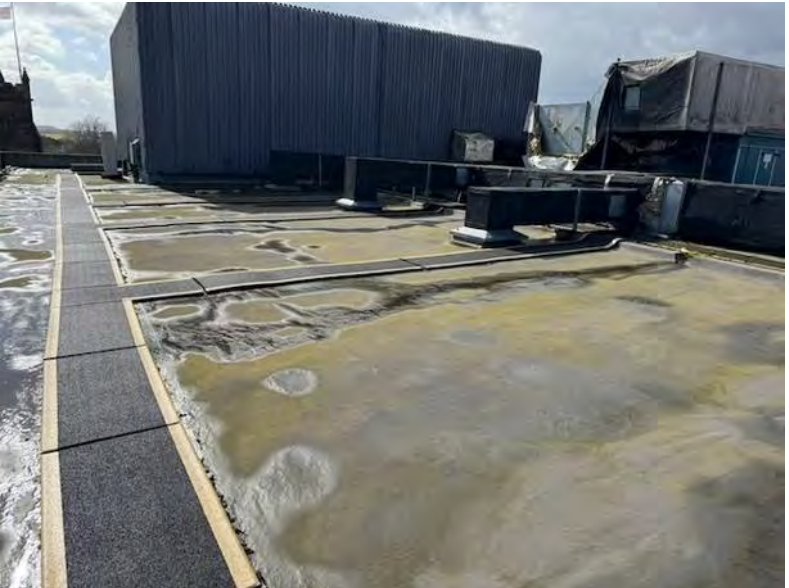
| <p>43.</p> | <p>Further view of undulation noted to the roof coverings.</p> | |

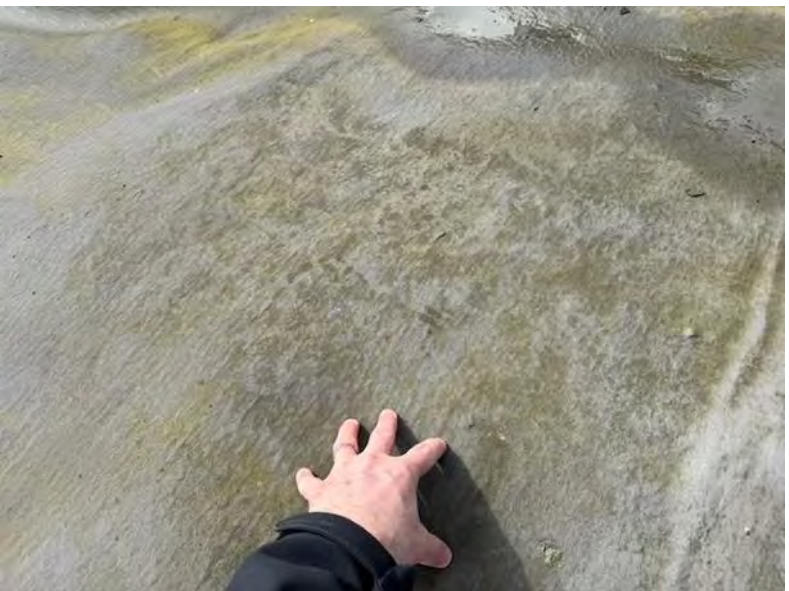
| | Risk |
|---|---|
| 4 <b>Roof and Rainwater Goods:</b> The flat roof coverings are in poor condition with evidence of localised rainwater ingress and more widespread signs of encapsulated moisture within the roof build up. We consider the roof coverings are approaching the end of their effective lifespan and recommend these be replaced with a guaranteed solution. | ■ |

| <p>44.</p> | <p>Several areas of encapsulated moisture are present below the roof coverings.</p> <p>We consider the roof coverings are life expired. The proposed solution to the replacement of the roof coverings will also need to be carefully considered in the context of the woodwool slab roof deck.</p> | |

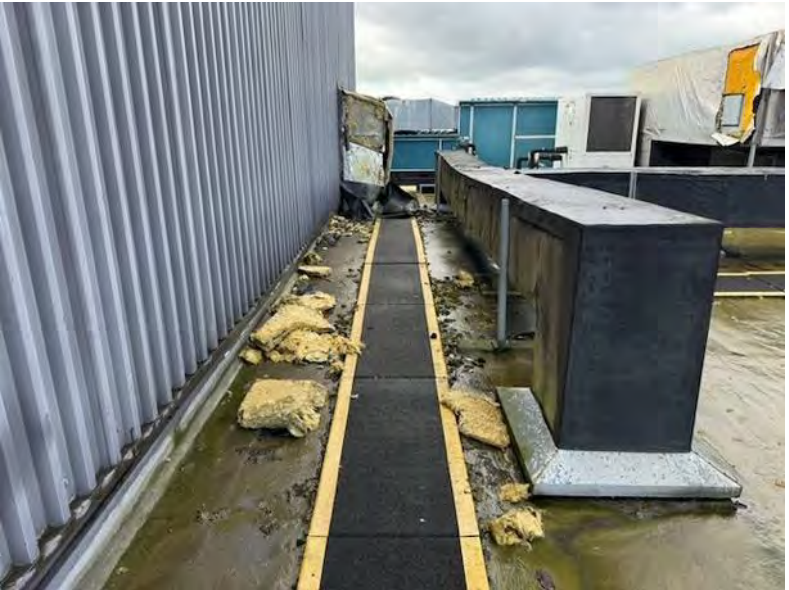
| <p>52.</p> | <p>View of displaced insulation accumulations across the roof.</p> | |

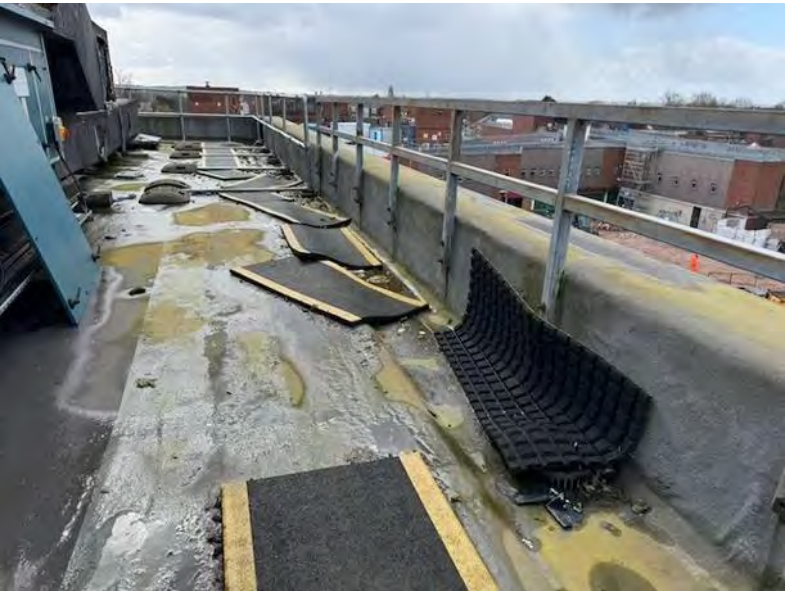
| <p>54.</p> | <p>The non-slip walkways are displaced to the south west roof areas.</p> | |

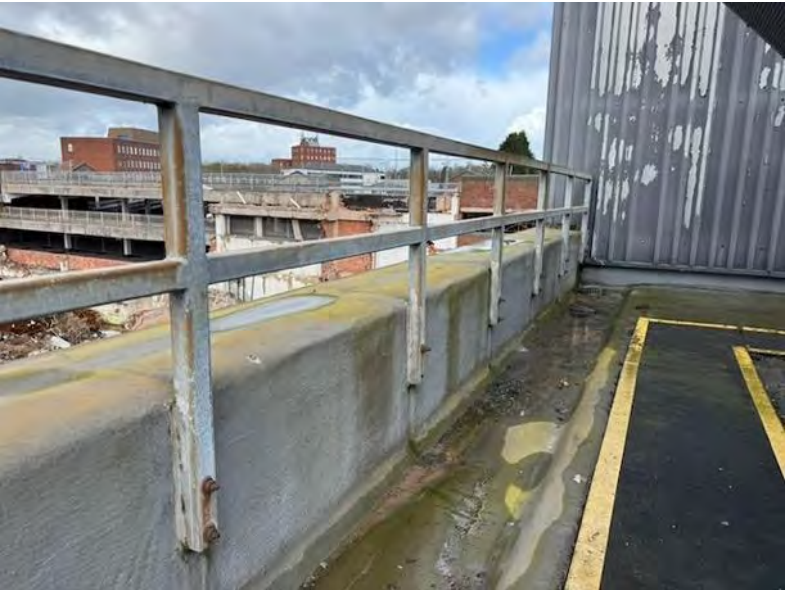
| <p>55.</p> | <p>Fixed edge protection is secured to parts of the west parapet.<br/><br/>The edge protection is in poor condition and there is no evidence of test certification.</p> | |

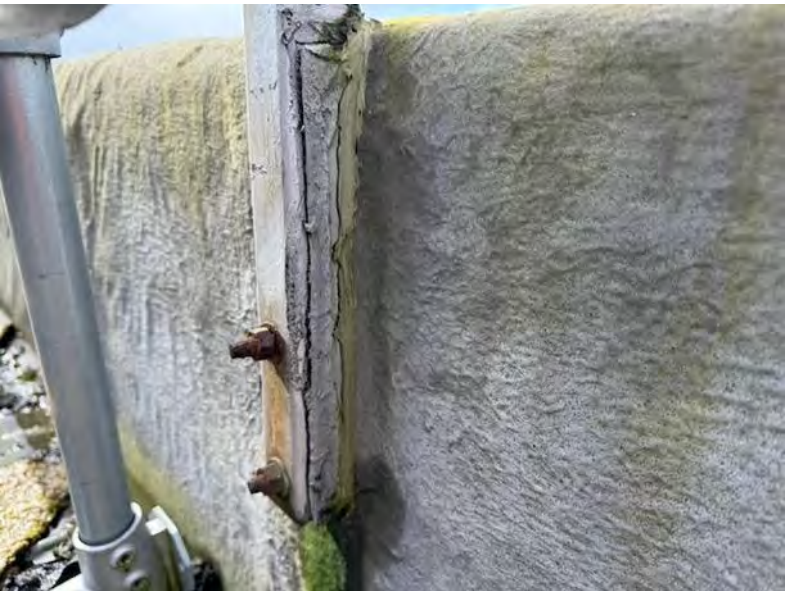
| <p>56.</p> | <p>Fixing bolts to the edge protection are corroded and this detail represents a vulnerable detail to rainwater ingress.</p> | |

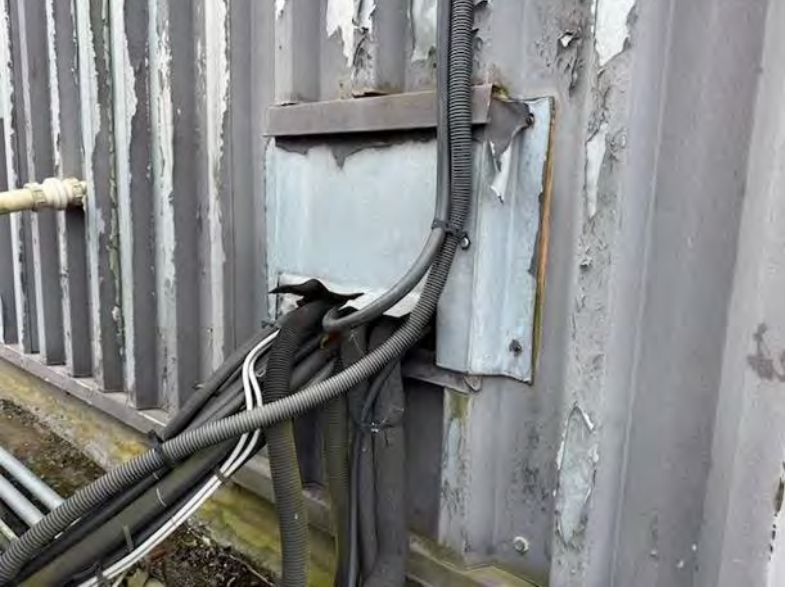
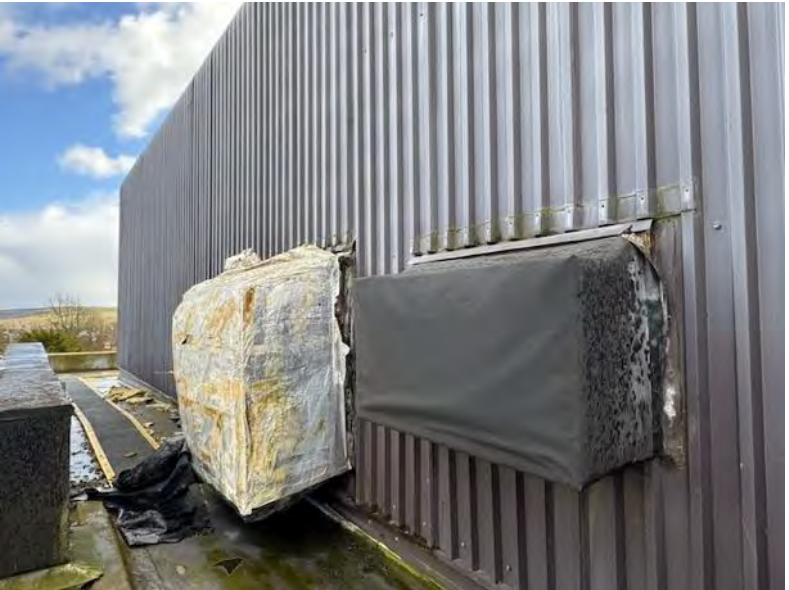
| 60. | <p>Several poorly formed services penetrations are visible across the roof areas which will be vulnerable to rainwater ingress.</p> | |
| 61. | <p>As above.</p> | |

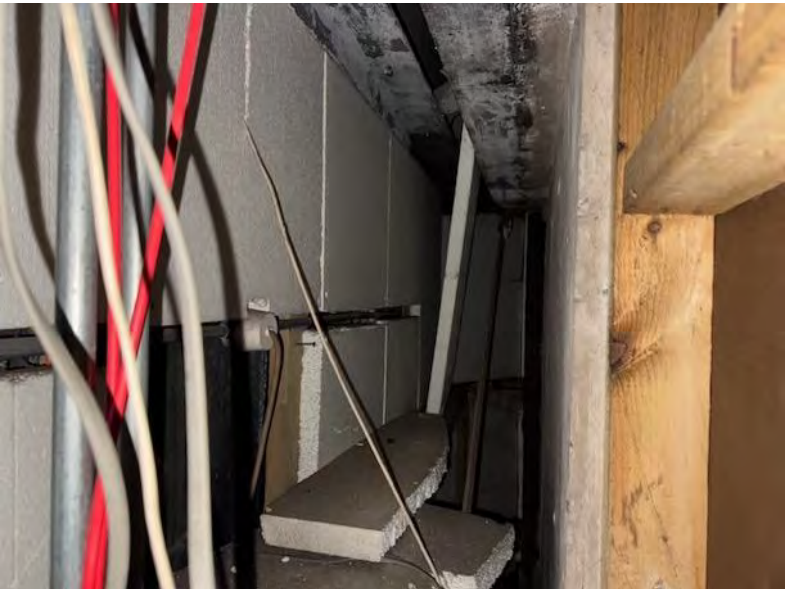
| <p>78.</p> | <p>An expanded polystyrene insulation is visible to the rear of the GRP cladding to the tower.</p> | |

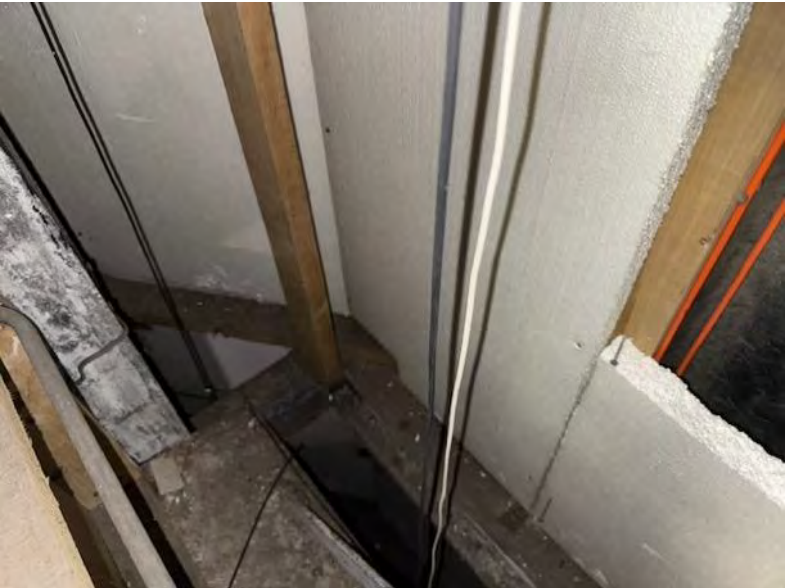
| <p>79.</p> | <p>The expanded polystyrene insulation is displaced to areas. We expect this insulation is highly flammable and should be replaced.</p> | |

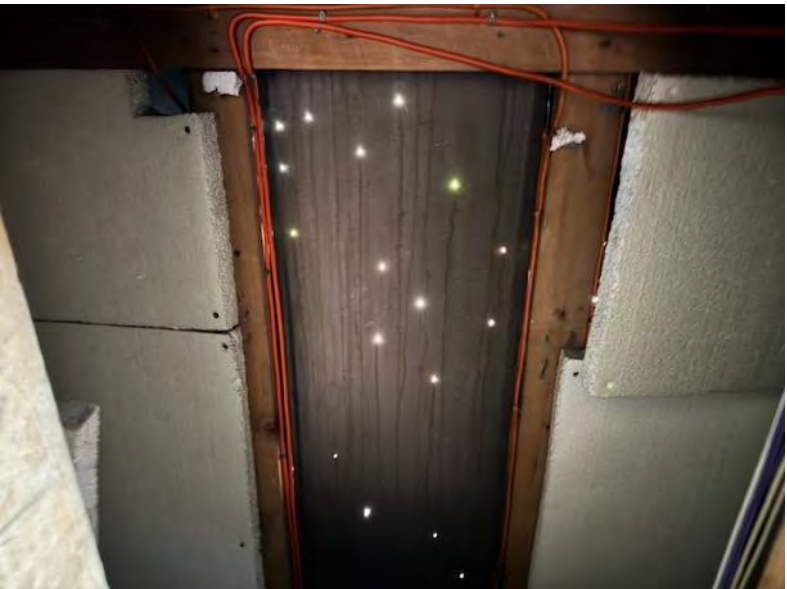
| <p>80.</p> | <p>View of the rear of the GRP cladding. Several redundant fixing holes are visible where previous signs or similar have previously been installed.</p> | |

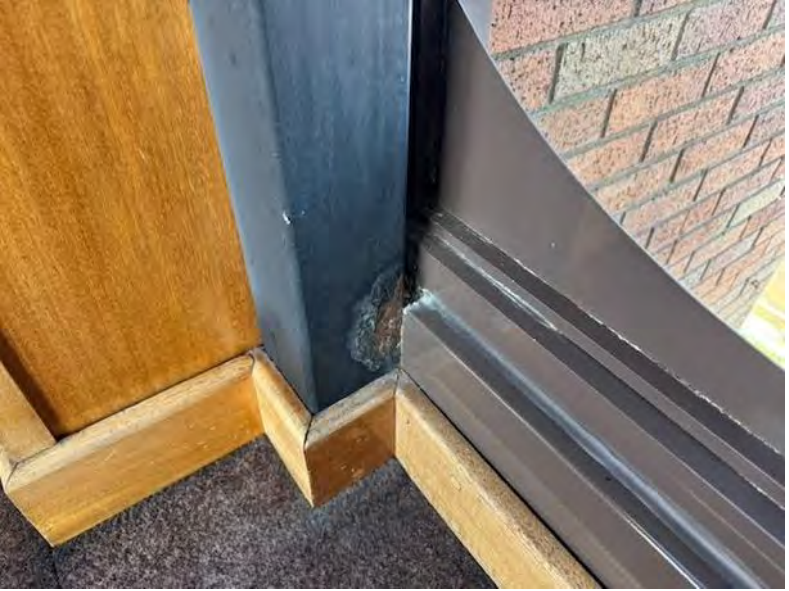
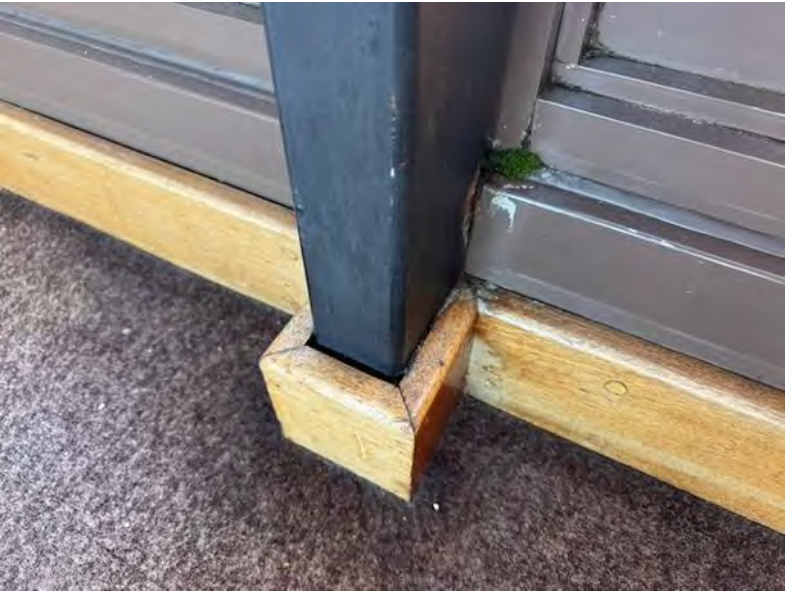
| 87. | Rainwater ingress is occurring via the windows with evidence of rusting to the steel columns and deterioration of joinery within these areas. | |
| 88. | As above. Note vegetation growth to the base rail where sustained rainwater ingress is occurring. | |

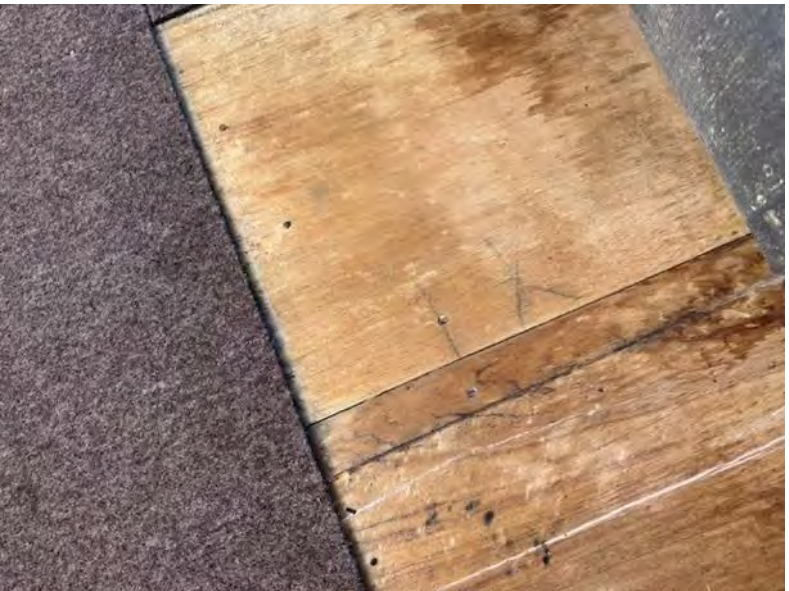
| 89. | <p>There is evidence of water staining to the plywood floor substrate and surface irregularity to the link bridge floors.</p> <p>Where visible above the suspended ceilings the timber floor joists were found to be in satisfactory condition, however, these will be susceptible to rot in areas of sustained rainwater ingress and further opening up is recommended.</p> | |

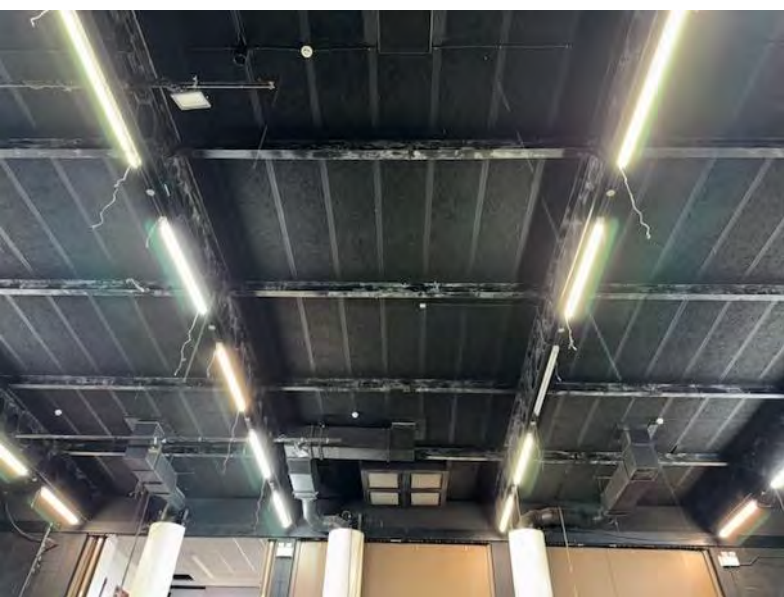
| | Risk |
|---|---|
| 5 The flat roof decks are formed from channel reinforced wood wool slabs which are classified as a fragile material in roof construction. Careful consideration needs to be given towards the impact this may have on both current access to the roof areas and the long term approach towards the repair of the flat roofs. However, for the avoidance of doubt these should be treated as fragile unless proved otherwise. | ■ |

| <p>92.</p> | <p>View of the castellated steel beam, steel purlins and channel reinforced wood wool slabs forming the roof structure.</p> <p>Woodwool slabs in roof construction are classified as a fragile material under HSE – Health and Safety in Roof Work (HSG33) Guidance. Factors such as the depth of the slabs, exposure to water, condition of reinforcement and roof loads will need to be established, to determine the level of risk, but where this cannot be determined the roof deck should be treated as a fragile.</p> <p>Consideration will need to be given towards the replacement of the roof deck as part of any works to replace the roof coverings. This will be a significant undertaking.</p> | |

| | Risk |
|---|---|
| 6 Whilst further investigations may support circumstances where the flat roof decking can be retained, it is difficult at this stage to support a case for replacing roof coverings over a material classified as fragile. It may be viable to provide additional support to strengthen the roof deck, however, in the long term interest we recommend that the wood wool decks be replaced. | ■ |

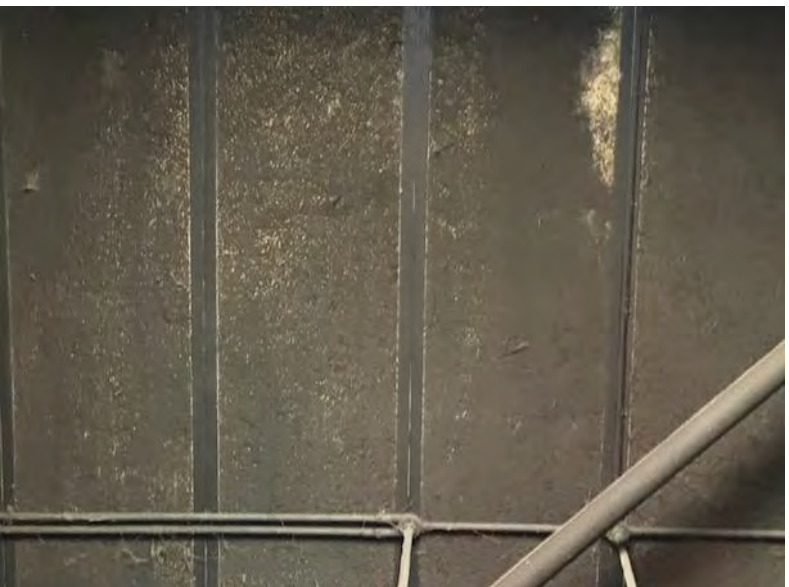
| 95. | The painting of the channel reinforced woodwool slabs in black makes the visual assessment of their condition difficult. However, there is evidence of localised deterioration and rainwater ingress. | |

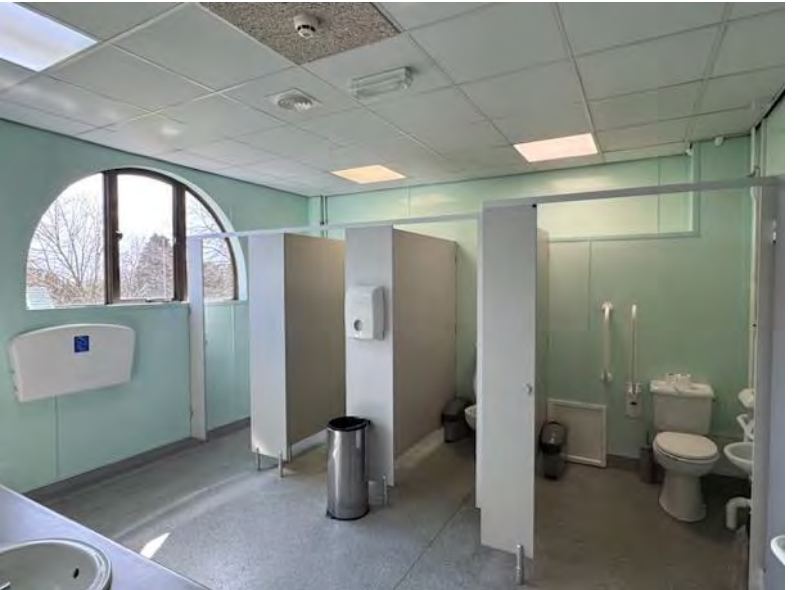
| 106. | Finishes within the toilets are generally worn and dated in appearance. | A photograph showing the interior of a toilet stall area. The walls are a light green color, and the floor is a grey speckled tile. There are white partitions for the stalls. A white toilet is visible in the background. A silver trash bin is in the foreground. The ceiling has a drop grid with fluorescent lights. |

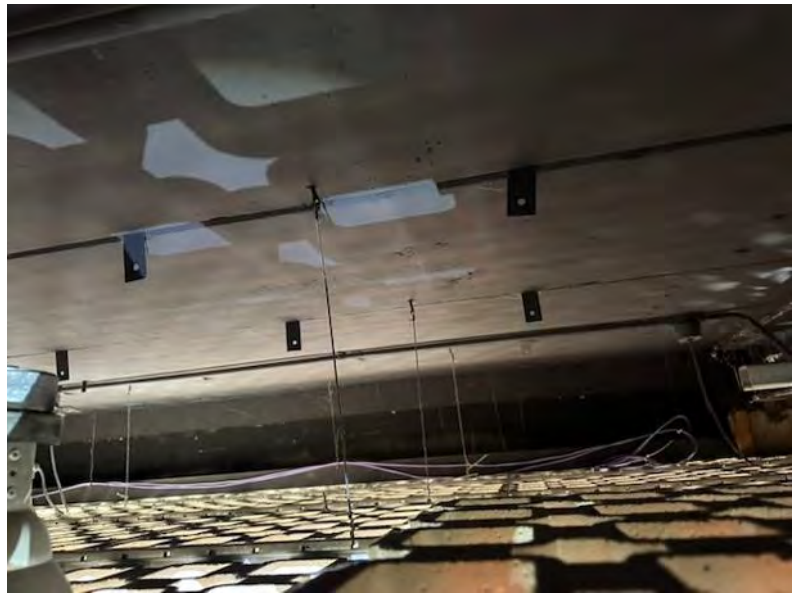
| | Risk |
|---|---|
| 2 We identified localised areas of concrete planks to the second floor structure. Whilst these appear consistent with a reinforced pre-cast concrete plank, access for inspection is limited and we recommend further investigations to confirm that no Reinforced Autoclaved Aerated Concrete (RAAC) is present. | ■ |

| 109. | <p>A pre-cast concrete plank floor structure was noted to part of the second floor soffit to the east of the property. The planks incorporate fixing lugs for hanging ceilings, however, these are not utilised.</p> <p>The planks would appear to be limited to a small area of the second floor only.</p> <p>The floor soffit is painted black making its visual inspection and identification of defects difficult. Whilst these appear consistent with a pre-cast concrete plank, further investigation is required to verify that no Reinforced Autoclaved Aerated Concrete (RAAC) planks have been utilised.</p> | |

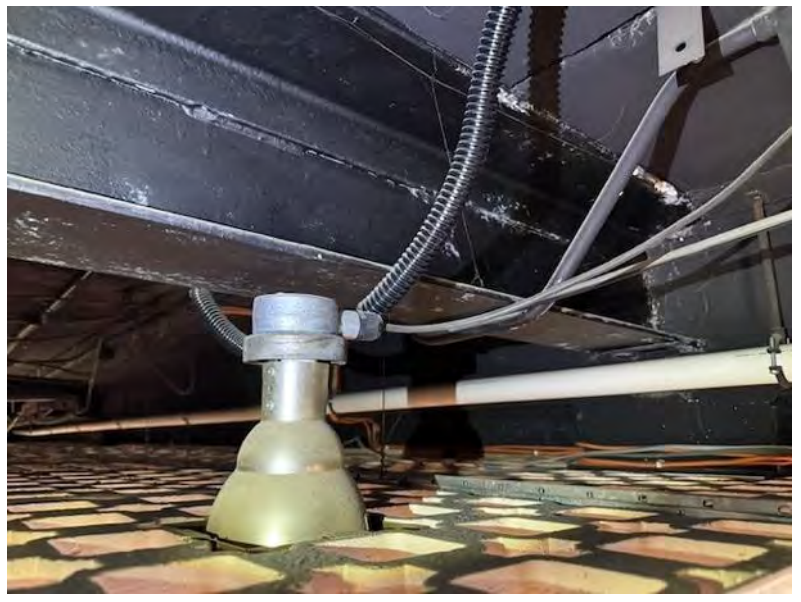
| 110. | <p>No fixed fire protection is provided to the steel downstand beams below the second floor. We expect the exposed steel work has been applied with an intumescent paint however further investigation is required to confirm.</p> <p>The paint finish is also degraded in areas of previous leaks.</p> | |

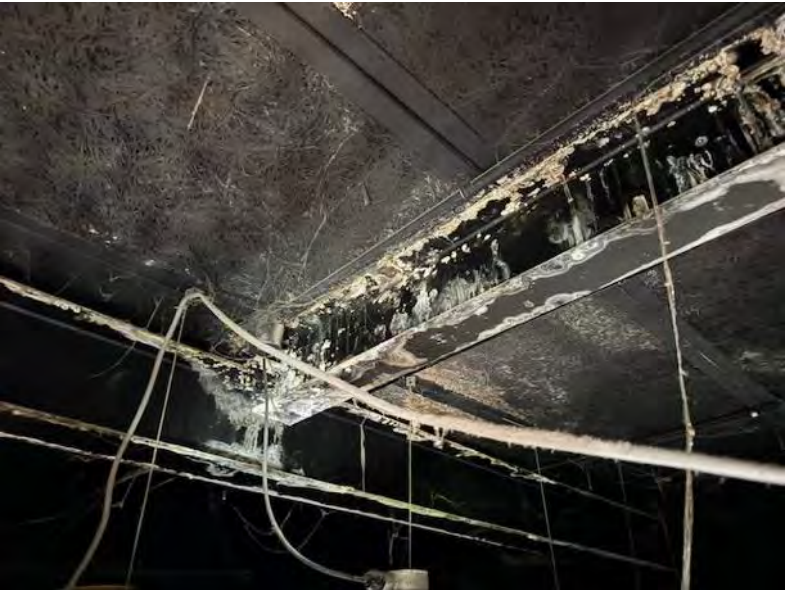
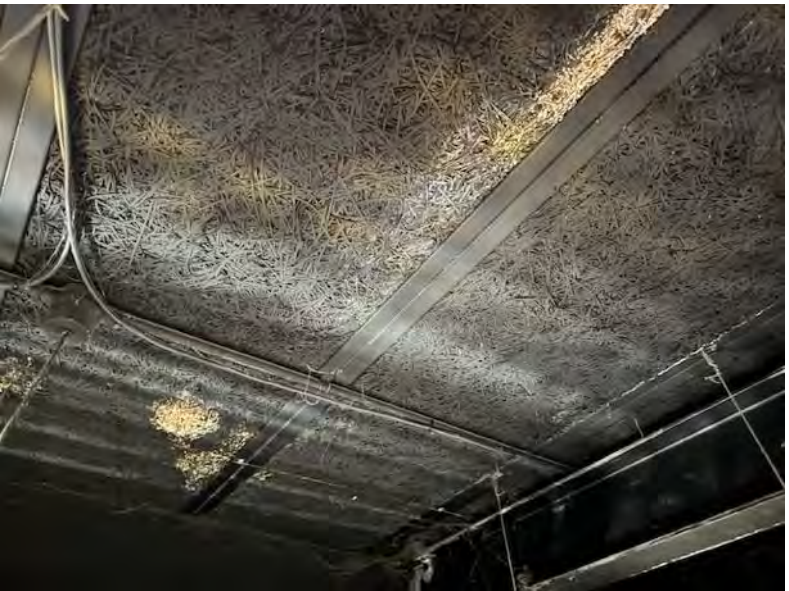
| 124. | There is evidence of rainwater ingress via the roof coverings, particularly to the south east, with evidence of deterioration to the channel reinforced woodwool slabs and steelwork. | |
| 125. | As above. | |

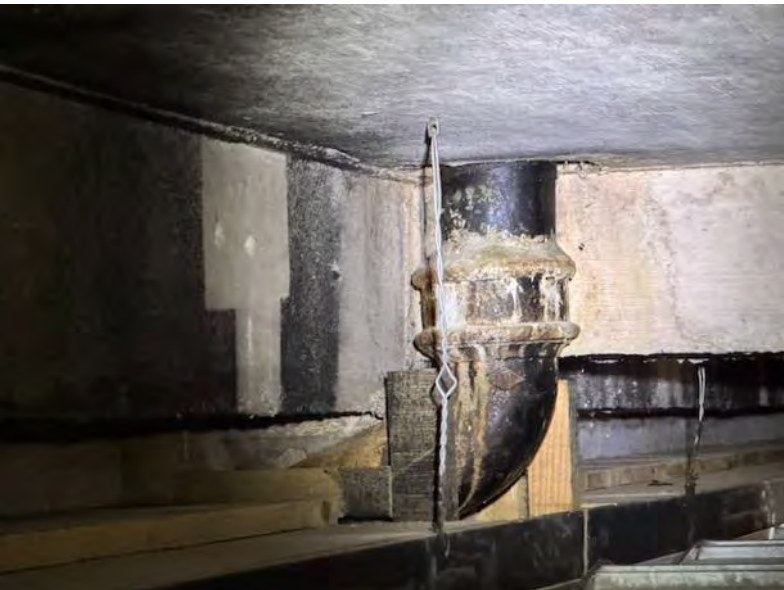
| <p>127.</p> | <p>There is evidence of leaks to the internal rainwater pipes. A CCTV survey is recommended to determine the condition of the pipes and to ensure these are free of blockages. Repairs are likely to be required at joints.</p> | |

| | Risk |
|---|---|
| 8 Localised leaks were identified to the cast rainwater pipes, with evidence of corrosion. We recommend CCTV surveys be undertaken and the rainwater goods overhauled. | ■ |

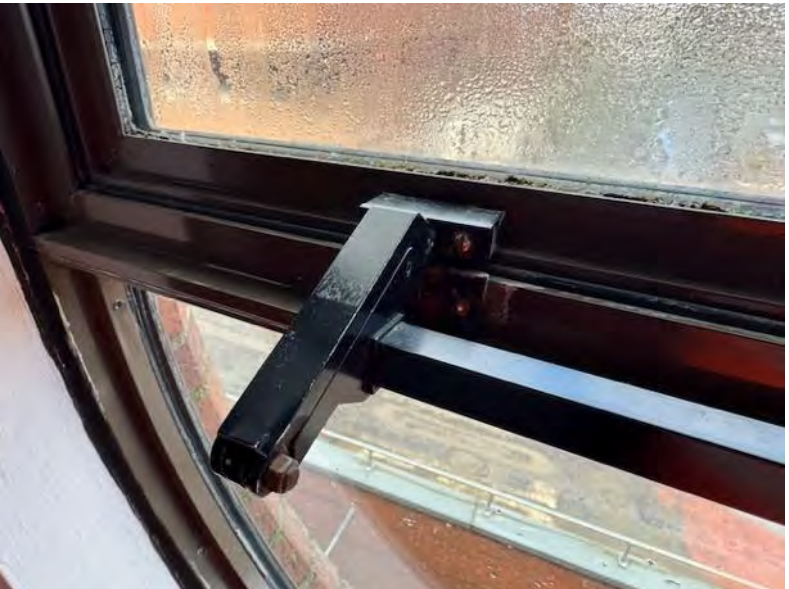
| 132. | <p>The quadilient stay ironmongery to the window opening lights is in poor condition and the opening lights are difficult to operate.</p> | A close-up photograph of a black metal window stay mechanism. The mechanism is mounted on a dark brown window frame. The metal shows signs of wear, including rust and peeling paint. The window glass is visible in the background, showing some condensation or dirt. |

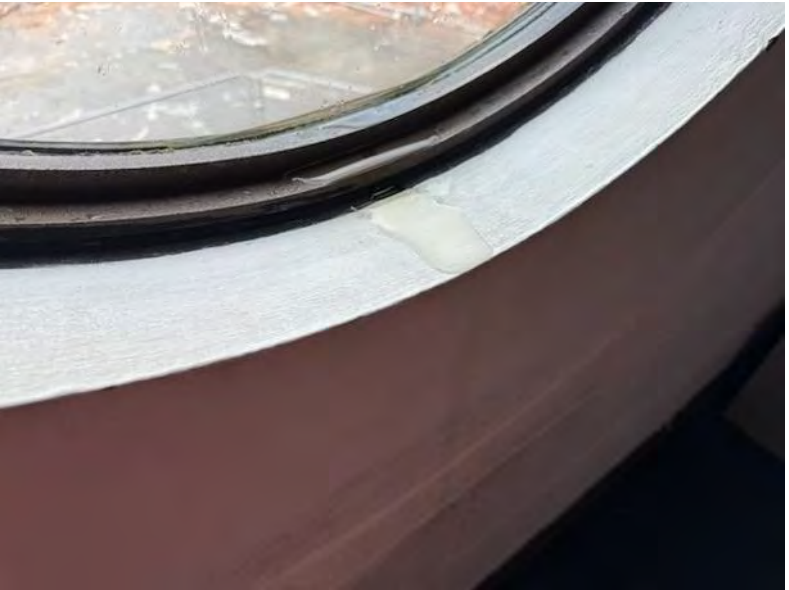
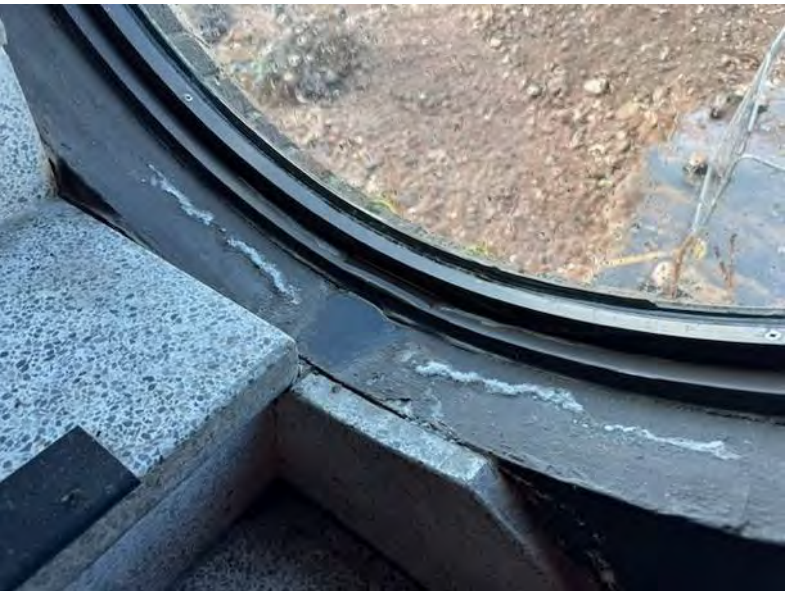
| 133. | <p>Further evidence of rainwater ingress to the second floor windows. This is typical throughout.</p> | A close-up photograph of a window frame. The frame is made of dark brown material, possibly wood or metal. There is a visible gap between the frame and the wall, and some white, crystalline deposits are visible on the frame, indicating water ingress and mineral deposits. |
| 134. | <p>As above to the west elevation.</p> | A close-up photograph of a window frame. The frame is made of dark brown material, possibly wood or metal. There is a visible gap between the frame and the wall, and some white, crystalline deposits are visible on the frame, indicating water ingress and mineral deposits. |

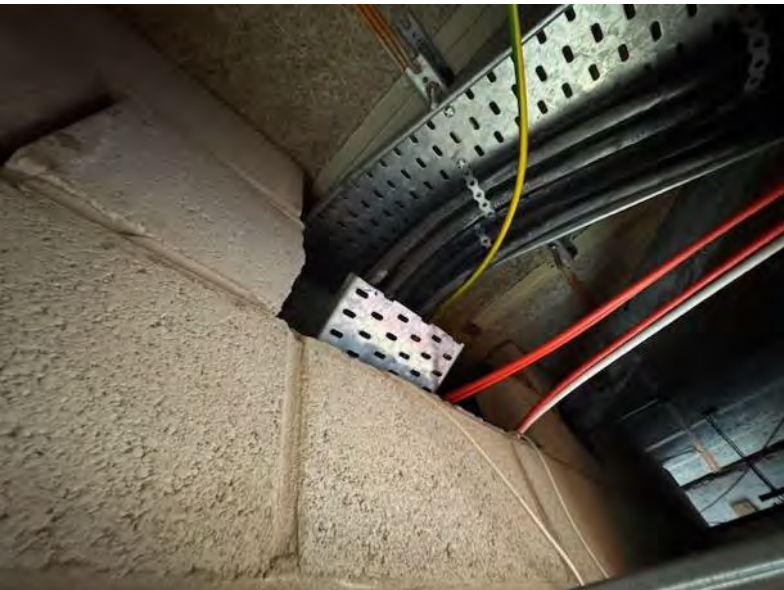
| 136. | <p>Gaps in fire stopping were identified around services penetrations through compartment walls.</p> | |

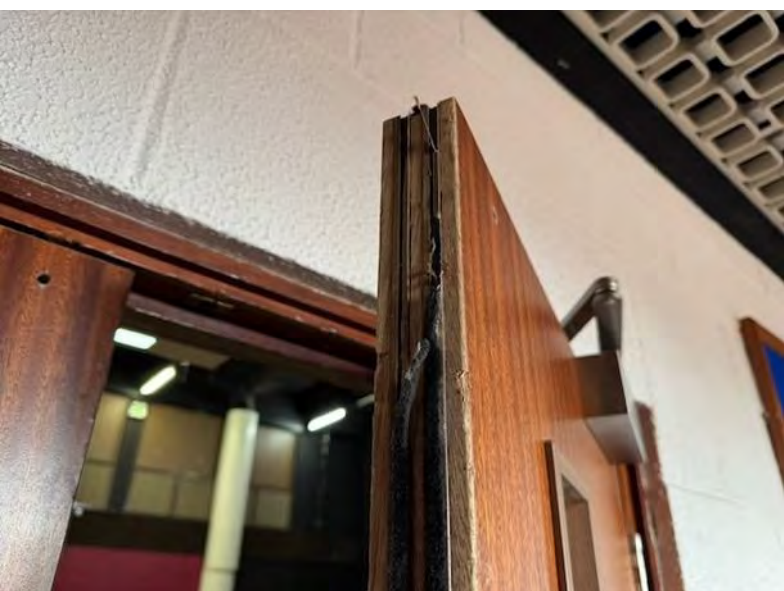
| 137. | <p>Internal doors are generally worn and dated in appearance, with evidence of more significant impact damage and defective intumescent strips / smoke seals to the principal circulation areas.</p> <p>An audit of all fire doors will need to be undertaken, however, significant door replacements will be required.</p> | |

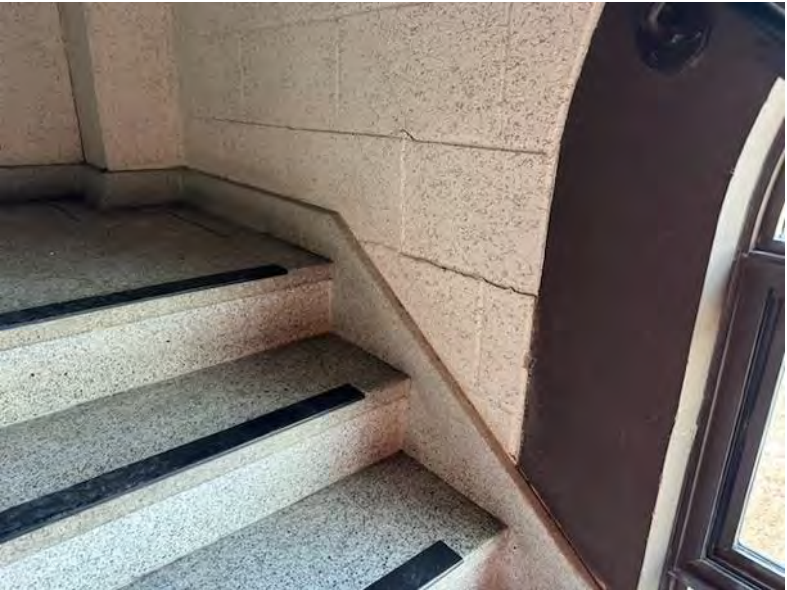
| <p>139.</p> | <p>Localised cracking is evident through the internal blockwork face along the west elevation. This remains relatively minor, however, we recommend this is monitored. The cracking identified may be linked to adjacent construction works.</p> | |
