# Prince of Wales Theatre Refurbishment & Demolition Survey

Prepared for: Cannock Chase District  
Council

Report Number:  
Cannock/Theatre/260417

# Asbestos Demolition Survey

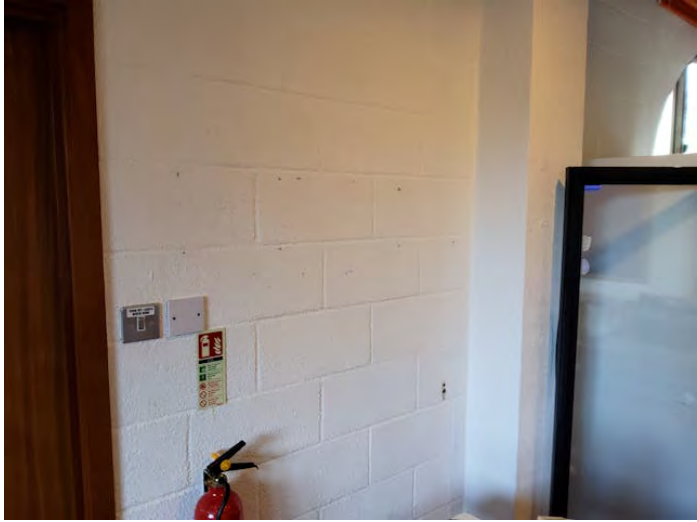
| Material | Textured Coating | Extent | <100 sq. m. |
| Strategy / Sample Id | Sample / S010 | Fibre Type | NADIS |
| General Comments | Textured coating | | |

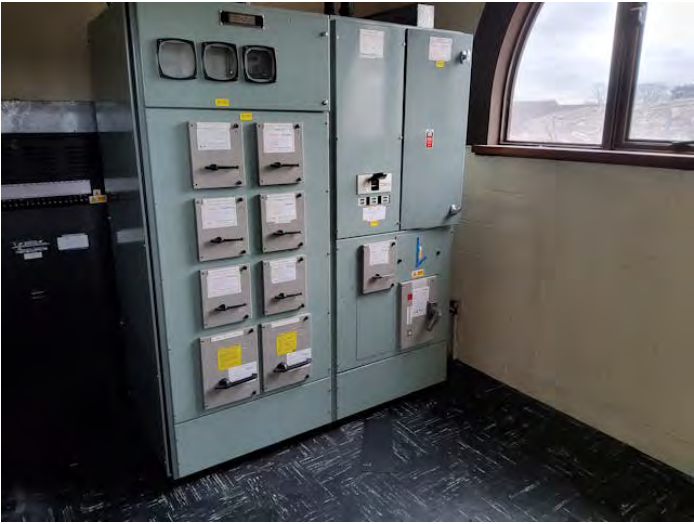
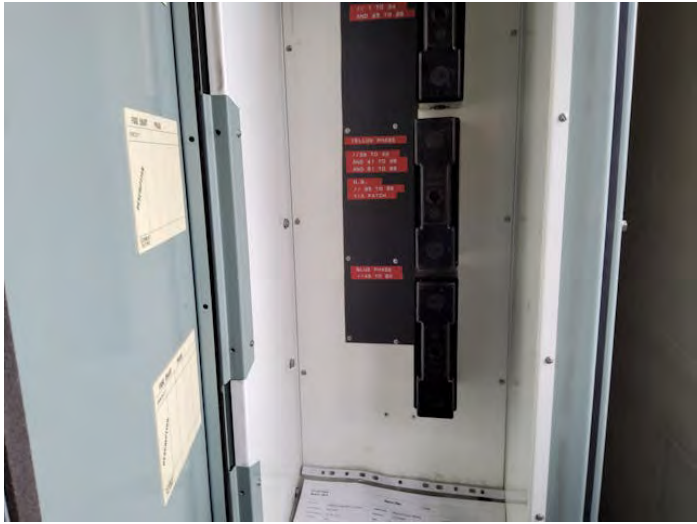
| Material | Flashguards | Extent | <10No. |
| Strategy / Sample Id | Strongly Presume | Presumed Fibre Type | Chrysotile |

| Product Type (or Debris from Product) | 2 | Extent of Damage / Deterioration | 0 |

| Recommendation | Removal by trained operatives | | |

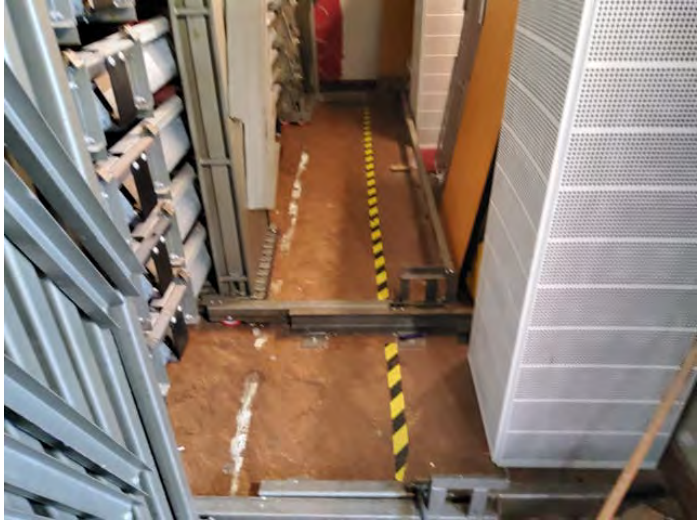
| Material | Linoleum | Extent | 16m. sq |
| Strategy / Sample Id | Sample / S011 | Fibre Type | NADIS |
| General Comments | Modern lino | | |

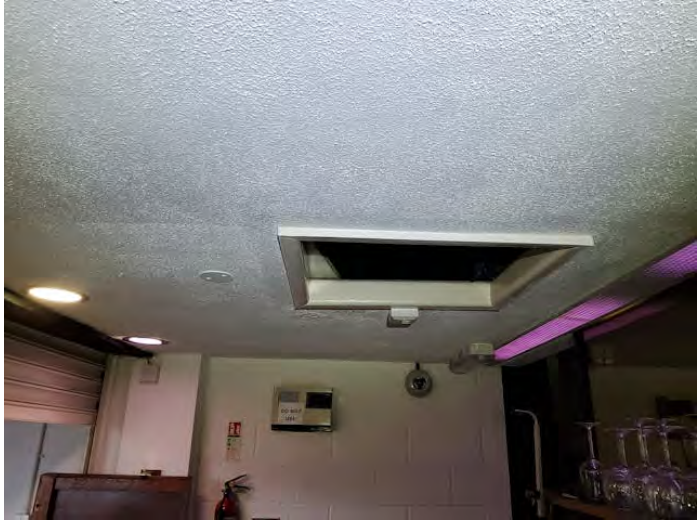
| Material | Textured Coating | Extent | 10m |
| Strategy / Sample Id | Sample / S014 | Fibre Type | NADIS |
| General Comments | Textured coating | | |

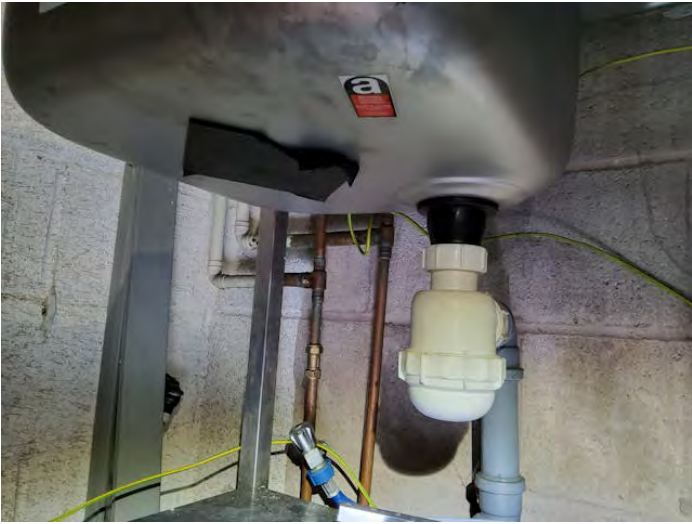
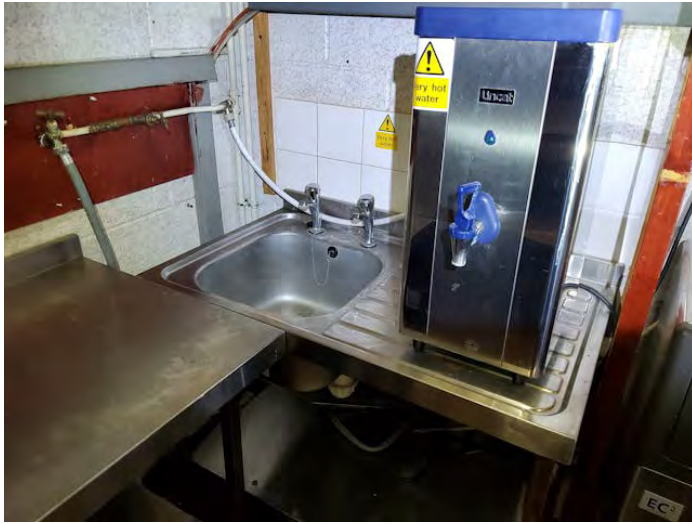
| Material | Acoustic pad | Extent | 1 |
| Strategy / Sample Id | Strongly Presume | Presumed Fibre Type | Chrysotile |

| Product Type (or Debris from Product) | 1 | Extent of Damage / Deterioration | 0 |

| Recommendation | Removal by licensed contractor | | |

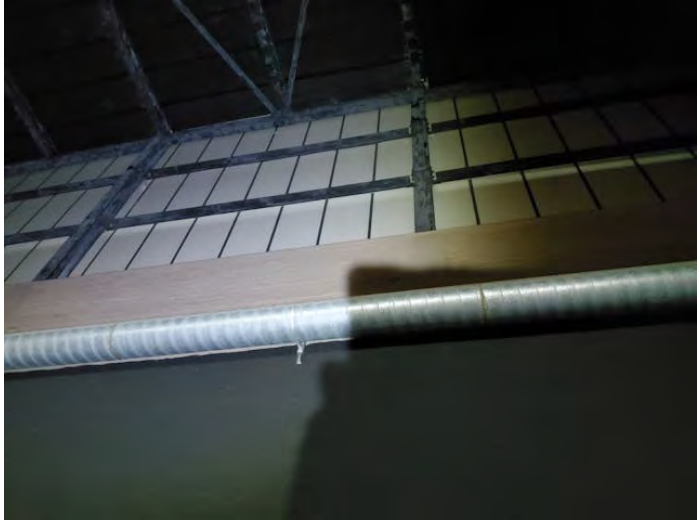
| Material | Insulating Board | Extent | <250 sqm |
| Strategy / Sample Id | Sample / S015 | Fibre Type | NADIS |
| General Comments | High level insulation Board | | |

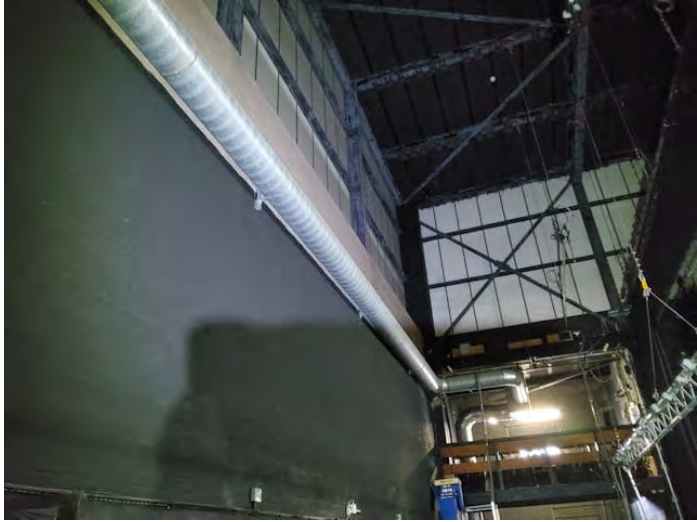
| Material | Mastic | Extent | Throughout |
| Strategy / Sample Id | Sample / S016 | Fibre Type | NADIS |
| General Comments | Mastic to ventilation | | |

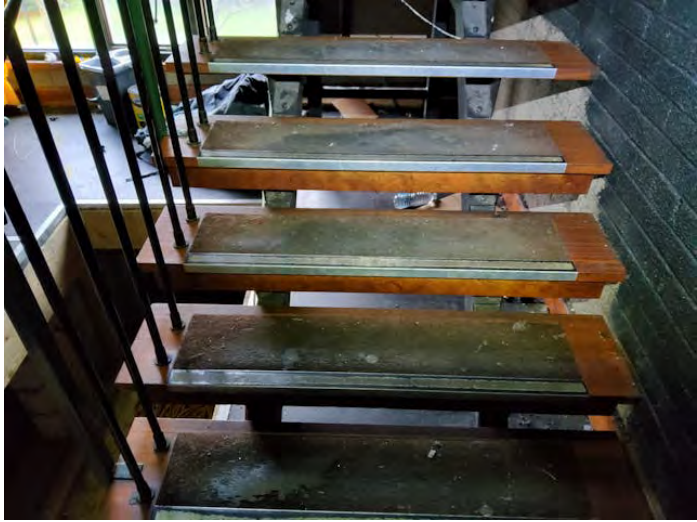
| Material | Stair nosing | Extent | 12 No. |
| Strategy / Sample Id | Sample / S017 | Fibre Type | NADIS |
| General Comments | Stair Noses | | |

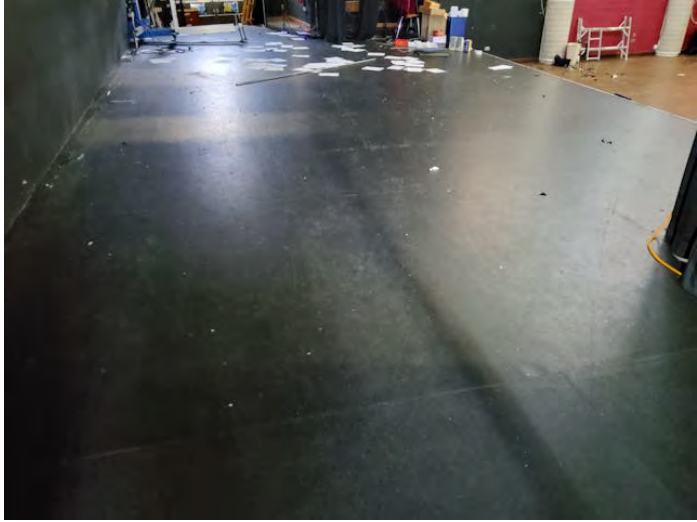
| Material | Modern Linoleum | Extent | 200 sqm |
| Strategy / Sample Id | Sample / S018 | Fibre Type | NADIS |
| General Comments | Modern lino | | |

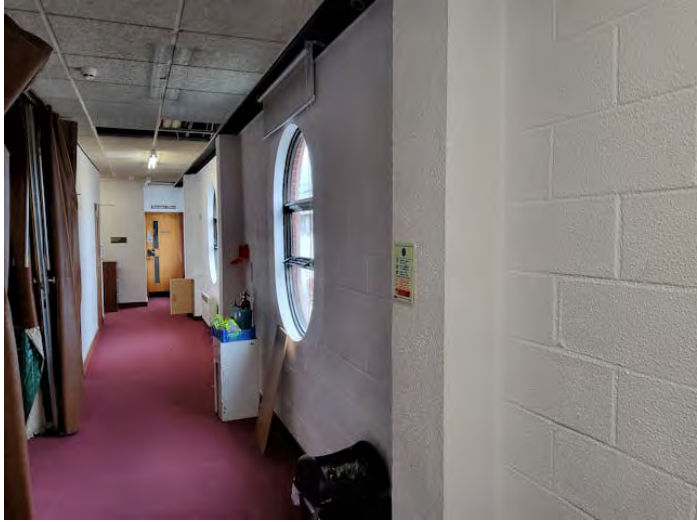
| Material | Textured Coating | Extent | <200 sqm |
| Strategy / Sample Id | Sample / S001 | Fibre Type | NADIS |
| General Comments | Textured coating to walls and ceiling | | |

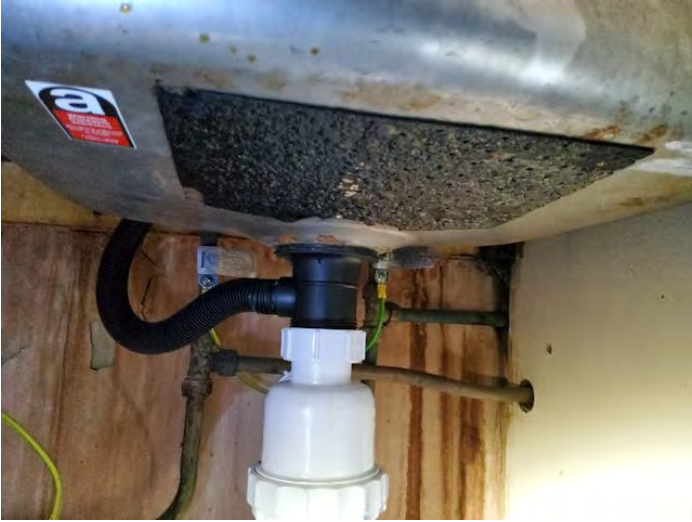
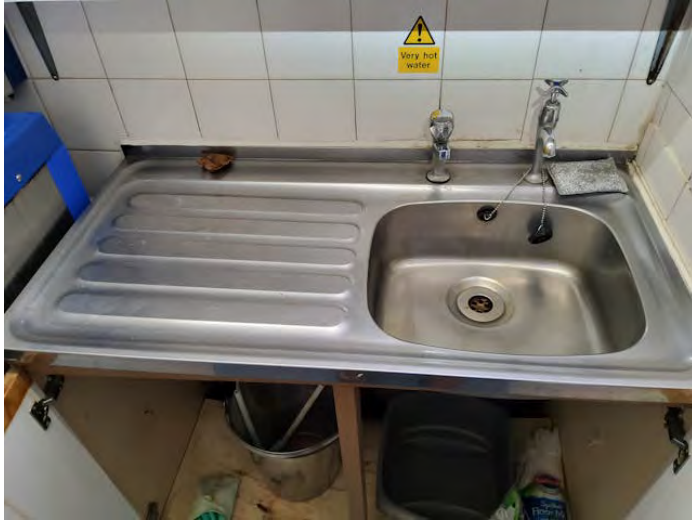
| Material | Acoustic pad | Extent | x1 |
| Strategy / Sample Id | Strongly Presume | Presumed Fibre Type | Chrysotile |

| Product Type (or Debris from Product) | 1 | Extent of Damage / Deterioration | 1 |

| Recommendation | Remove | | |

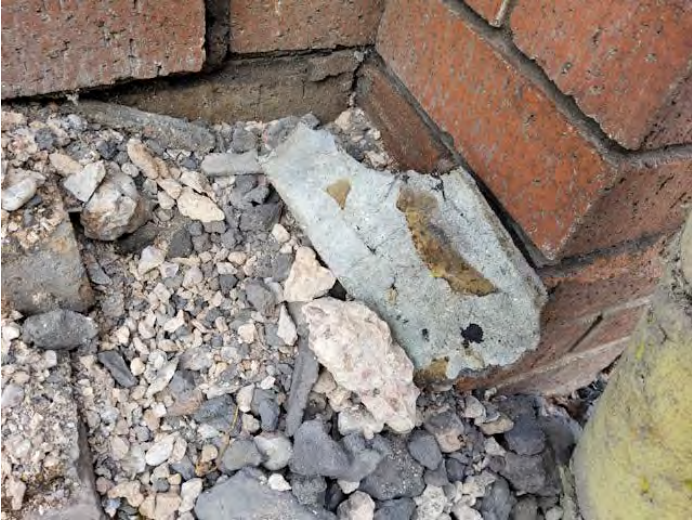
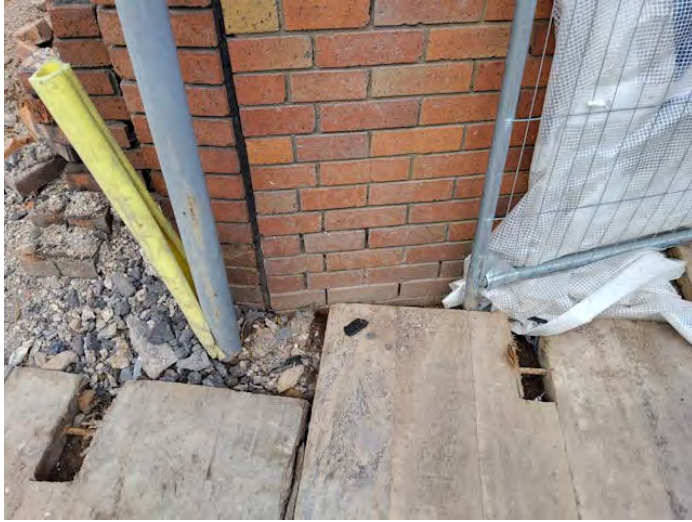
| Material | Bituminous Product | Extent | <150LM |
| Strategy / Sample Id | Sample / S030 | Fibre Type | Chrysotile |

| Product Type (or Debris from Product) | 1 | Extent of Damage / Deterioration | 0 |

| Recommendation | Removal by licensed contractor | | |

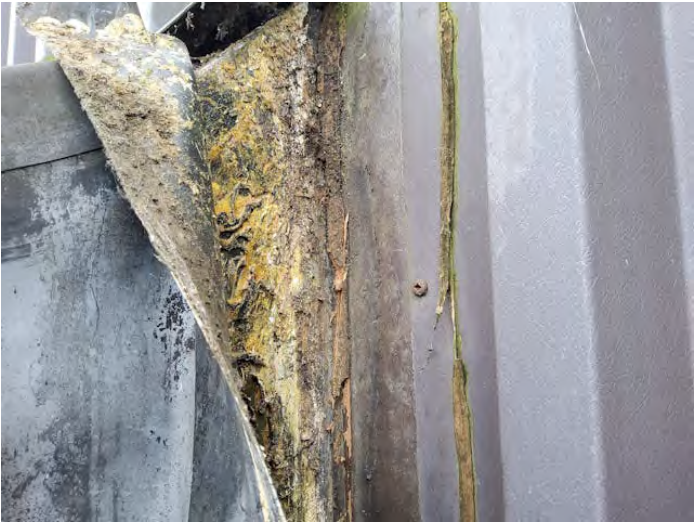
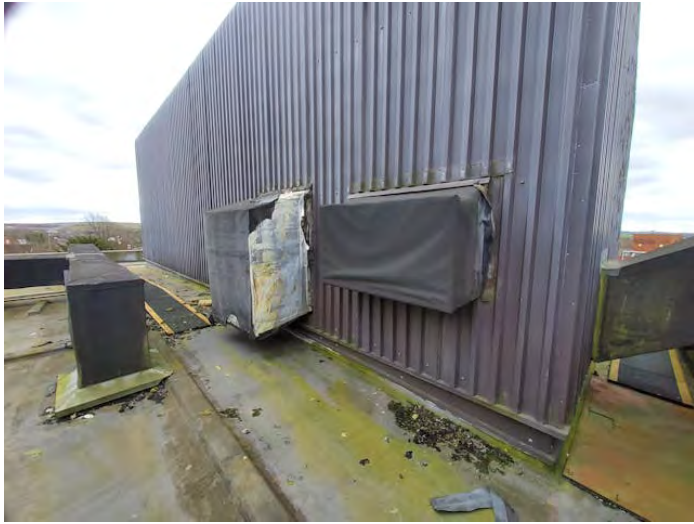
| Material | Mastic | Extent | Throughout system |
| Strategy / Sample Id | Sample / S008 | Fibre Type | Chrysotile |

| Product Type (or Debris from Product) | 1 | Extent of Damage / Deterioration | 0 |

| Recommendation | Removal by licensed contractor | | |

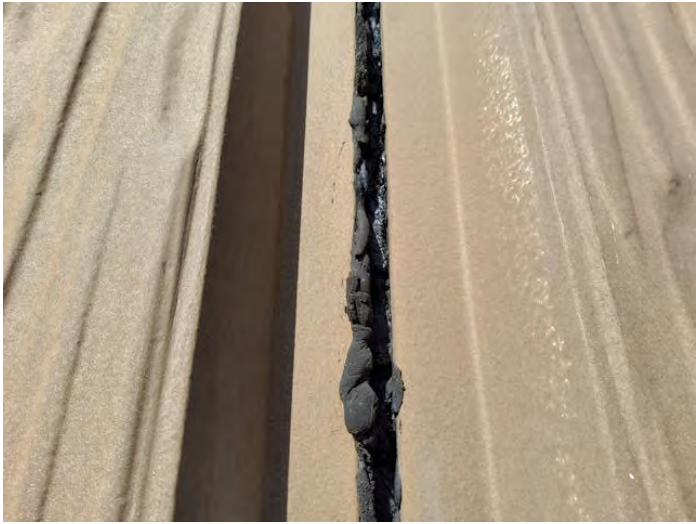
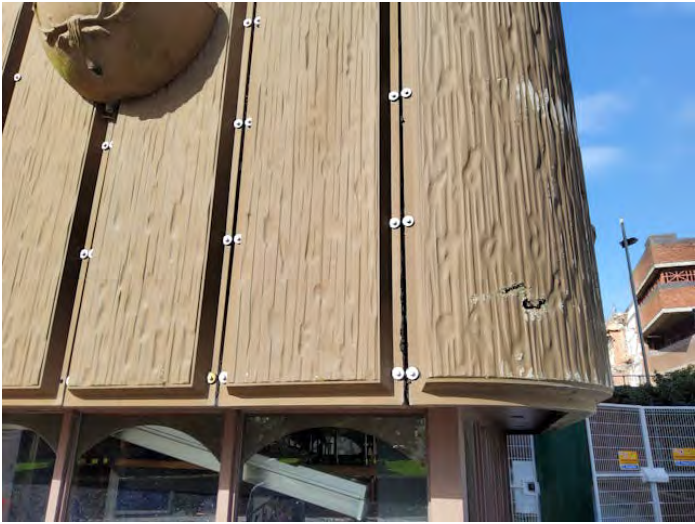
| Material | Mastic | Extent | 400LM |
| Strategy / Sample Id | Sample / S029 | Fibre Type | NADIS |

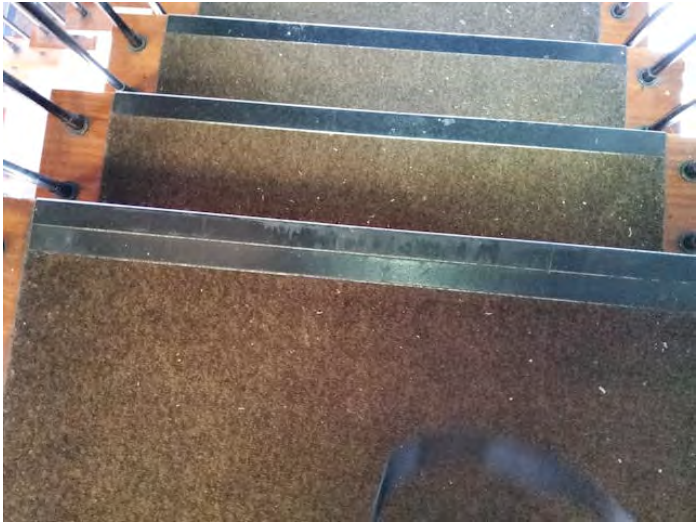
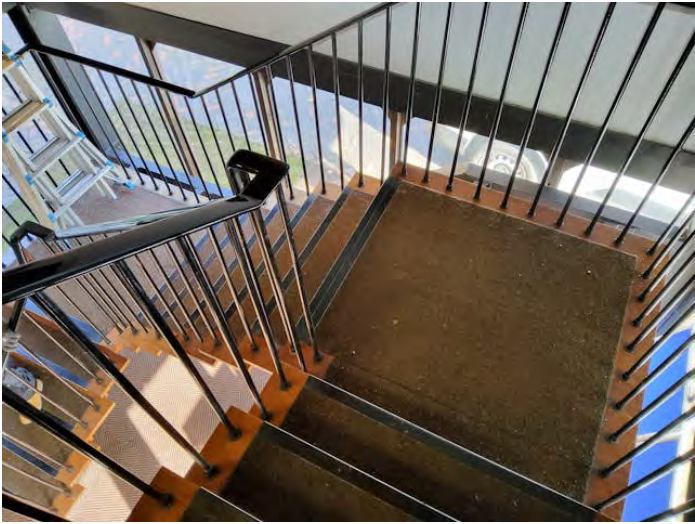
| Material | Stair nosing | Extent | 15 |
| Strategy / Sample Id | Strongly Presume / S022 | Presumed Fibre Type | NADIS |
