**Cannock Chase District  
Council**

**Environmental Protection Act  
1990, Part 2A: Initial Site  
Investigation**

**Land West of Fiveways,  
Cannock Road, Heath Hayes,  
Staffordshire**

February 2012

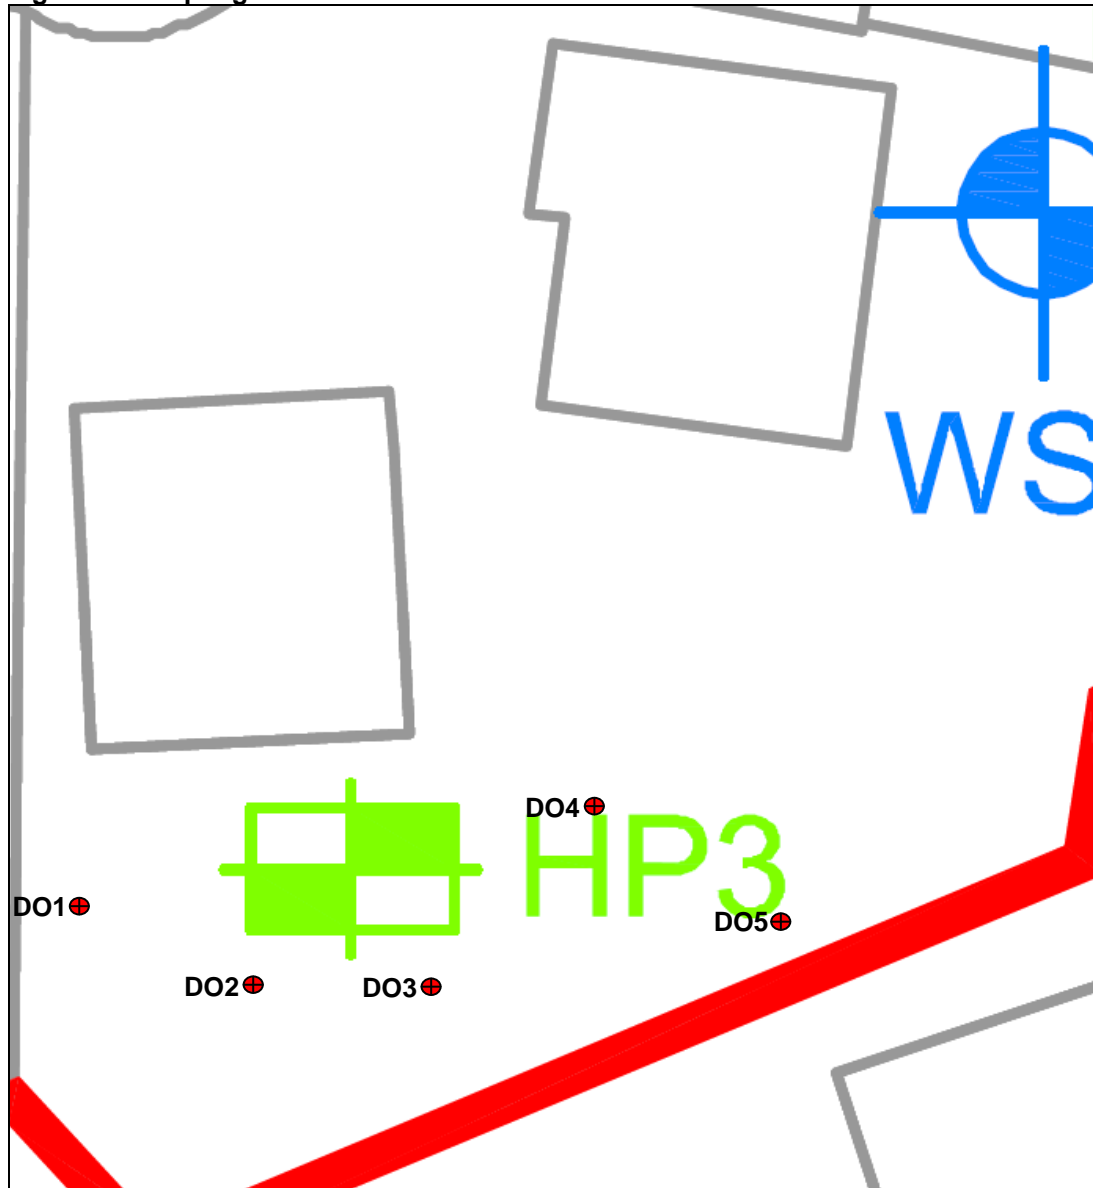
**Figure 1: Sampling Locations in 6 Newlands Court**

The two figures below indicate the locations from which soil samples were taken:

Five hand pits (DD01 to DD05) were excavated within borders and flower beds to a maximum depth of 0.5m. Ground conditions typically comprised an indeterminate topsoil/made ground mix, comprising brown sand with gravel of quartz, brick, ash and breeze block, with some shallower rootlets. The material was notably compact and was difficult to penetrate into. A piece of possible asbestos-containing tile was noted in DD01 at 0.3m bgl.

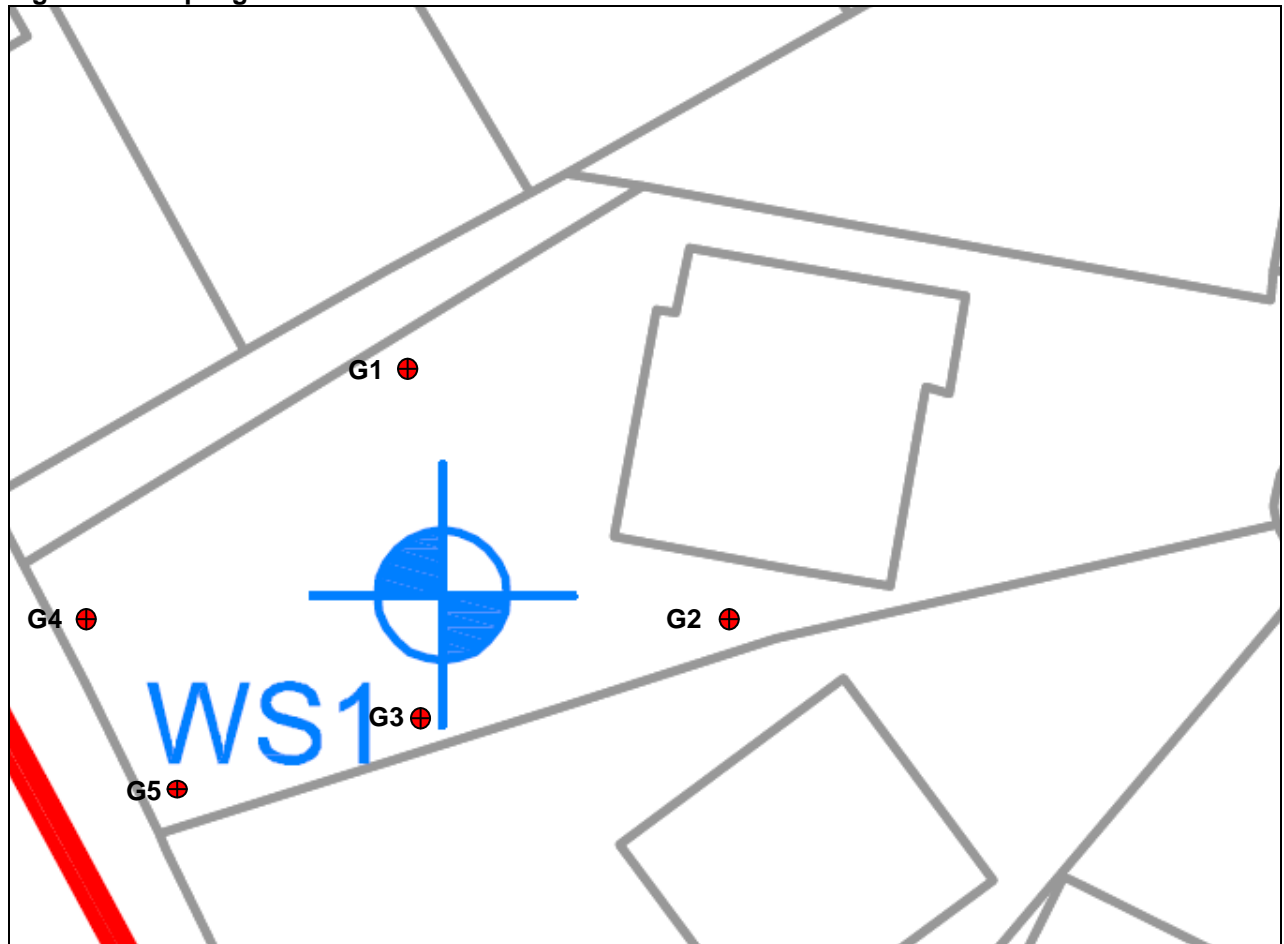
**Figure 2: Sampling Locations in 11 Newlands Court**

Five hand pits (G1 to G5) were excavated within borders and flower beds to a maximum depth of 0.55m. Ground conditions typically comprised brown sandy topsoil, to depths of between 0.05m and 0.25m bgl, over Made Ground, comprising brown slightly clayey gravelly sand. The gravel content of the made ground generally included brick and concrete, with glass, clinker and pieces of metal also noted. Black semi brittle material and gravel of broken tile was noted within sample G1 from 0.15 to 0.45m bgl – this material was suspected to be potentially asbestos-containing.

Five samples of made ground were retained from a variety of depths for laboratory testing. The samples included soil from G1 at 0.3m to 0.4m bgl, to include the material noted to be potentially asbestos-containing in the field.

At #11 Newlands Court, asbestos was found in two samples (the 31<sup>st</sup> May sample intended for leachate analysis, and in sample G1) in the form of pieces of asbestos-containing cement and a section of asbestos-containing bitumen-backed roofing felt. Asbestos fibres were not detected in the soil at #11 (at the limit of laboratory detection). It is unlikely that asbestos fibres will be liberated from the soil into the air, and potentially inhaled during gardening activities.

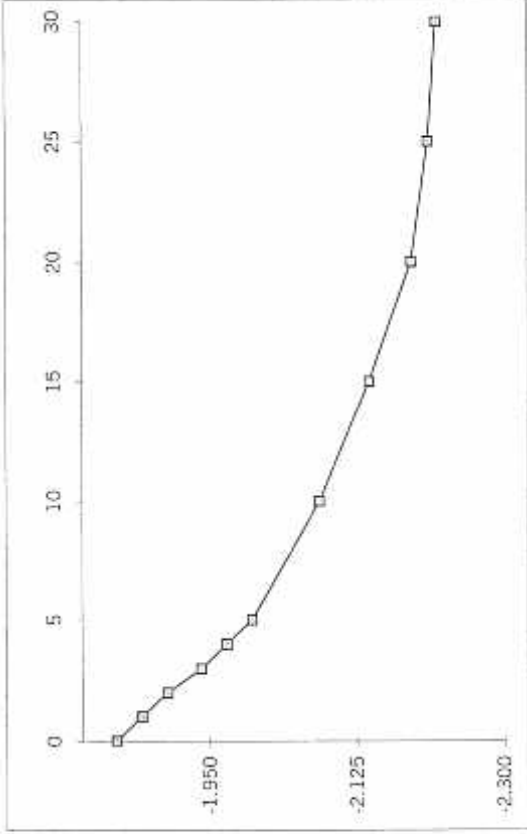
width 0.65  
length 1.95  
depth 2.28  
free space (%) 30

time/min	depth/m
0	-1.840
1	-1.870
2	-1.900
3	-1.940
4	-1.970
5	-2.000
10	-2.080
15	-2.140
20	-2.190
25	-2.210
30	-2.220

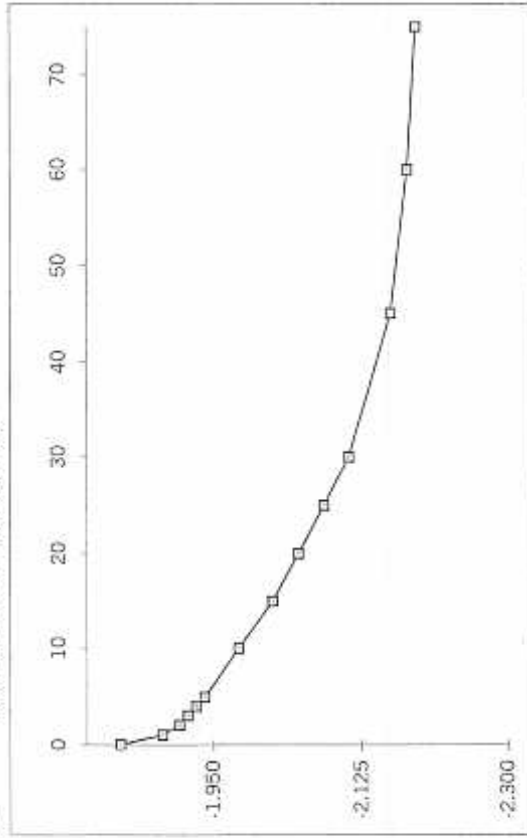
width 0.6G  
length 1.96  
depth 2.28  
free space (%) 30

time/min	depth/m
0	-1.840
1	-1.890
2	-1.910
3	-1.920
4	-1.930
5	-1.940
10	-1.980
15	-2.020
20	-2.060
25	-2.080
30	-2.110
45	-2.160
60	-2.190
75	-2.19

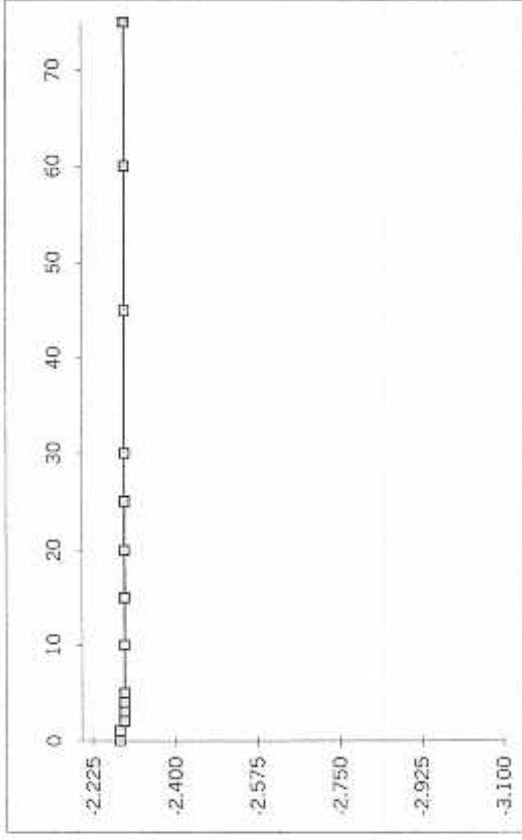
width 0.65  
length 1.80  
depth 3.10  
free space (%) 30

time/min	depth/m
0	-2.280
1	-2.280
2	-2.290
3	-2.290
4	-2.290
5	-2.290
10	-2.290
15	-2.290
20	-2.290
25	-2.290
30	-2.290
45	-2.290
60	-2.290
75	-2.29
