## Technical Due Diligence Condition Survey Report

Prince of Wales Theatre, Church  
Street, Cannock WS11 1DE

April 2026

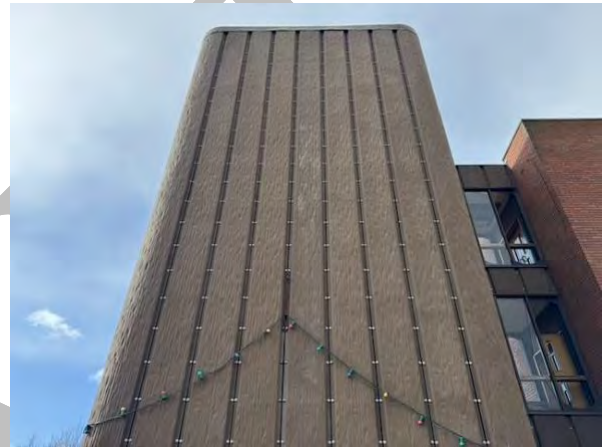
| | Risk |
|---|---|
| 11 The fibreglass cladding to the main entrance tower is in poor condition and we consider this is life expired. The cladding is degraded, impact damaged and fixings display evidence of corrosion. The | ■ |

| cladding is also lined internally with expanded polystyrene insulation which is expected to be highly flammable. We recommend the cladding is replaced in its entirety. | |

*Fig 8 - View of fibre glass cladding to the entrance tower.*

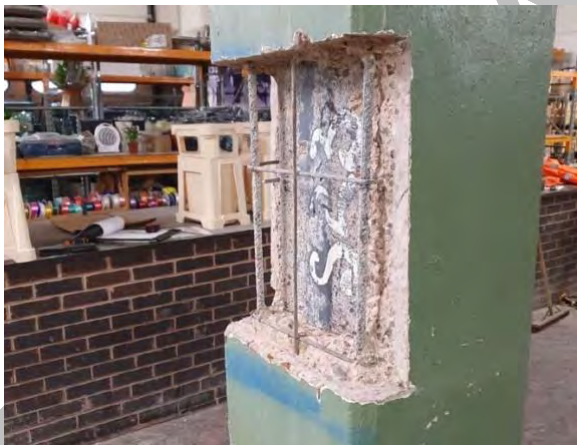
- 3.1.2 We have been provided with photographic records of previous intrusive investigations coordinated by Tetra Tech, which include the opening up of the concrete encasement to columns and beams, together with localised investigations to expose column bases and foundations. The images provided confirm the presence of a steel reinforced concrete encasement to the principal steel frame and assumed concrete pad foundations at column positions. It is reasonable to assume these investigations are representative of the wider structure.

*Fig 13 - View of previous investigations showing the steel frame, concrete encasement and steel reinforcement*

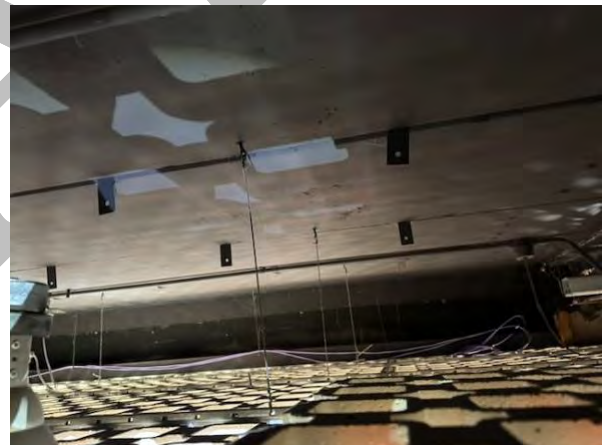
*Fig 14 - View of pre-cast concrete planks noted to parts of the second floor soffit.*

| | Risk |
|---|---|
| 2 We identified localised areas of concrete planks to the second floor structure. Whilst these appear consistent with a reinforced pre-cast concrete plank, access for inspection is limited and we recommend further investigations to confirm that no Reinforced Autoclaved Aerated Concrete (RAAC) is present. | ■ |

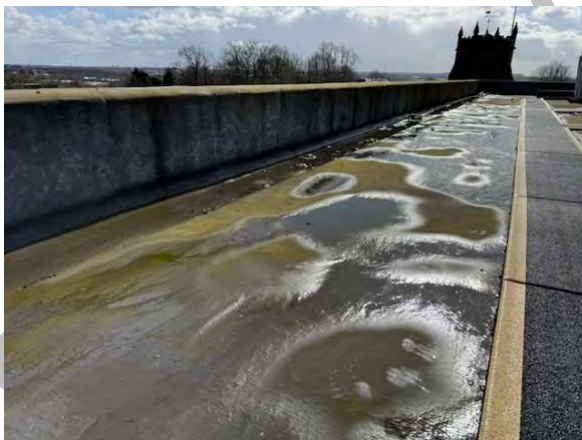
- 3.2.1 The roof coverings are in poor condition with evidence of moisture encapsulated within the roof build up and localised evidence of rainwater ingress to the roof soffits and internal accommodation below.
- 3.2.2 Blisters were identified in the liquid applied waterproofing and the assumed felt roof coverings below have de-bonded where moisture is trapped. Elsewhere, surface rucking is visible to the roof coverings indicative of thermal movement, possibly to older mastic asphalt roof coverings, which have previously been overlaid. A notable split was also identified through the roof coverings to the south east of the fly tower, which corresponds with evidence of significant rainwater ingress at second floor.

*Fig 15 - View of blistering noted to the roof coverings. No edge protection is provided to the shallow parapet.*

- 3.2.3 We recommend that further investigations are undertaken to determine the build-up of the roofs, including the condition of any underlying legacy roof coverings, the extent of encapsulated moisture and condition of the roof decks. However, whilst it may be possible to repair active areas of rainwater ingress and prolong the life span of the roof coverings, further failures are likely and we consider the roof coverings are reaching the end of their effective lifespan.
- 3.2.4 The appropriate approach towards the treatment of the roof coverings will also need to take in to account the nature of roof decking material. The channel reinforced woodwool slabs noted to the flat roof soffits are

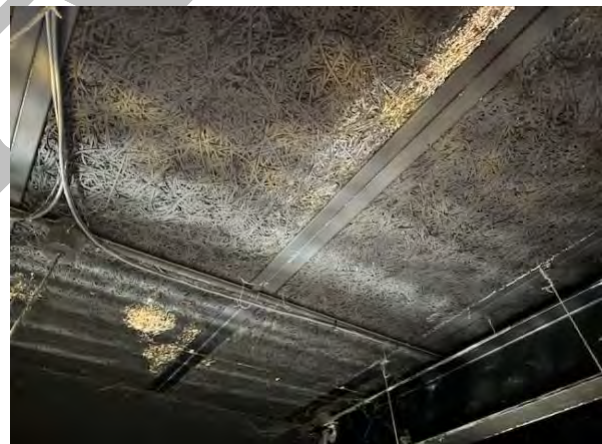
*Fig 16 - View of the channel reinforced woodwool slab roof deck and evidence of previous rainwater ingress.*

- 3.2.5 We identified evidence of deterioration and damp staining to the woodwool slabs internally in locations of rainwater ingress and whilst this remains relatively isolated, the extent of deterioration is masked somewhat by the black paint finish. It is also recommended that the exterior (concealed) face of the woodwool slabs and channel reinforcement be checked upon removal of roof coverings, with attention to locations where encapsulated moisture is evident.

- 3.2.6 We can only speculate at this stage on the condition of the woodwool roof decks and their suitability for on-going use. However, the fragile classification of this material, will require very careful risk management and the continued patch repair of overlaying of the roof coverings will reach a point where this is not viable. In the longer term interest of the property, it is therefore recommended that roof decks be replaced in conjunction with works to renew the roof coverings with a fully guaranteed solution.

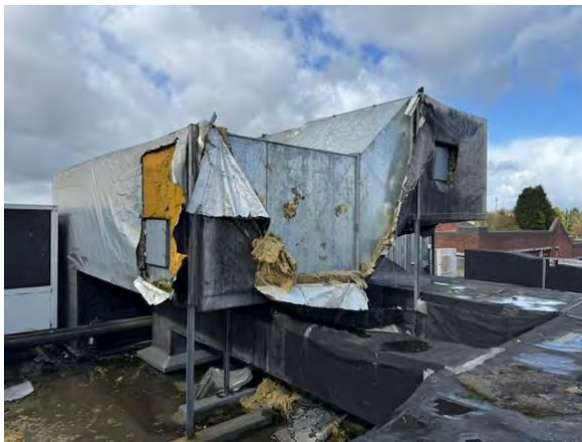
*Fig 17 - View of roof mounted plant and poor condition of insulation.*

- 3.2.7 A significant volume of roof mounted plant and equipment is also present to the principal roof areas and we recommend that more immediate checks are undertaken to confirm the adequacy of the roof deck to accommodate the relevant loads. We have also identified immediate concerns with regard the presence of loose materials to the roof areas, safe means of access and edge protection. Further comment in this regard is included at Section 8.2.

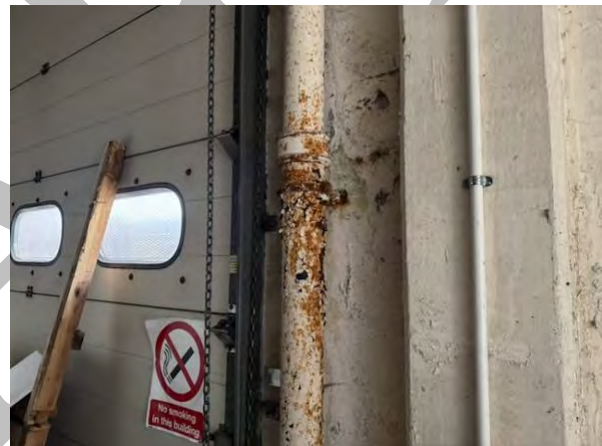
*Fig 18 - There is evidence of leaks and corrosion to cast rainwater pipes.*

| | Risk |
|---|---|
| 8 Localised leaks were identified to the cast rainwater pipes, with evidence of corrosion. We recommend CCTV surveys be undertaken and the rainwater goods overhauled. | ■ |

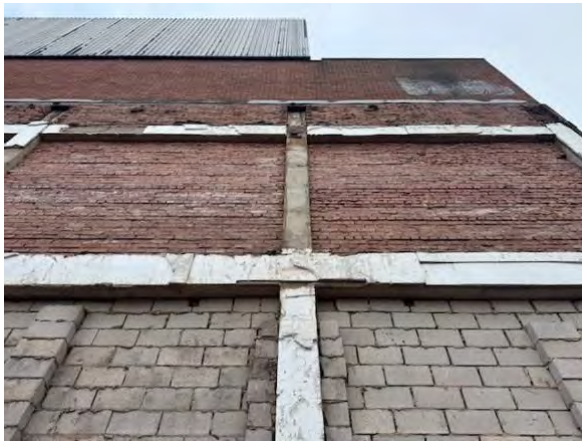
- 3.3.3 The completion of demolition works to remove adjoining buildings has left the south elevation exposed to weathering and the blockwork and brick walls at ground and first floor are visibly poor having seemingly been erected 'over-hand' up to the former adjoining property. Interim repairs or hoardings are required in more exposed locations to mitigate against rainwater ingress and proposals will need to be developed to reclad this elevation. This will need to comply with current building regulations with respect to thermal insulation and any specific acoustic requirements associated with the buildings use as a theatre will need to be allowed for.

*Fig 19 - View of exposed south elevation where adjoining buildings have been removed.*

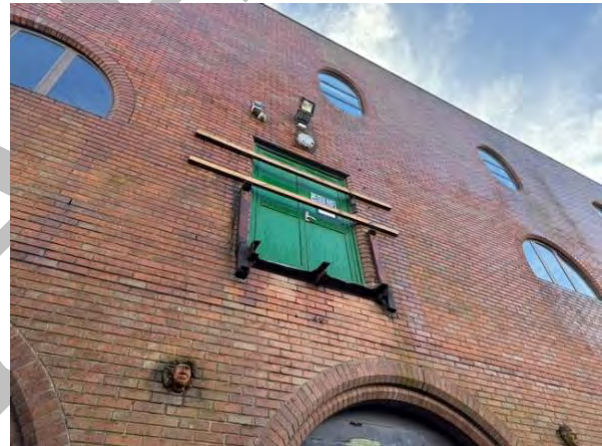
*Fig 20 - View of west elevation where link bridges / means of escape have been removed.*

- 3.3.4 The concrete encased steel frame structure to the south elevation is similarly exposed, including remnants of expanded polystyrene insulation boards, whilst elsewhere former door apertures and fire escapes have been boarded over along the west elevation where link bridges have been removed. The affected areas will need to be reclad and made good, including the reinstatement of fire escapes where appropriate to ensure adequate means of escape. The expanded polystyrene insulation noted is also likely to be highly flammable and should be removed.

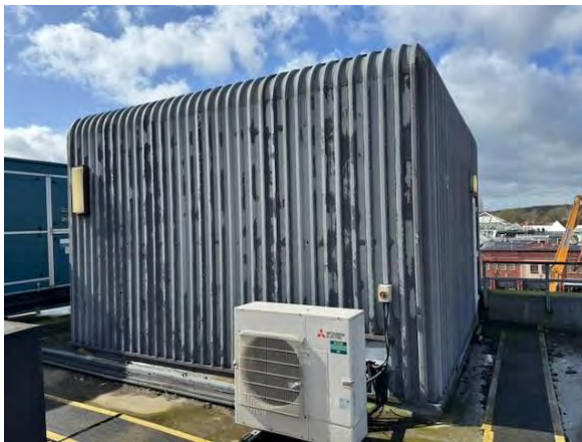
| <b>12</b> | The plastisol coating to the profiled metal cladding to the stage fly tower and north west stairwell has almost entirely failed. The cladding sheets and fixings are in poor condition and we recommend the metal cladding is replaced. ■ |

- 3.3.8 Localised damage is also visible to the cladding sheets and apertures have been formed for services distribution between these elevations and the adjacent roof mounted plant and equipment. The services apertures through the cladding sheets are poorly formed and will be vulnerable to rainwater ingress.

*Fig 21 - View of the profiled metal cladding to the north west stairwell.*

- 3.3.9 It may be possible to re-coat the cladding sheets in conjunction with the replacement of damaged cladding sheets and repairs to fixing and cover caps, however, the cladding is in poor condition and we recommend this be replaced. We were also unable to determine the nature and condition of any underlying insulation and its replacement will provide opportunity to upgrade the exterior fabric to current regulations.

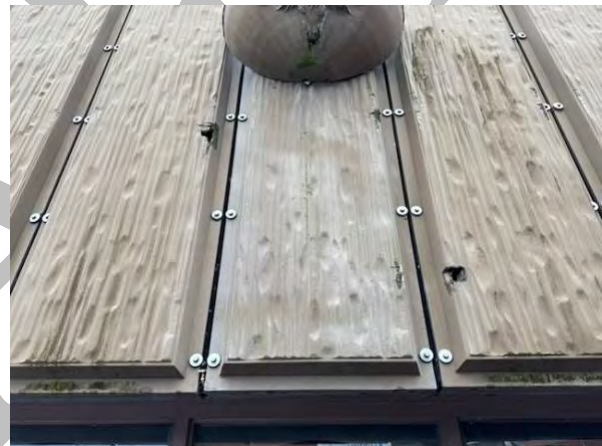
*Fig 22 - View of the fibreglass cladding to the main entrance tower.*

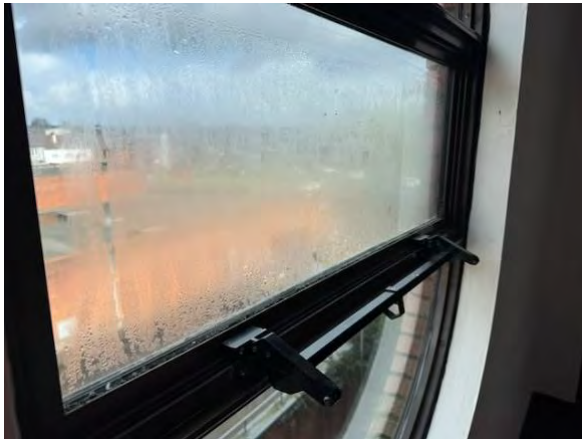
- 3.3.11 The seals to several double glazed units at second floor have failed and display interstitial condensation. It is estimated that this is currently affecting approximately 15% to 20% of the windows, however, this is indicative of further failures arising over the short to medium term. Elsewhere, windows at first floor are single glazed and have been replaced in some locations with perspex sheeting. The perspex sheets are obscure in appearance and these repairs are to a poor standard.

*Fig 23 - View of interstitial condensation to second floor window.*

- 3.3.14 We expect that the windows and curtain walling can be refurbished through a coordinated package of repair works, to include the replacement of defective glazing, ironmongery and sealant, together with the recoating and localised repair of the window frames. However, these will continue to fall short of the performance criteria provided by a modern equivalent window, particularly regarding thermal and acoustic insulation. Where budgets permit it is therefore recommended that consideration is given towards replacement.

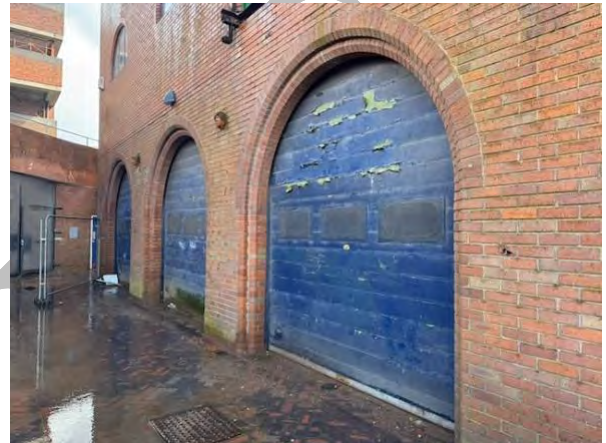
*Fig 24 - View of loading doors to the former market hall areas.*

- 3.3.16 The volume and setting out of the up and over loading doors is somewhat bespoke to the use of these areas as a market hall and are likely to require alteration where alternative uses are proposed. It was not possible to test all doors and whilst it is evident a number of the doors remain in use, there is evidence of impact damage to the sectional door panels and the external paint finish are heavily soiled and delaminating.

- 3.3.17 Assuming the doors are retained, we recommend that these are serviced and overhauled in conjunction with repairs to replace impact damage sections. The exterior paint finishes will also need to be fully prepared and to include removal of all delaminating paint and doors redecorated or resprayed with a new proprietary paint.

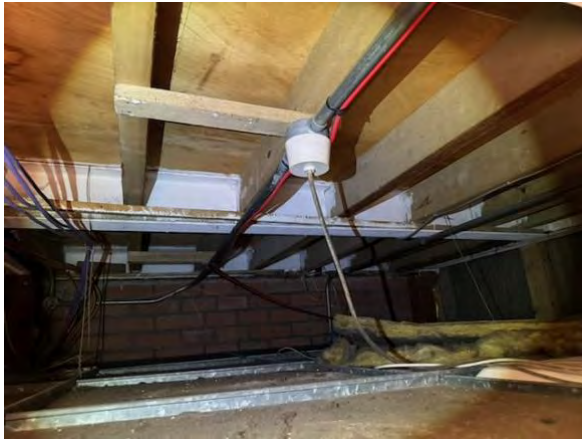
- 3.4.2 Suspended timber joists were identified to part of the floor structures within the entrance tower, including the link bridge areas and stair landings. Suspended ceiling tiles were removed to allow inspection and where visible the floors are in satisfactory condition. However, we did identify evidence of rainwater ingress via the exterior fabric, particularly to the link bridge areas, and staining is visible to the plywood floor substrate below internal floor finishes. We recommended that further opening up works are undertaken to confirm that no timber decay has occurred in these locations.

*Fig 25 - View of limited suspended timber flooring to link bridge and landing areas.*

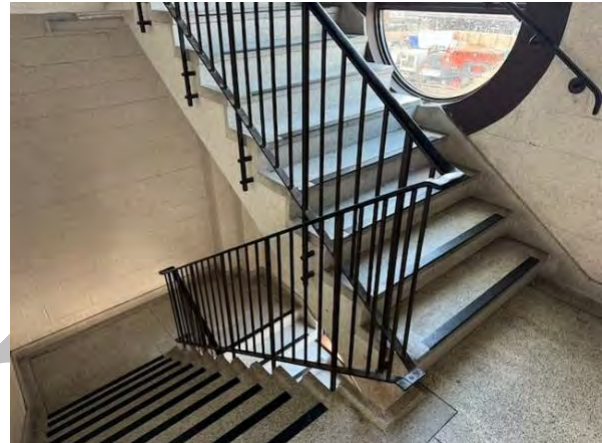
*Fig 26 - View of the north west fire escape stair.*

- 3.4.3 The stairs and balustrades to both the entrance tower and principal premises are generally in satisfactory condition and no significant issues were identified.

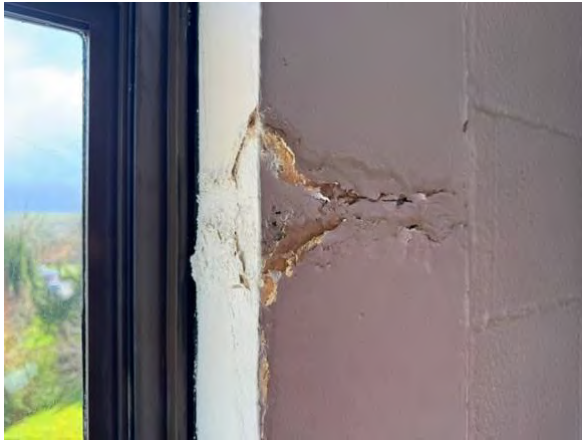
- 3.5.2 Floor finishes, suspended ceilings and decorations are soiled and more localised areas of damage were identified in locations subject to rainwater ingress via the external fabric. This includes delamination of paint finishes around windows apertures and more localised leaks via the roof coverings.

*Fig 27 - View of penetrating damp around window apertures*

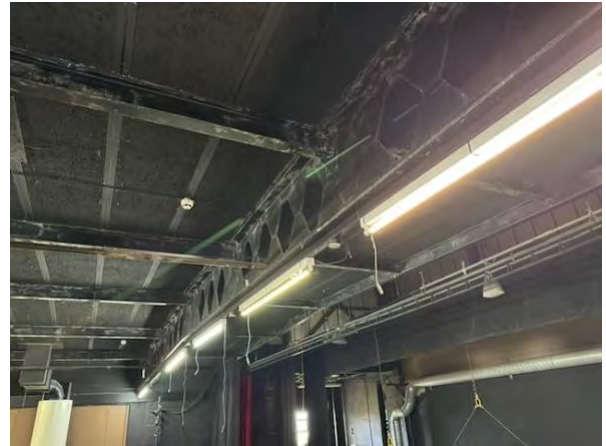
- 3.5.3 Elsewhere the paint finish to the exposed steel work within the auditorium and below the principal roof coverings is in poor condition and is faded and chalky in appearance. It is not clear if this is the consequence of general wear or if this has been accelerated by leaks from the roof coverings.

*Fig 28 - The paint finish to the steelwork is in poor condition.*

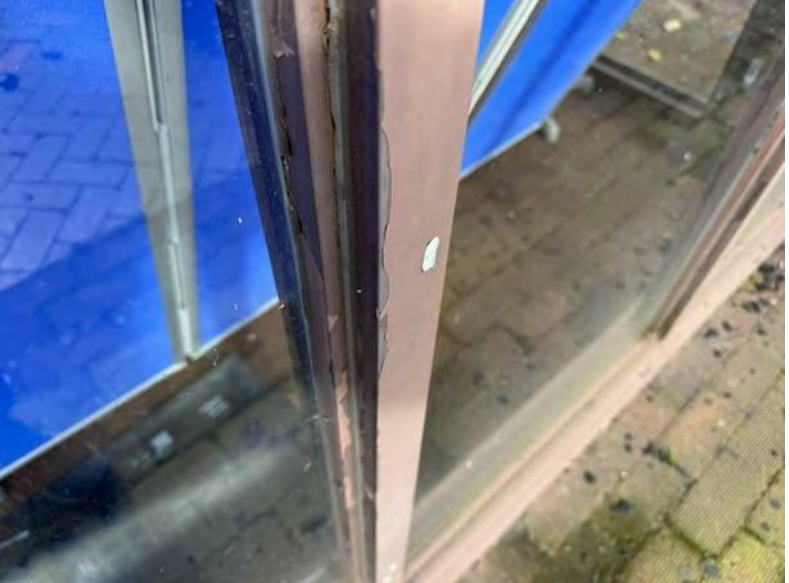
| 8. | The paint finish is solar degraded and delaminating. | A close-up photograph of the aluminium frame of the entrance doors. The paint finish is visibly degraded, showing signs of solar degradation and delamination, with the underlying metal exposed in some areas. |

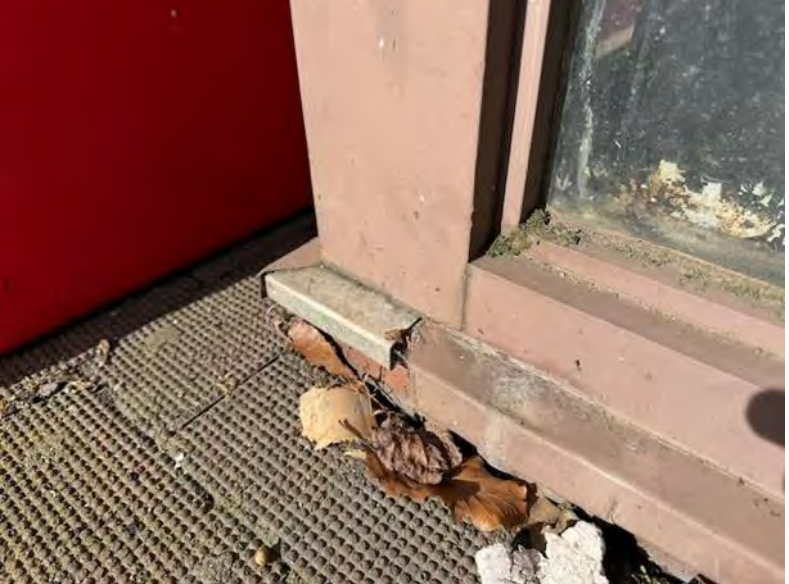
| 9. | Localised damage and patch repairs are evident to the cill. | A close-up photograph of the cill (sill) of the entrance doors. The cill is made of aluminium and shows signs of localised damage and patch repairs, with some debris and peeling paint visible. |

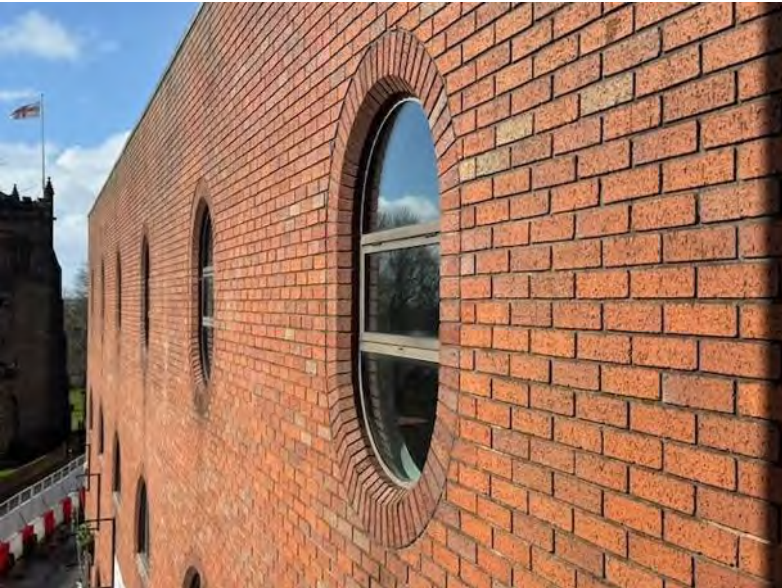
| <p>14.</p> | <p>View of the facing brickwork typical to the principal elevations. The brickwork is generally in a satisfactory condition subject to soiling and localised damage.</p> | |

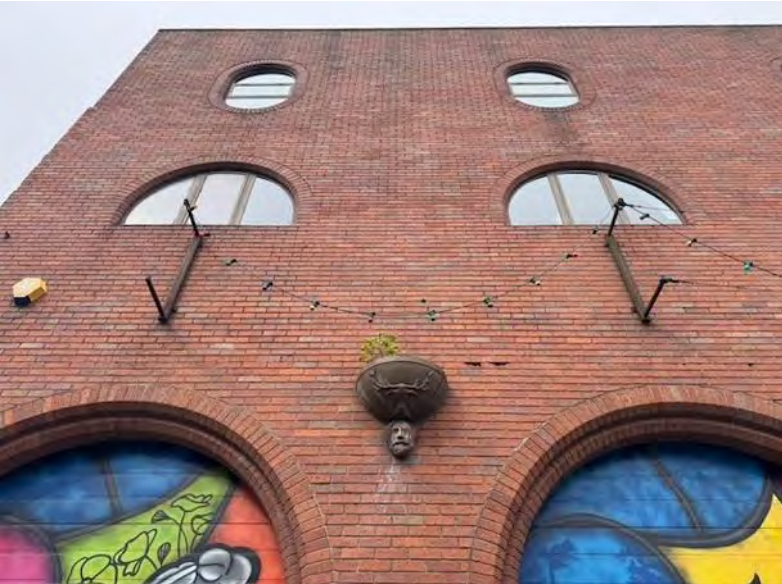
| <p>15.</p> | <p>Decorative planters, brackets and legacy fixtures and fittings remain to the elevations.</p> | |

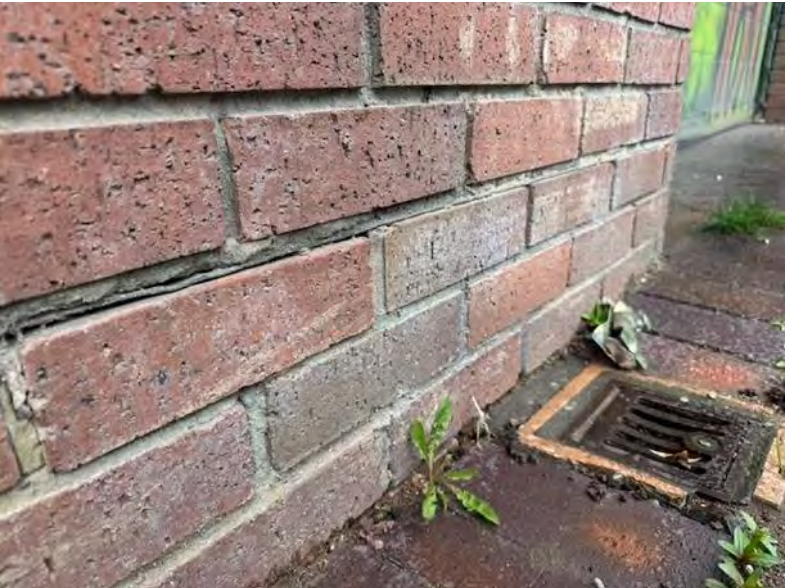
| <p>17.</p> | <p>The damp proof course (dpc) is visible at low level and appears to be performing satisfactorily.</p> | |

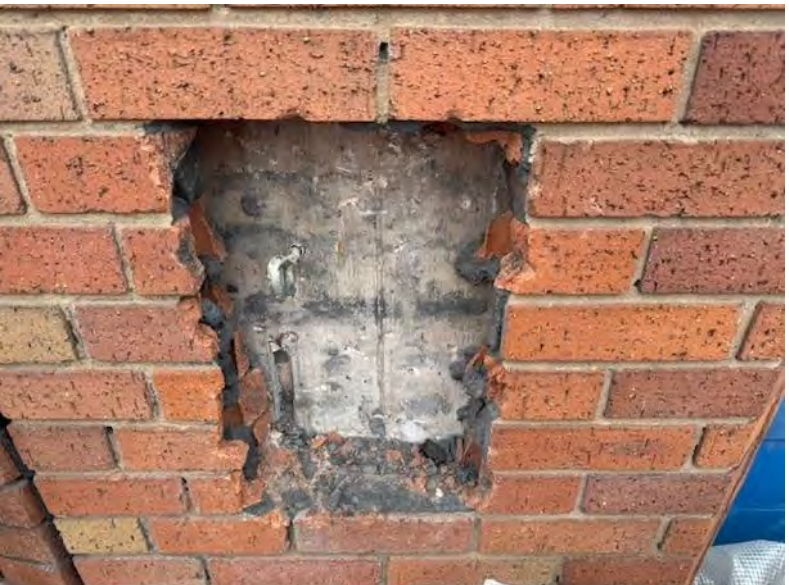
| <p>18.</p> | <p>Localised opening up works have previously been undertaken to the south east corner revealing the concrete encasement to the corresponding column. We assume this relates to previous structural investigation works.</p> <p>It would be prudent to check if any brick slips are present to the elevation with attention to the upper floor levels.</p> | |

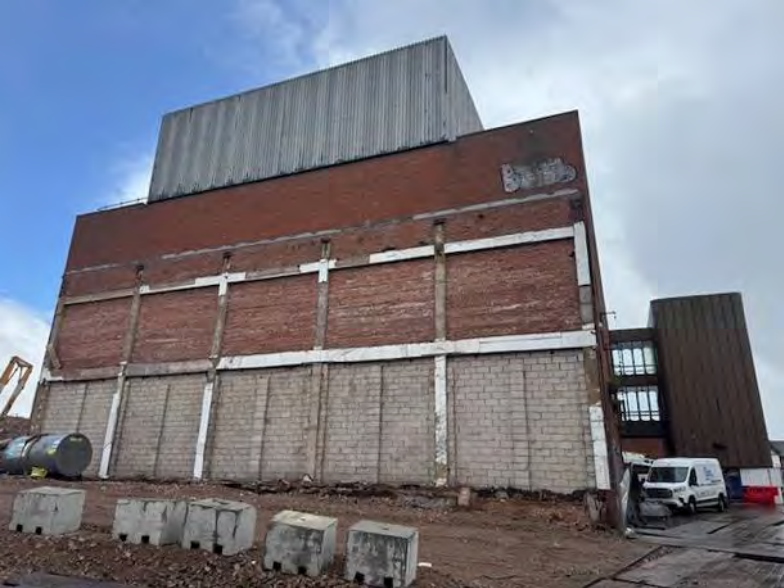
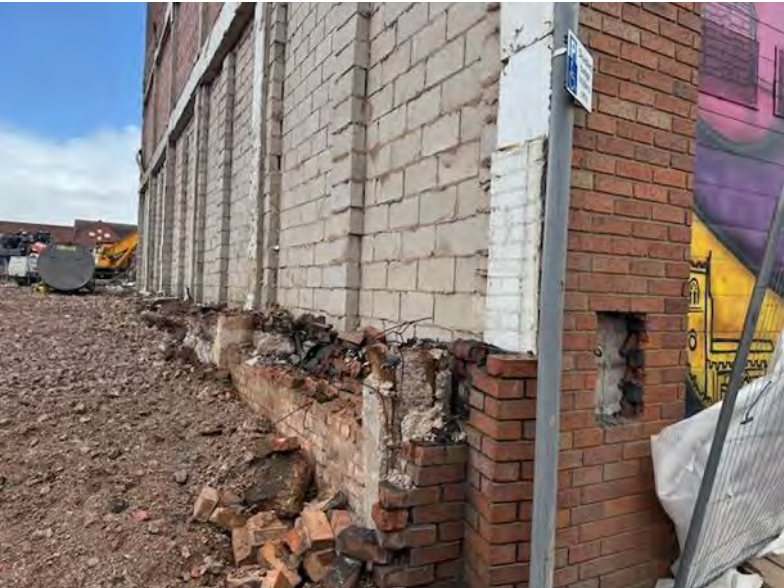
| <p>19.</p> | <p>General view of the south elevation. The structural frame and low level blockwork is exposed to these areas following the completion of demolition works to the adjoining premises.</p> | |

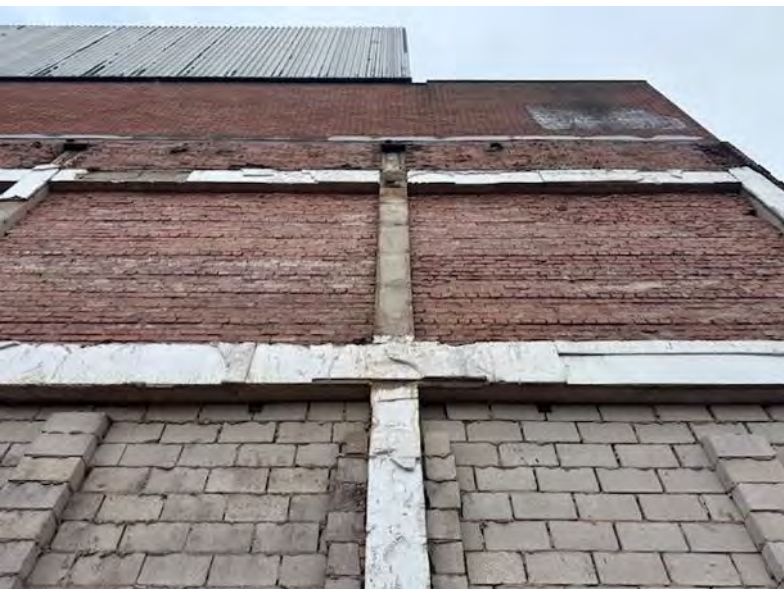
| <p>21.</p> | <p>The brick and blockwork to the ground and first floors is generally irregular in appearance and has likely been laid over-hand up to the former adjacent property. Consideration will need to be given towards the repair of this elevation with attention to weatherproofing, thermal and acoustic performance.</p> <p>Expanded polystyrene insulation boards remain to the parts of the exposed frame.</p> | |

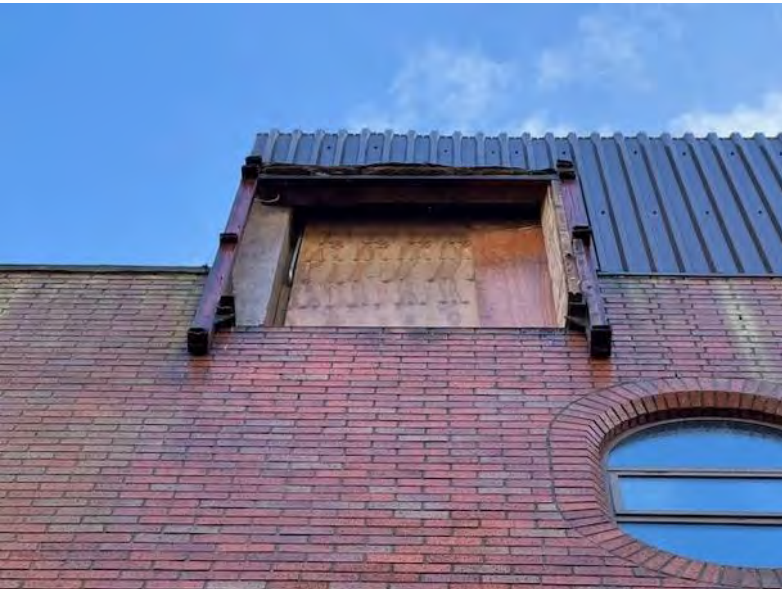
| <p>28.</p> | <p>Temporary protection works should be upgraded to avoid accidental use.</p> | |

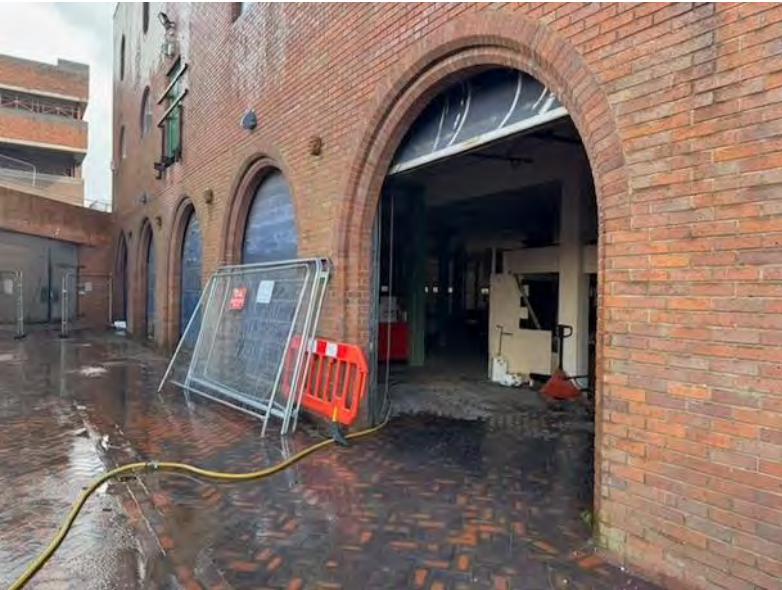
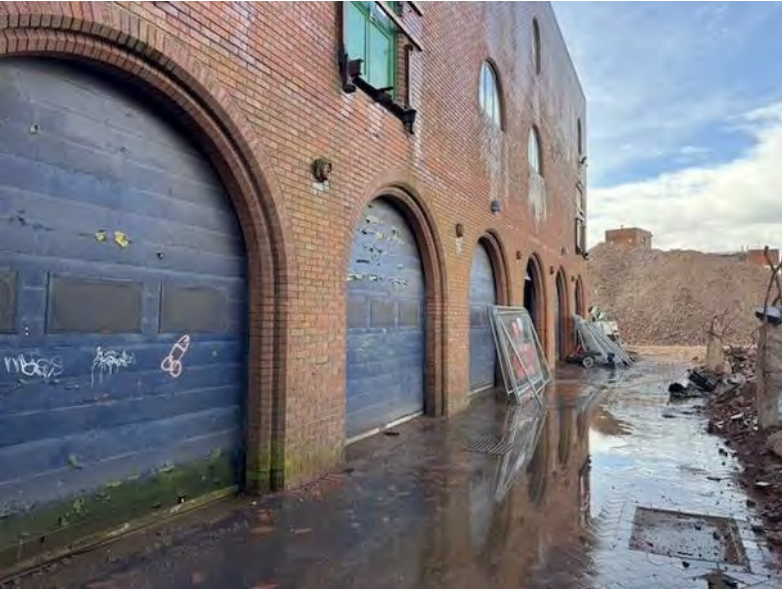
| <p>29.</p> | <p>View of extensive up and over loading doors to the former market hall areas.<br/>Several doors are impact damaged and whilst these could not all be tested the doors are visibly in poor condition.</p> | |

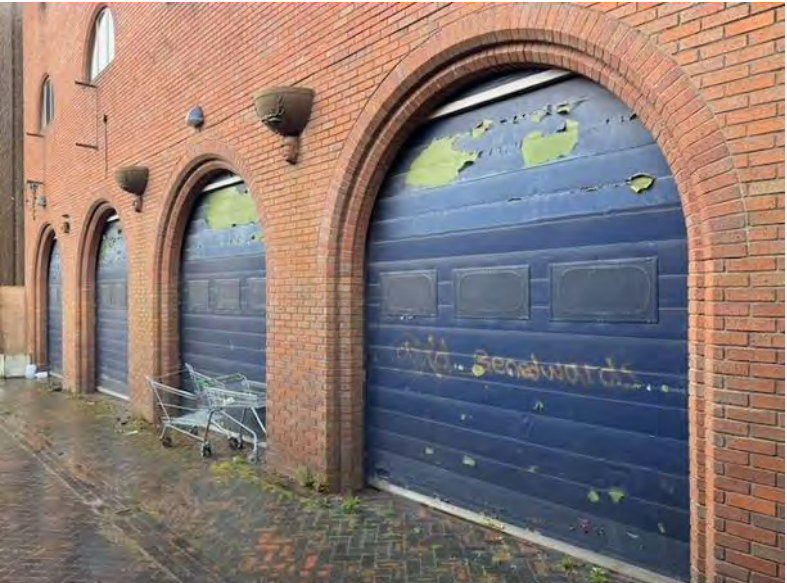
| 32. | The loading doors are generally consistent with those noted to the east and west elevations. | |

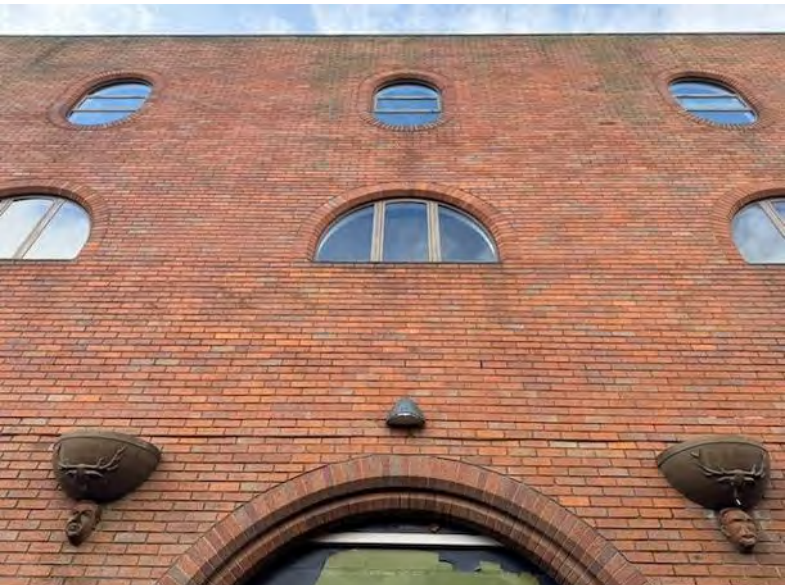
| 33. | View of the facing brickwork and windows to the north elevation.<br><br>Further comment in respect of the windows is included within the internal areas, however, these were generally found to be in poor condition. | |

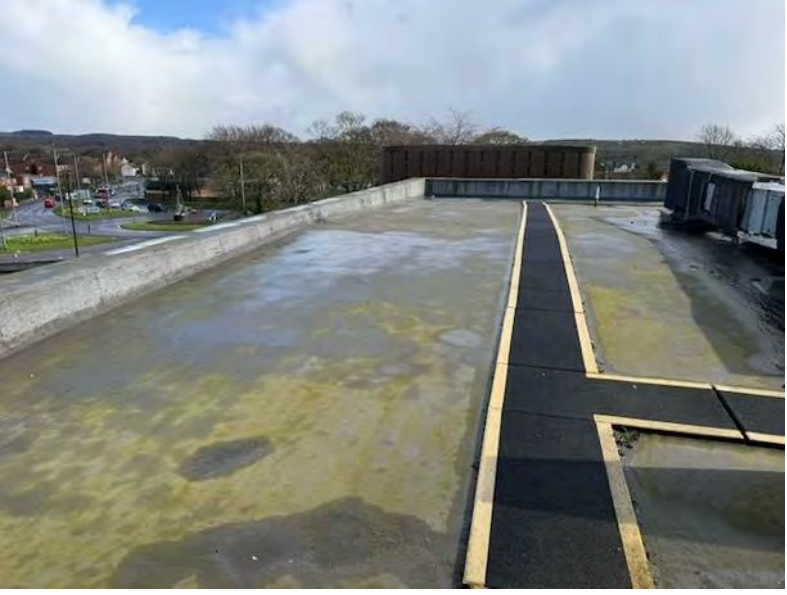
| 39. | <p>View of the flat roof coverings above the principal flat roof areas and non-slip walkways installed across these areas.</p> <p>Please also refer to our comments in respect of the channel reinforced wood wool slabs forming the roof deck which should be deemed fragile.</p> | |

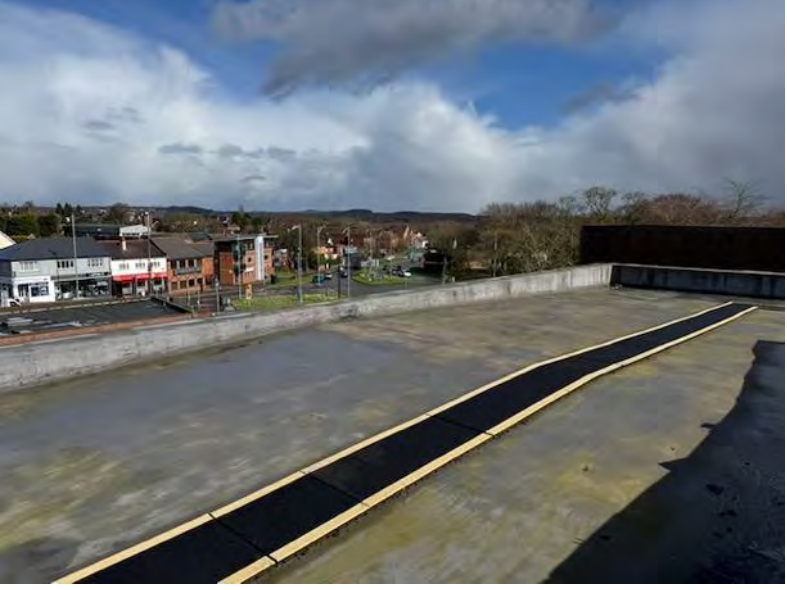
| 40. | <p>The flat roof falls to parapet gutters along the east and west elevations, draining to rainwater outlets and internal cast rainwater pipes.</p> | |

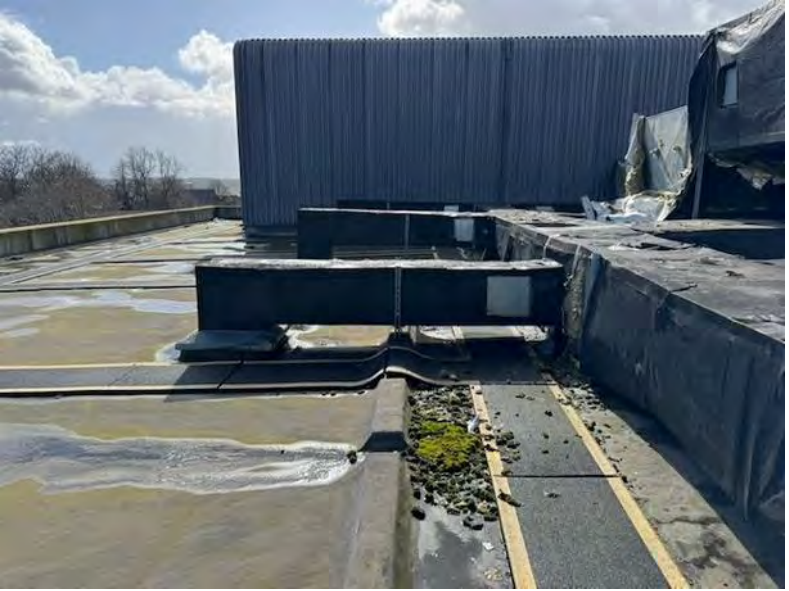
| <p>45.</p> | <p>Kerb upstands are provided to the perimeter of the central plant area which incorporate openings for rainwater drainage.</p> | |

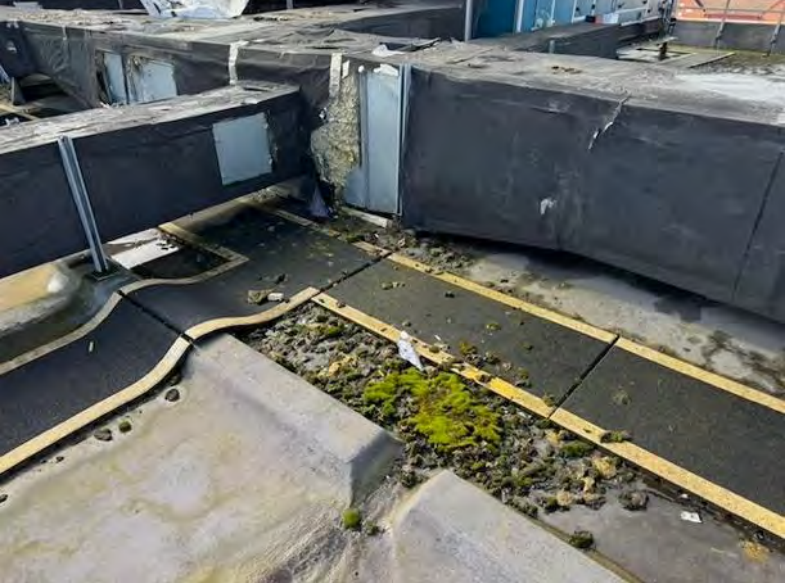
| <p>46.</p> | <p>Accumulations of moss and vegetation growth are evident in these locations</p> | |

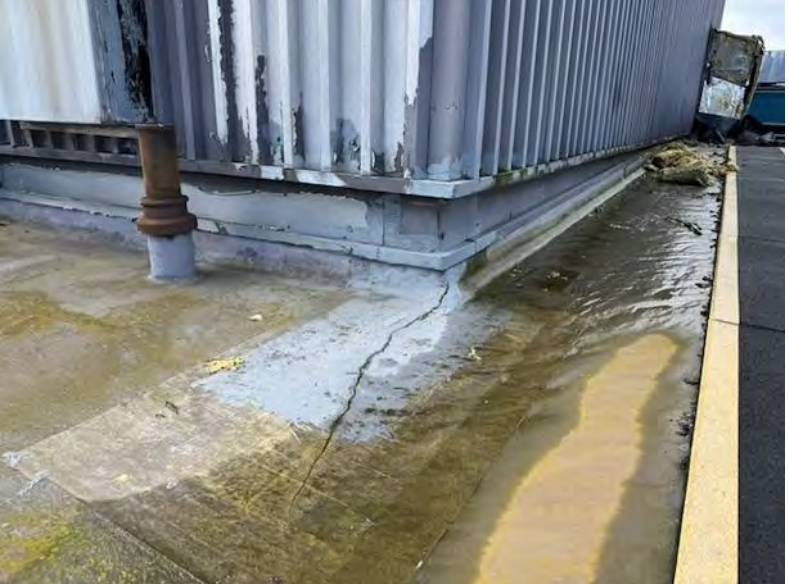
| <p>47.</p> | <p>A localised split was identified through the roof coverings to the south east with evidence of previous patch repairs which have failed.</p> | |

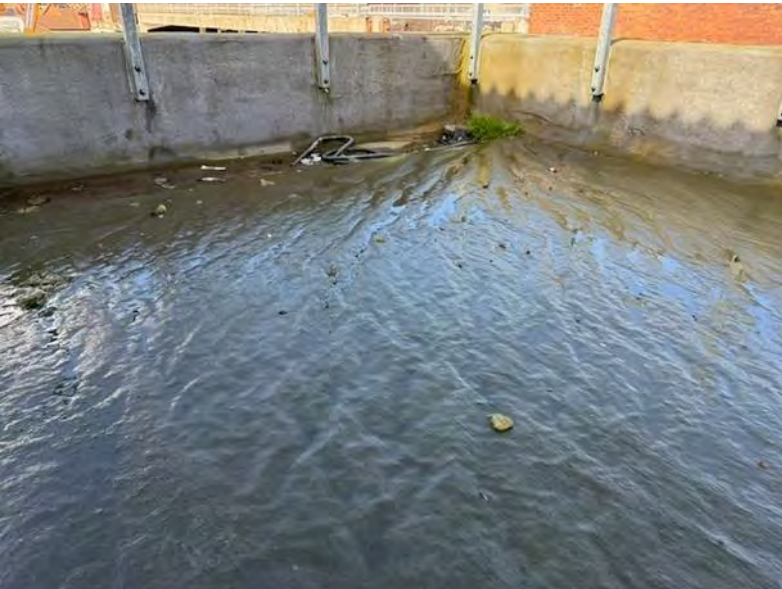
| 48. | Localised rucking is visible to the surface of the roof coverings indicative of thermal movement to assumed underlying asphalt. | |

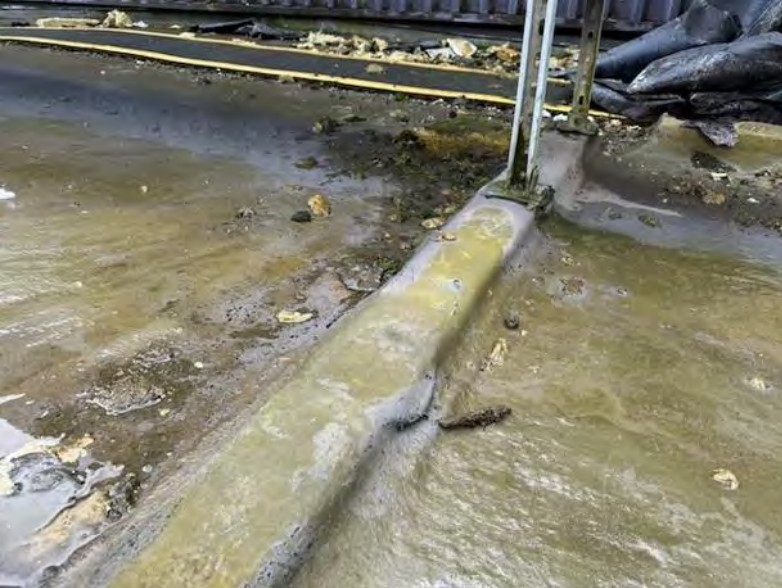
| 49. | Localised damage is visible to the kerb upstands and plinths to the roof mounted plant and equipment. | |

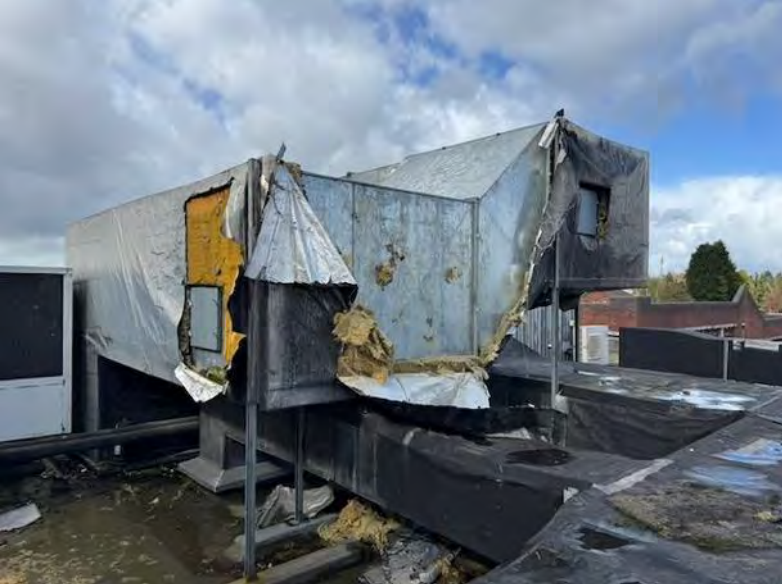
| 50. | The roof mounted plant and equipment is in poor condition. Widespread areas of loose insulation and materials are strewn across the roof presenting an immediate health and safety risk. | |

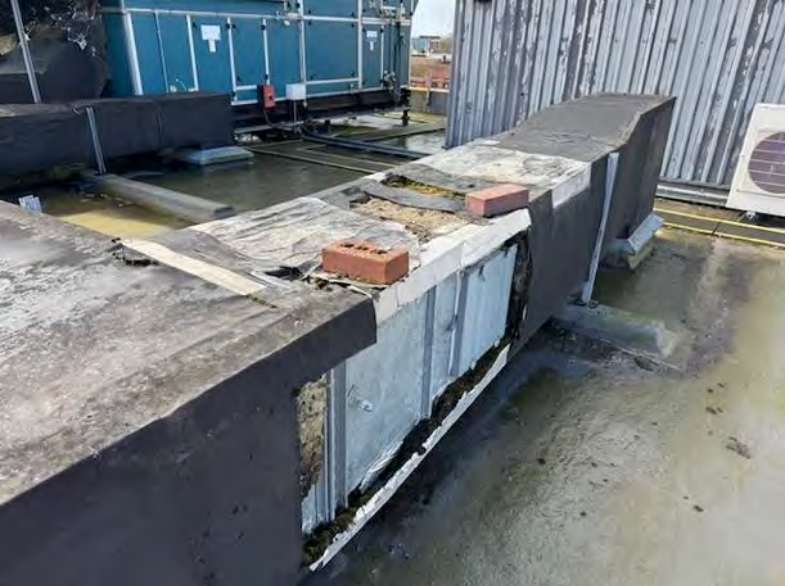
| <p>51.</p> | <p>Attempts have been made to secure the insulation however, these have failed and represent a short term solution only.</p> | |

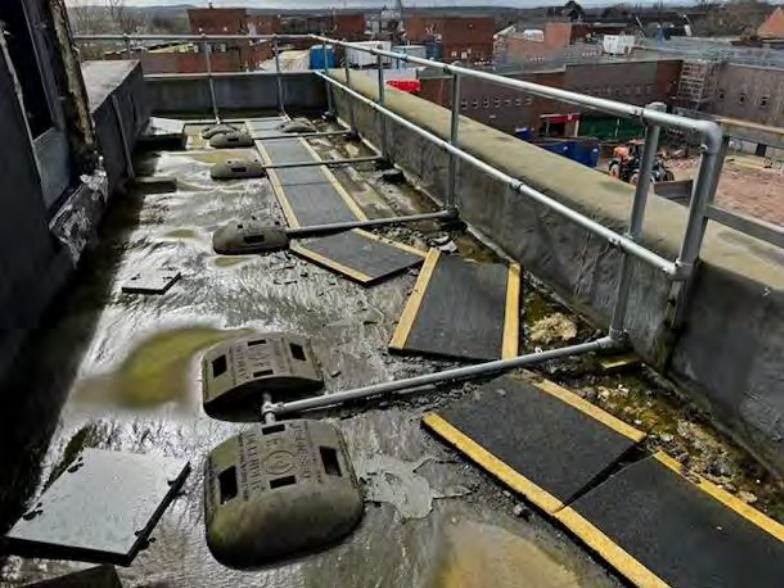
| <p>57.</p> | <p>A free-standing edge protection system is installed to the south west corner.</p> <p>No evidence of certification was identified and the coverage provided by this system is very limited.</p> | |

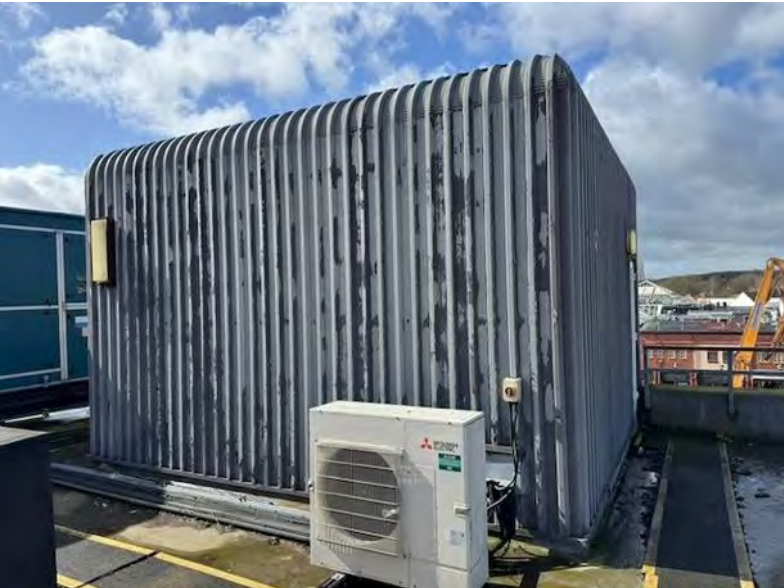
| <p>58.</p> | <p>The factory applied plastisol finish to the profiled metal cladding to the stairwell elevation has entirely failed.</p> | |

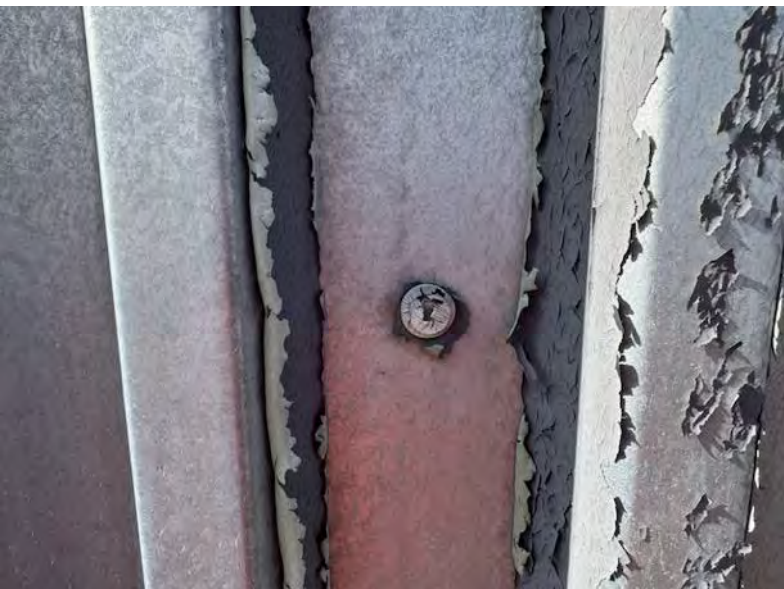
| <p>59.</p> | <p>Cover caps are solar degraded and brittle with evidence of corrosion to the underlying fixings.</p> | |

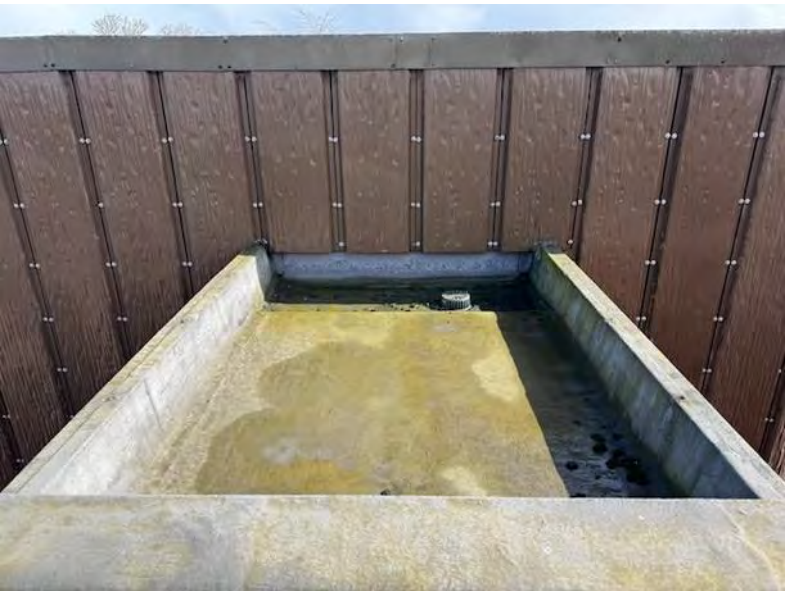
| 62. | <p>Access was not possible to inspect the roof coverings to the link bridge, entrance tower or elevated roof areas to the stairwell and stage gantry. However, where visible these appear to be consistent with the principal roof.</p> <p>A cat ladder and access hatch is provided to the entrance tower roof, however, this has been locked and could not be accessed safely.</p> | |

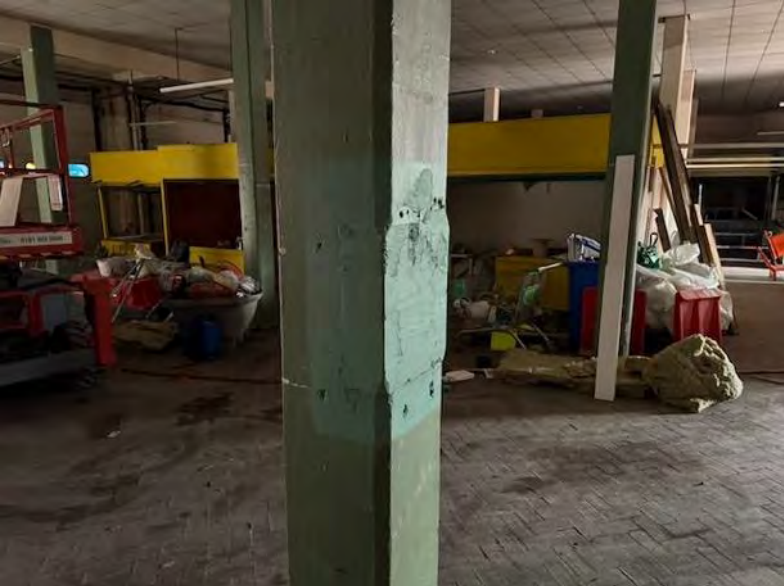
| <p>66.</p> | <p>Evidence of previous investigative works and making good noted to the column positions.</p> | |

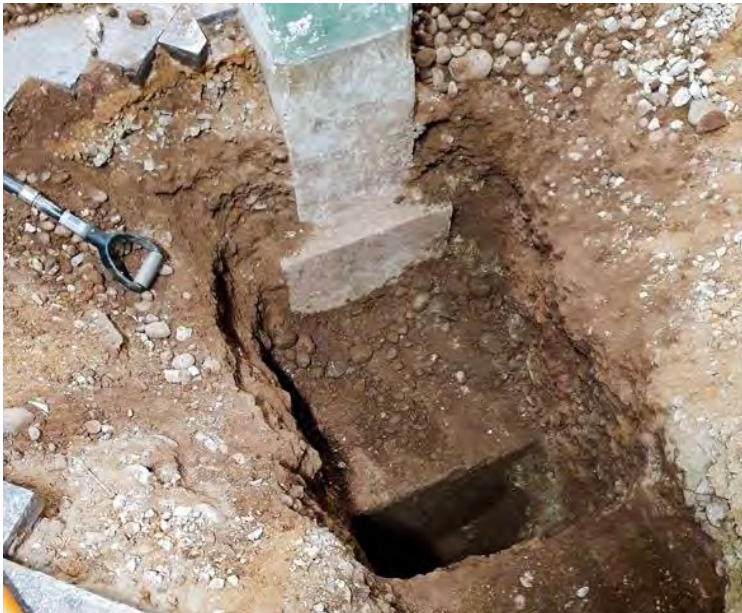
| <p>68.</p> | <p>Extract of an earlier photograph provided by Tetra Tech showing intrusive investigations to reveal a concrete pad foundation to a column base.</p> <p>The principal structure appears to be performing satisfactorily and no significant concerns were identified. Flexibility towards future alterations and its load bearing capacity will need to be carefully considered as part of any future proposals.</p> | |
