## Technical Due Diligence Condition Survey Report

Prince of Wales Theatre, Church  
Street, Cannock WS11 1DE

April 2026

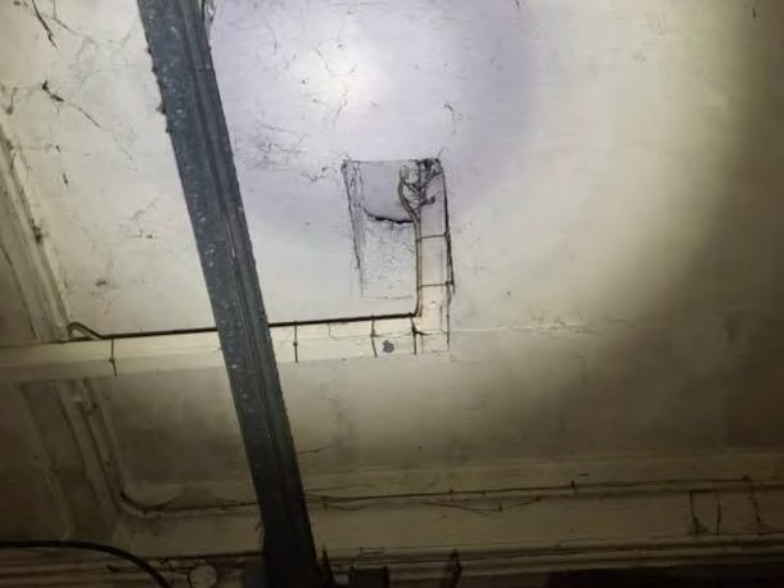
| <p>72.</p> | <p>View of service aperture through the assumed cast-in-situ concrete floor soffit.</p> <p>Fire stopping at services penetrations through compartment floors needs to be checked and appears missing in some locations.</p> | |

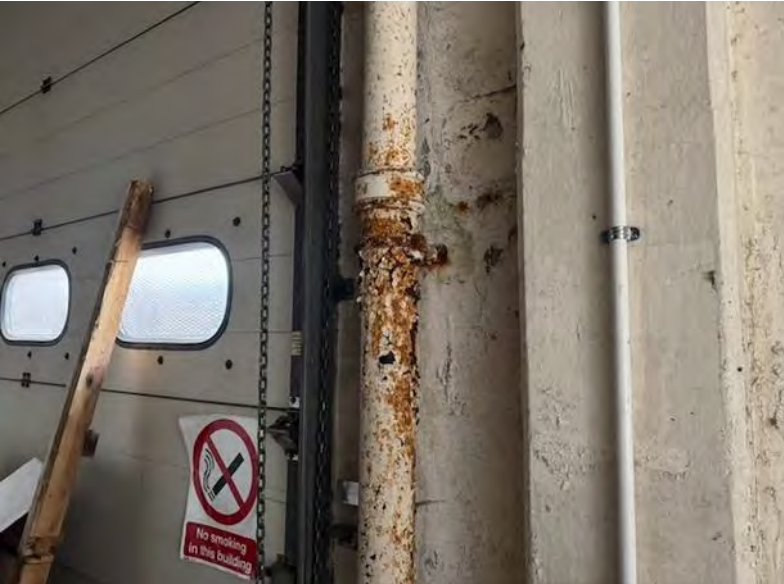
| <p>74.</p> | <p>View of internal rainwater pipe. The cast pipes are corroded locally where leaks have occurred.</p> | |

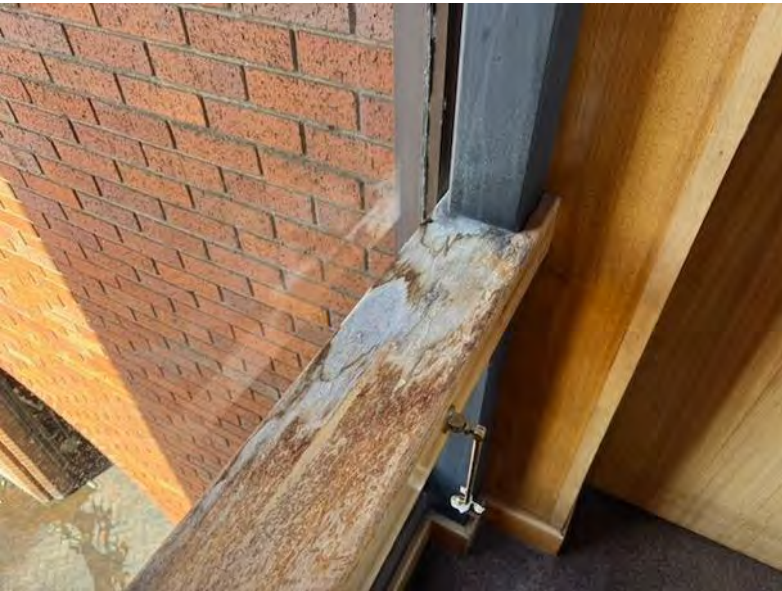
| 84. | There is evidence of rainwater ingress via the exterior fabric to the link bridge. | |

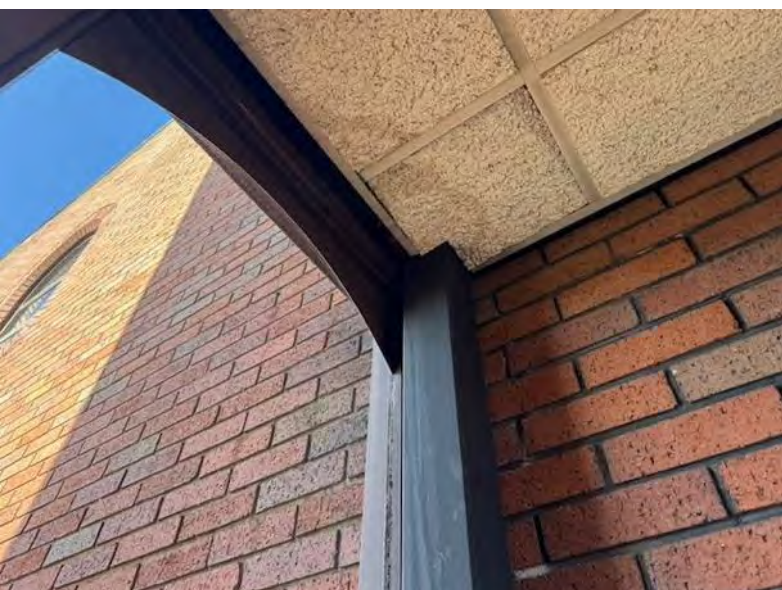
| 85. | Staining is visible to ceiling tiles where previous leaks have occurred. This appeared historic. | |

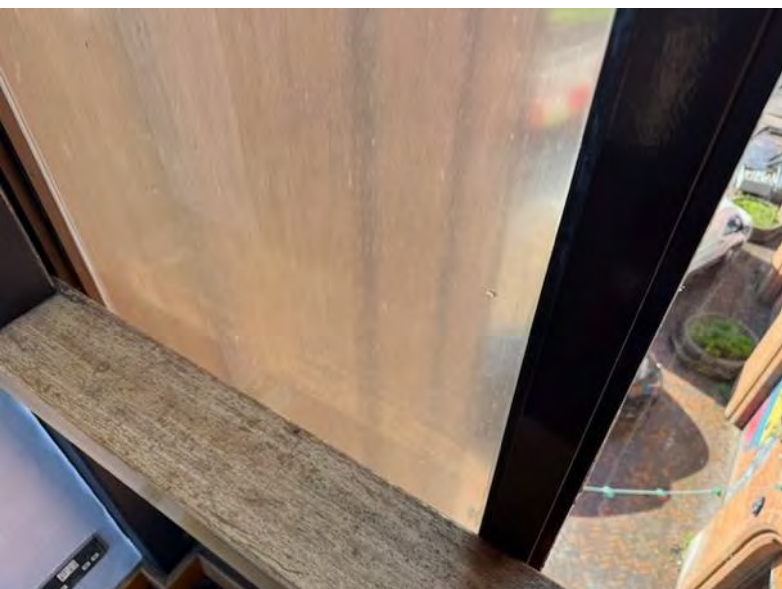
| 86. | Glazing to an isolated number of the windows has been replaced with perspex sheeting. | |

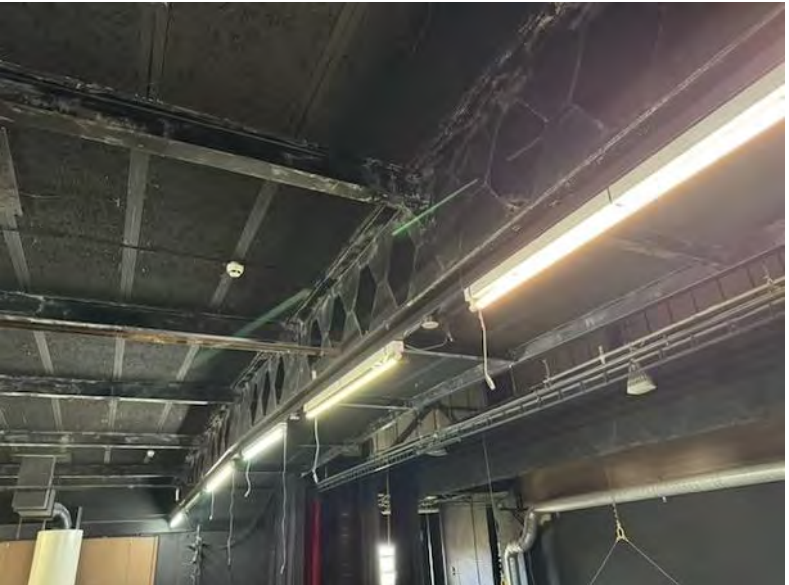
| 94. | The paint finish to the high level steelwork is in poor condition. It is not clear if this is in part caused by problems of rainwater ingress via the roof coverings. | |

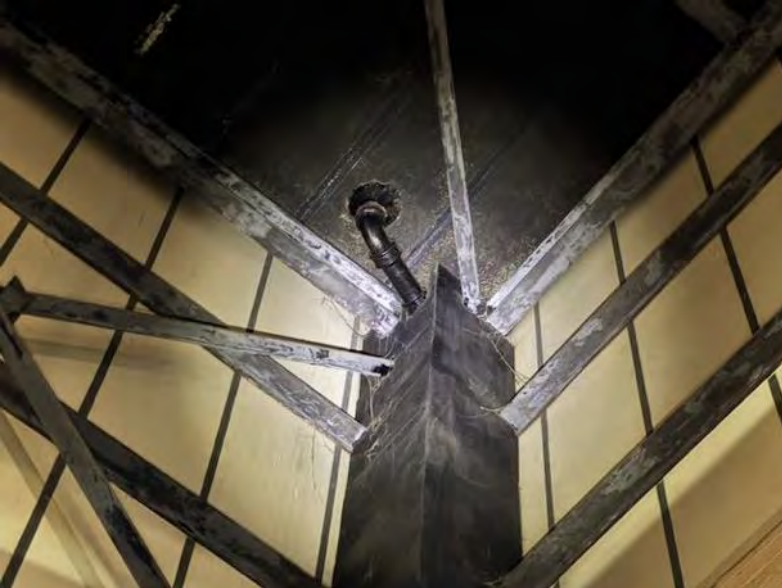
| 97. | <p>As above and including image of internal cast rainwater pipe.</p> <p>The paint finish to the steel frame in these areas is similarly poor and there is evidence of staining to the cladding around the rainwater pipe indicative of leaks.</p> | |

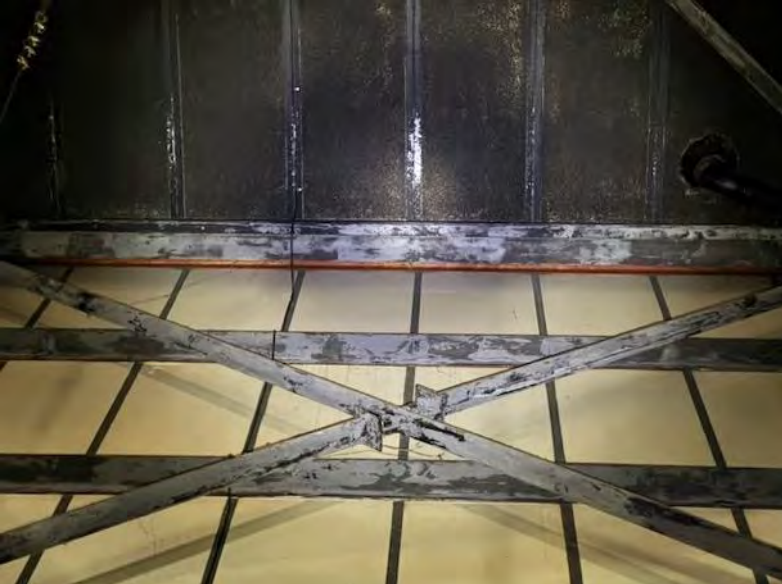
| 98. | There is evidence of deterioration and delaminating paint to the channel reinforcement to the roof deck. | |

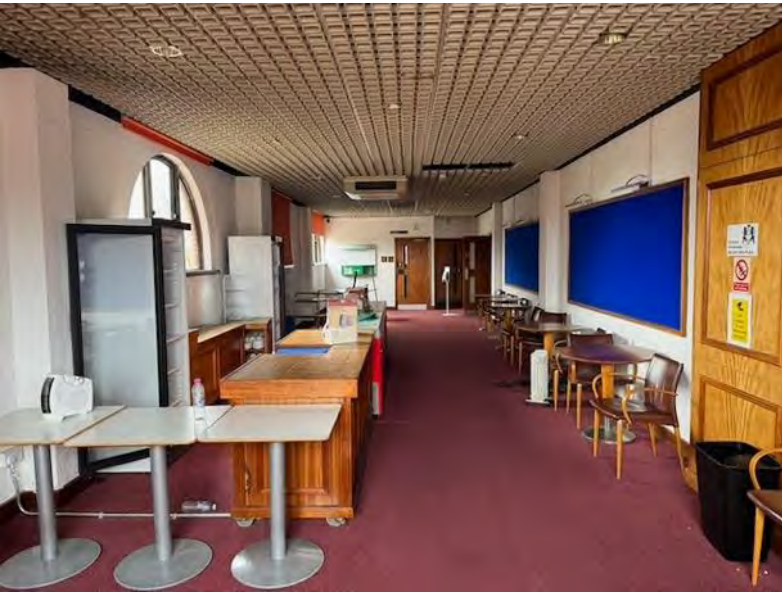
| 102. | <p>General view of bar and ancillary areas to the east of the first floor.</p> <p>Finishes are generally dated and worn.</p> | A long, narrow room with a red carpet and a textured, grid-patterned ceiling. On the left, there are several long wooden tables with metal legs. On the right, there are blue noticeboards and a wooden door. The room appears to be a bar or ancillary area. |

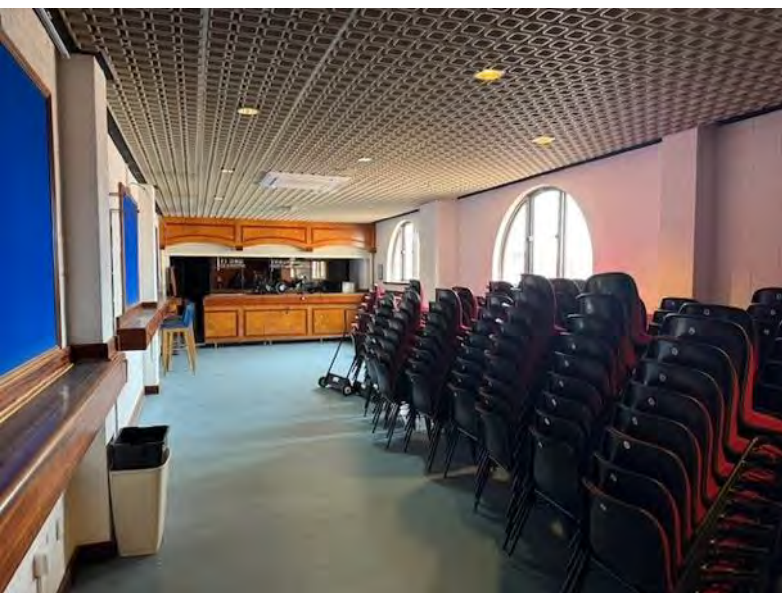
| 104. | <p>General view of bar and ancillary areas to the west of the first floor.</p> | A room with a blue carpet and a textured, grid-patterned ceiling. On the left, there are blue noticeboards and a wooden counter. On the right, there are rows of black chairs. In the background, there is a bar area with a wooden counter and a sign. |

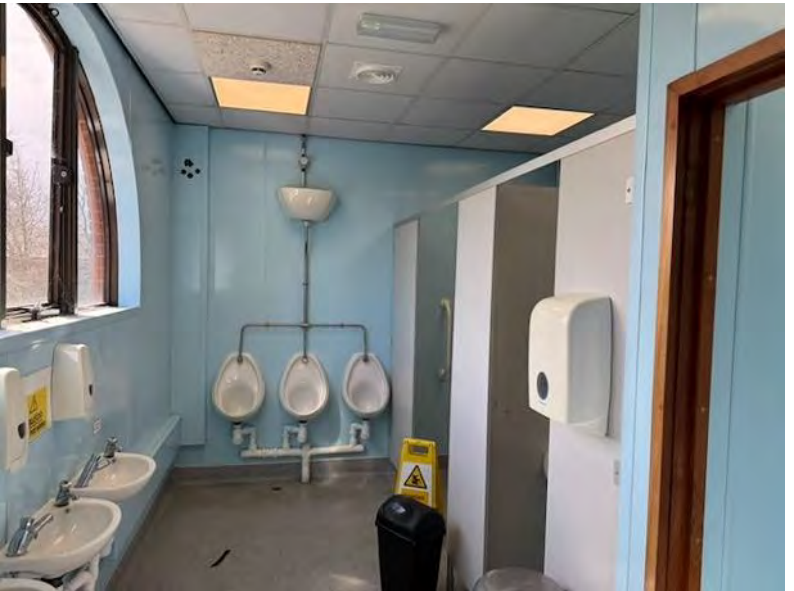
| 105. | General view of typical toilet accommodation at first floor. | A photograph of a public toilet facility. On the left, there are two white ceramic sinks with chrome faucets. In the center, three white urinals are mounted on a light blue wall. To the right, there is a white paper towel dispenser and a black trash bin. A yellow 'Caution' sign is on the floor. The room has a drop ceiling with fluorescent lights and a window on the left. |

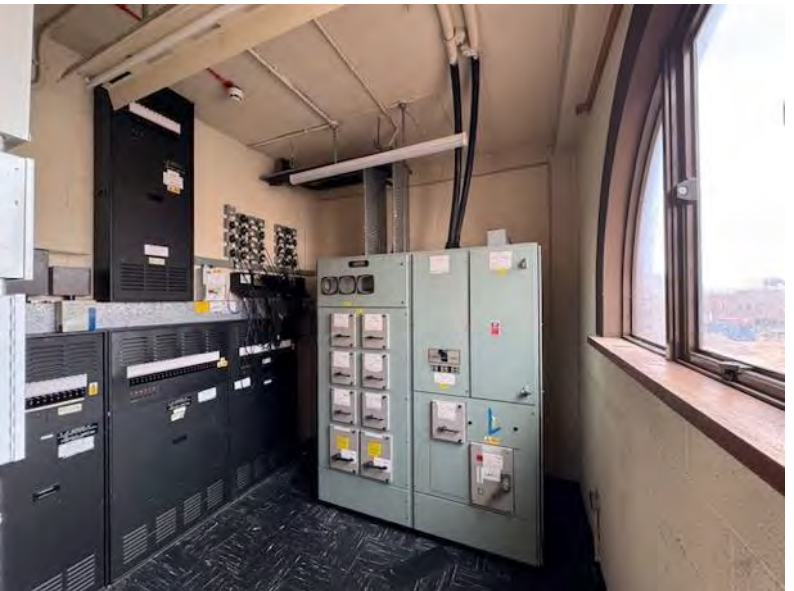
| 107. | General view of the electrical distribution room to the north east of the first floor. | A photograph of an electrical distribution room. It features several large, dark grey metal cabinets with multiple doors and drawers. A large black server rack is visible in the background. The room has a concrete floor and a window on the right side with a wooden frame. |

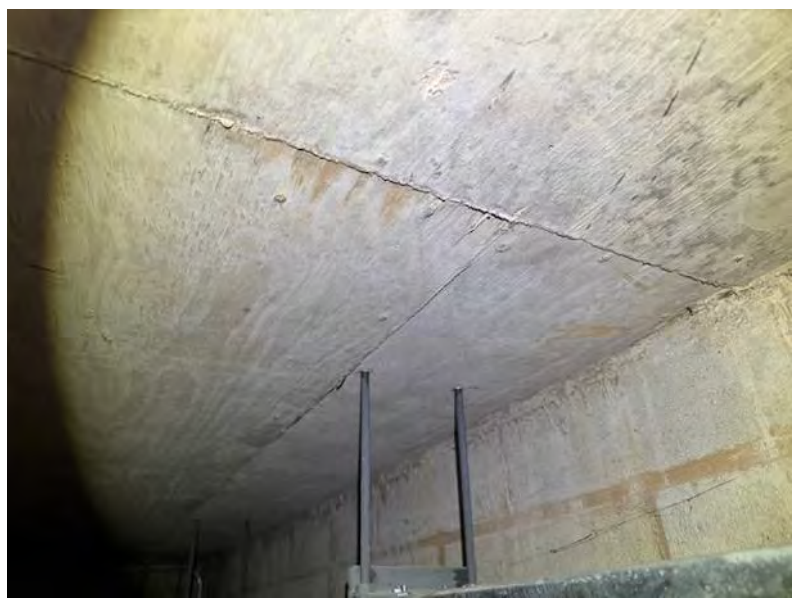
| 108. | <p>View of the cast-in-situ concrete second floor soffit visible above the suspended ceilings. No significant issues were identified.</p> | |

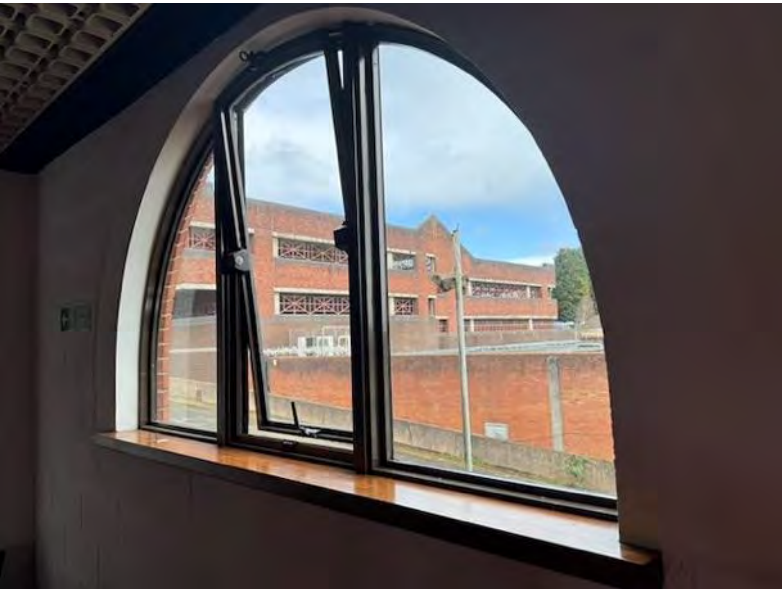
| <p>111.</p> | <p>View of the metal framed windows at first floor.</p> <p>Windows at first floor are single glazed and offer poor thermal performance.</p> | |

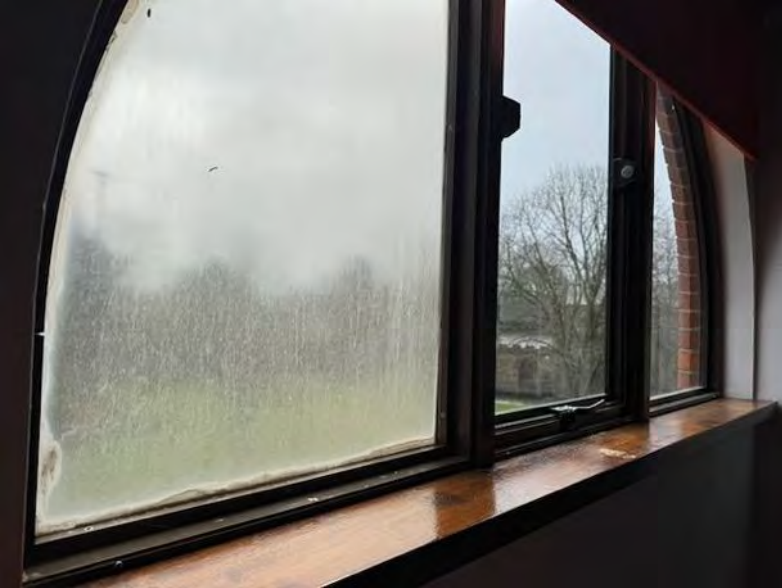
| <p>112.</p> | <p>Glazing to an isolated number of windows have been replaced with Perspex sheeting. This contrasts significantly with the adjacent glazing and is obscured.</p> | |

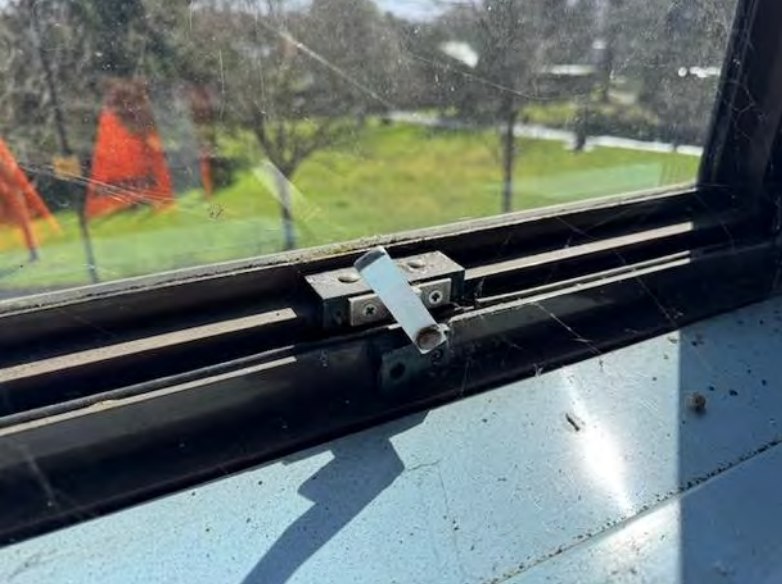
| <p>113.</p> | <p>Where tested the opening lights were generally operational, however, the window ironmongery is in poor condition.</p> | |

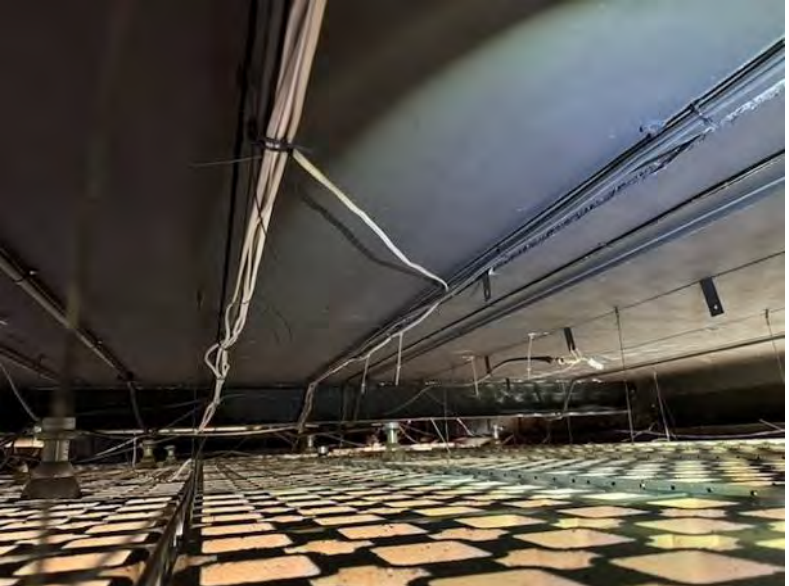
| <p>114.</p> | <p>Ceiling voids were generally free from obstruction, however, localised gaps in fire stopping are evident around services penetrations through compartment walls.</p> <p>A fire stopping audit is required.</p> | |

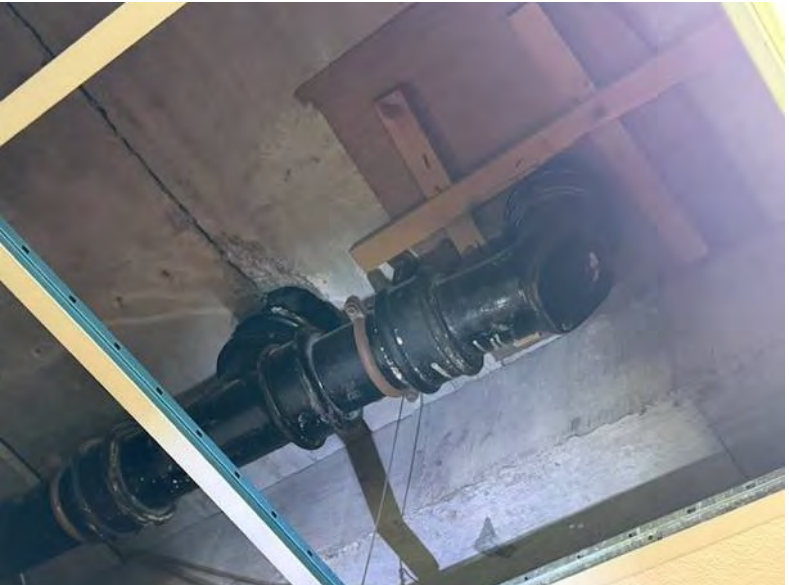
| <p>115.</p> | <p>Fire stopping around waste pipework penetrations is inadequate.</p> | |

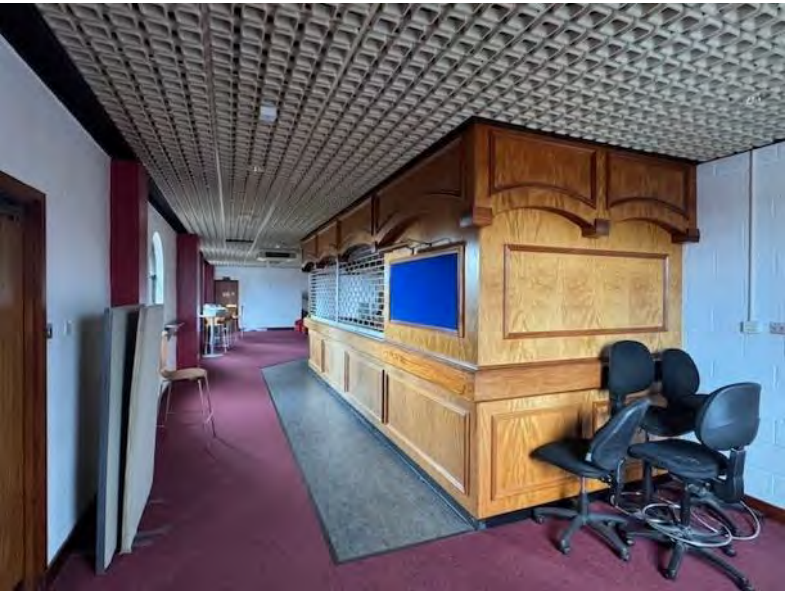
| <p>117.</p> | <p>General view of the bar and ancillary areas to the east at second floor.<br/>Finishes are generally dated and worn.</p> | |

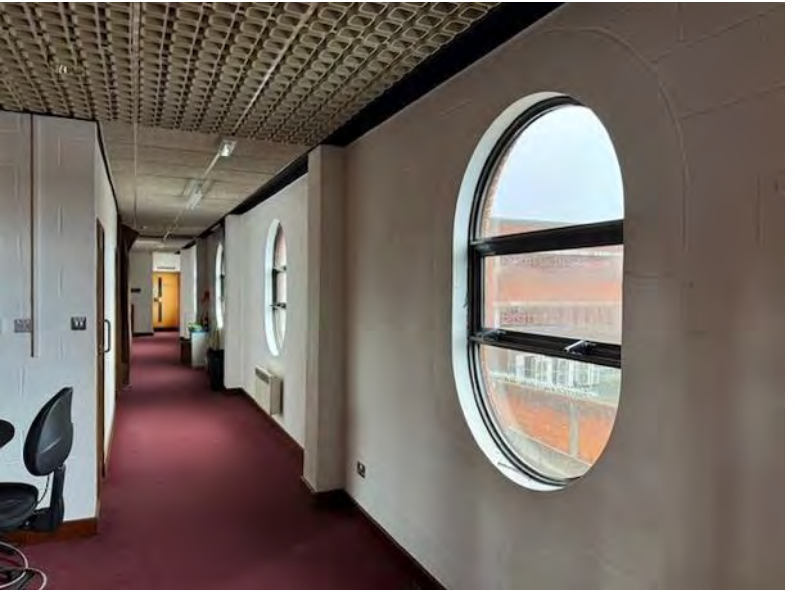
| <p>118.</p> | <p>General view of the corridor areas at second floor.</p> | |

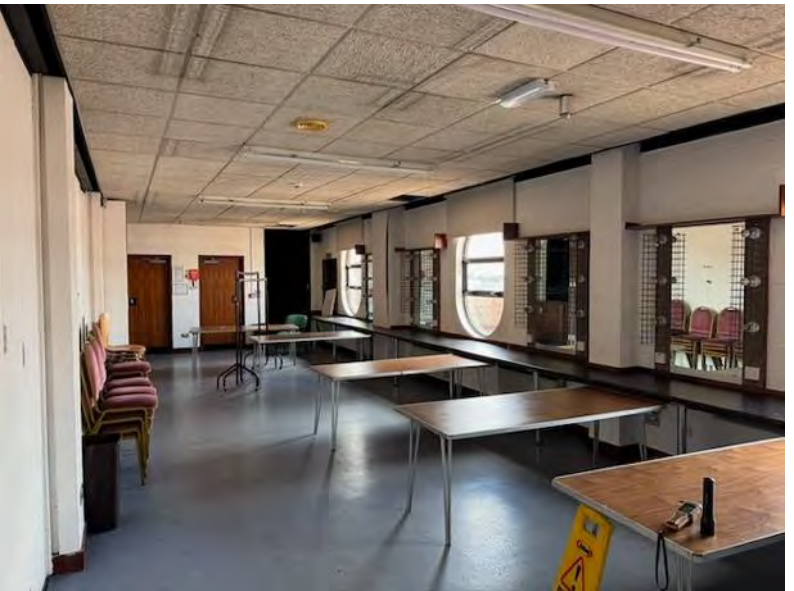
| <p>119.</p> | <p>General view of the theatre changing room areas to the west of the second floor.</p> | |

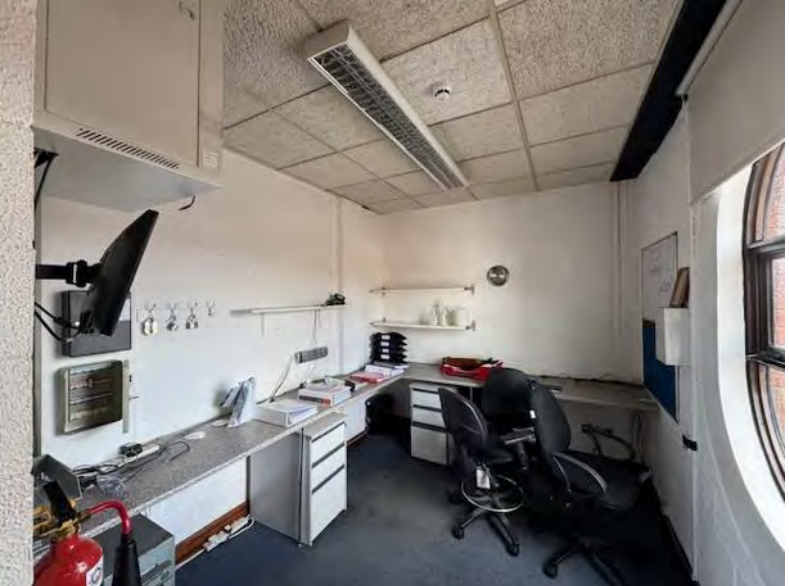
| 120. | View of limited office accommodation to the north west of the second floor. | |

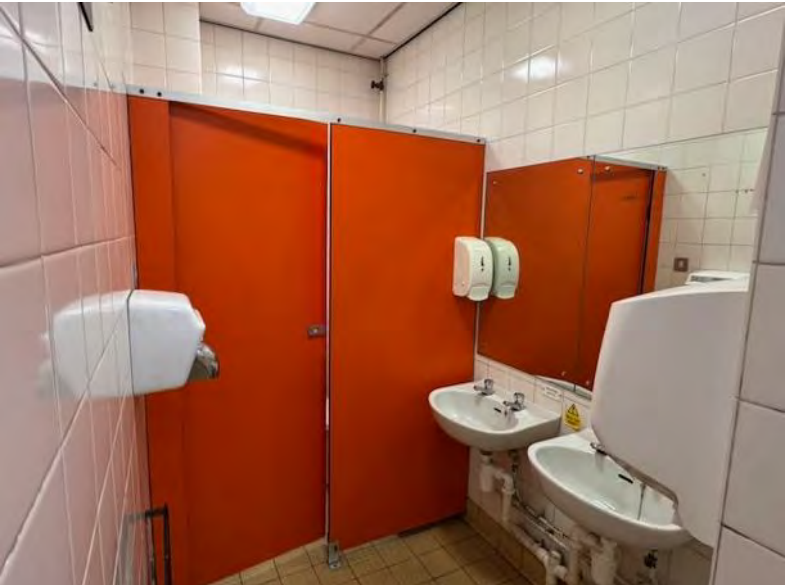
| 121. | View of the staff toilet facilities.<br>Finishes are generally dated and worn. | |

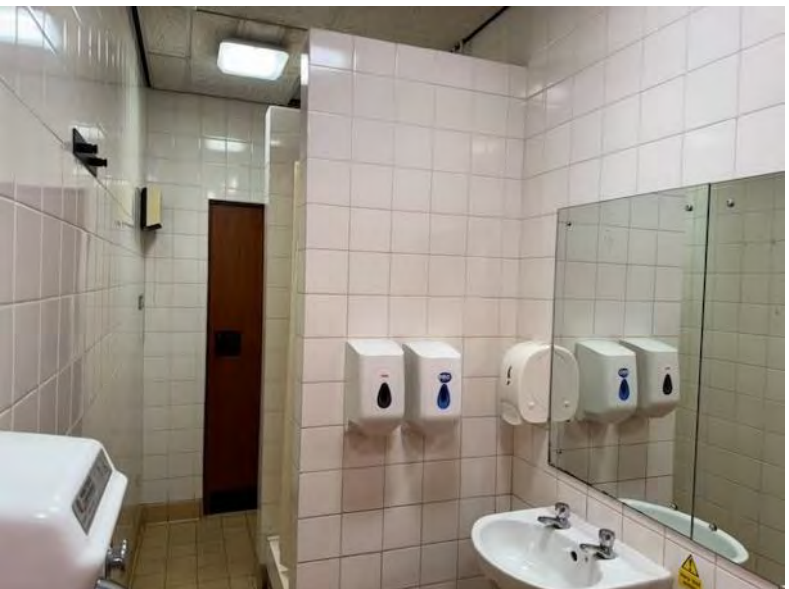
| 122. | View of staff toilet and shower facilities. | |

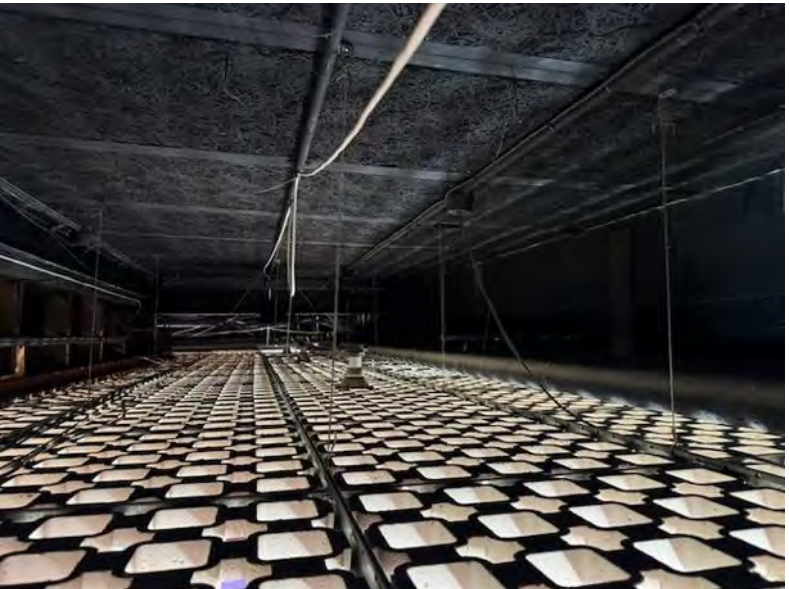
| 123. | View of the suspended ceiling voids below the roof deck. | |

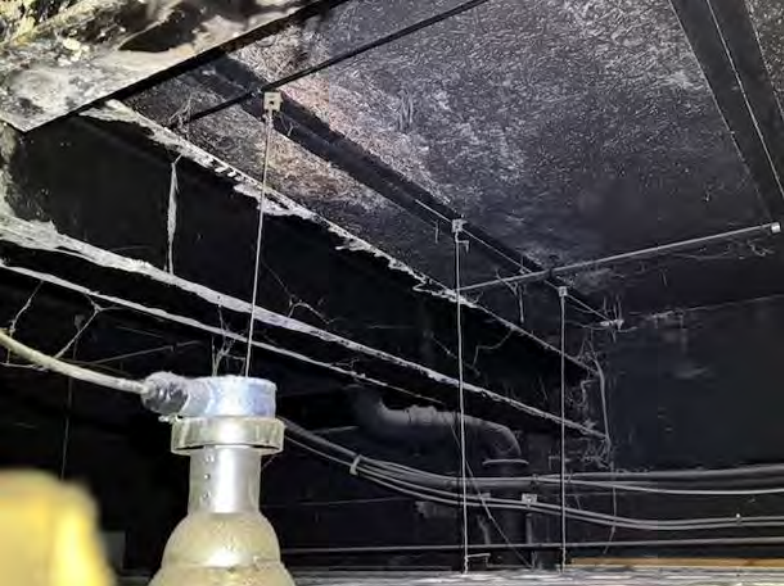
| <p>126.</p> | <p>Further evidence of rainwater ingress and associated damage to the roof deck and steel downstand beams in these areas.</p> | |

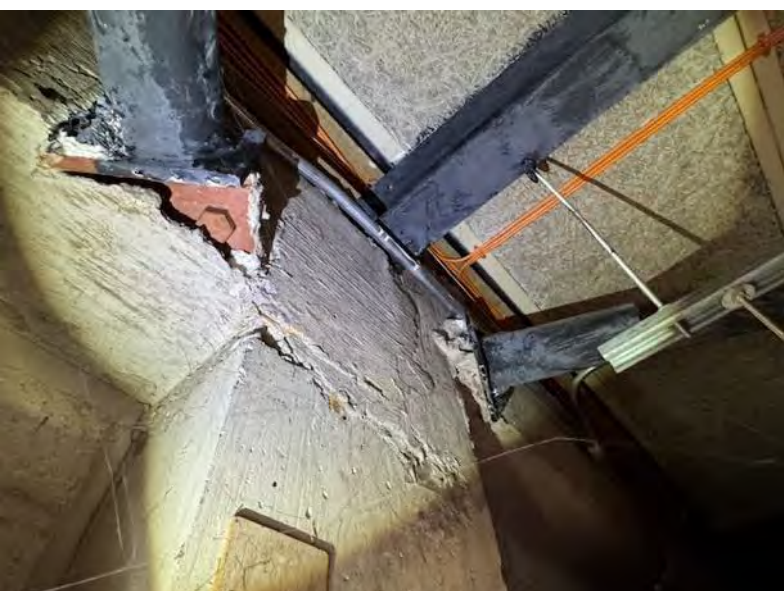
| <p>128.</p> | <p>View of exposed tubular steel wind bracing to the roof structure. The steel columns and beams to which these connect are encased in concrete as noted elsewhere.</p> | |

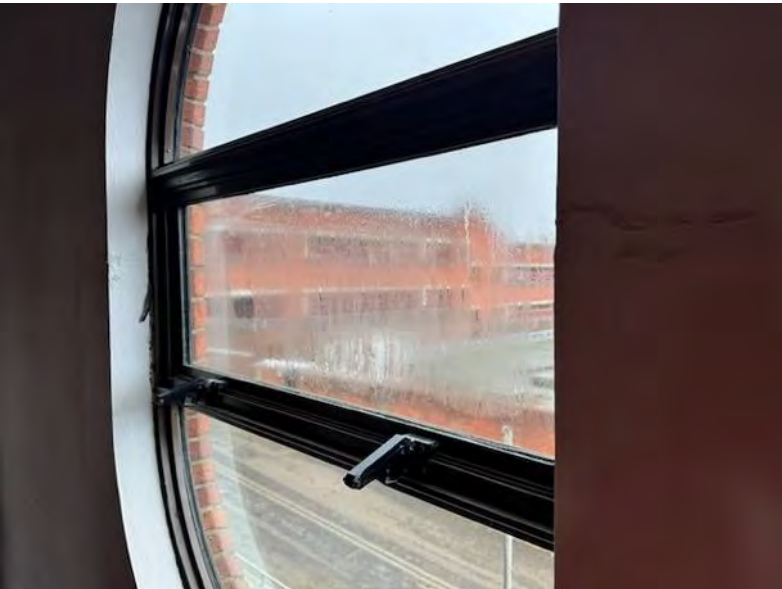
| <p>129.</p> | <p>The double glazed windows at second floor are in poor condition.</p> <p>Whilst it may be possible to repair the windows, we consider these have reached the end of their lifespan and recommend these be replaced with a modern equivalent.</p> | |

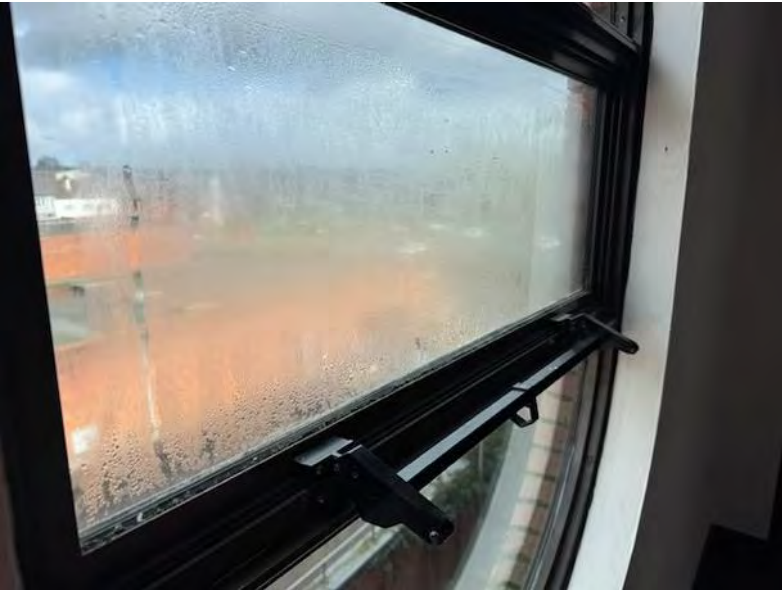
| <p>130.</p> | <p>Several failed double glazed units were identified which display interstitial condensation.</p> | |

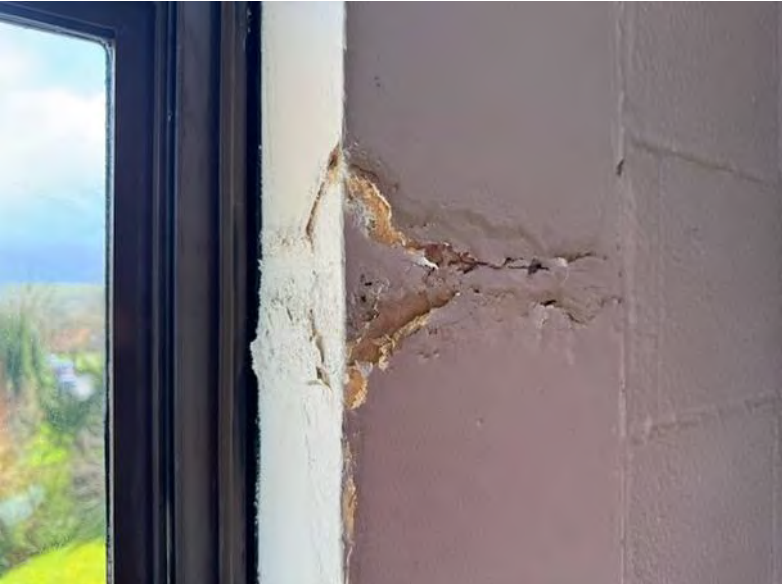
| <p>131.</p> | <p>There is evidence of damp ingress to the window reveals where perimeter mastic seals are degraded externally.</p> | |

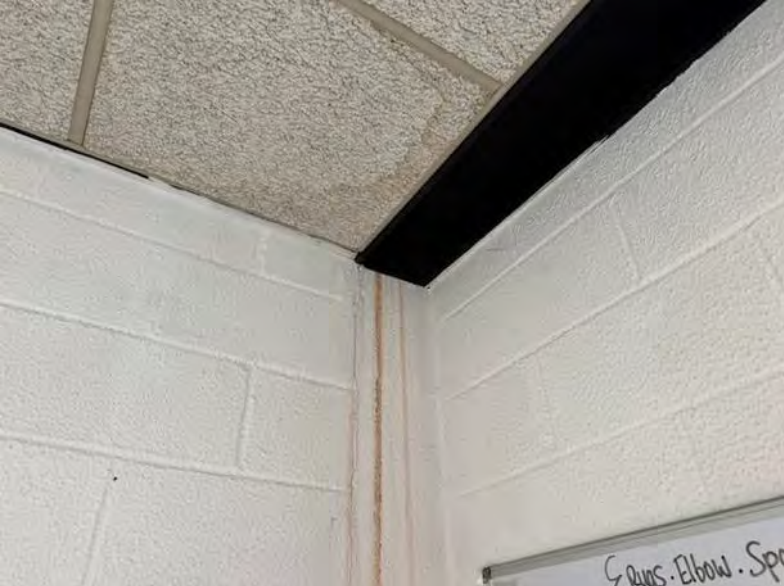
| 135. | <p>There is evidence of staining to the suspended ceiling tiles where leaks have occurred from the roof coverings. Some of these appear to be historic.</p> | |

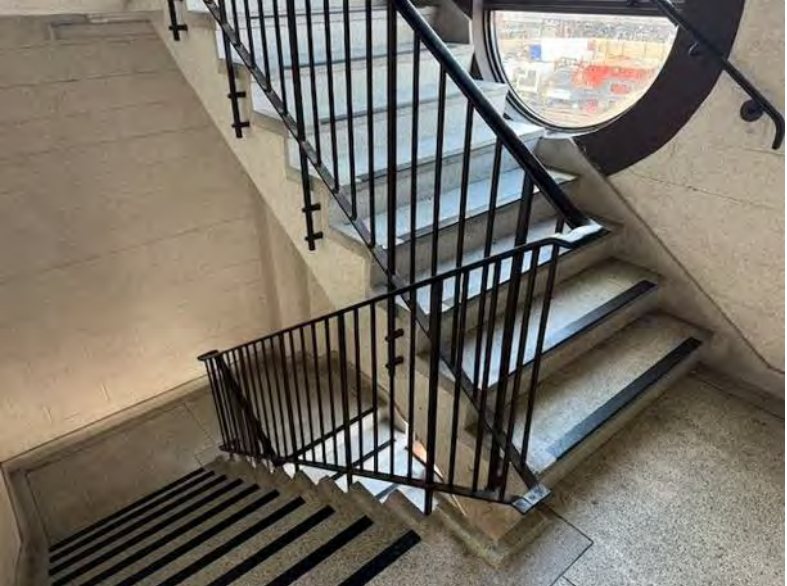
| <p>138.</p> | <p>View of the fire escape stairwell to the north west. A terrazzo style floor finish is provided to the stairs and landings. Walls to these areas are provided with a portafleck paint.</p> <p>Finishes are dated and worn.</p> | |
