# Prince of Wales Theatre Refurbishment & Demolition Survey

Prepared for: Cannock Chase District  
Council

Report Number:  
Cannock/Theatre/260417

# Asbestos Demolition Survey

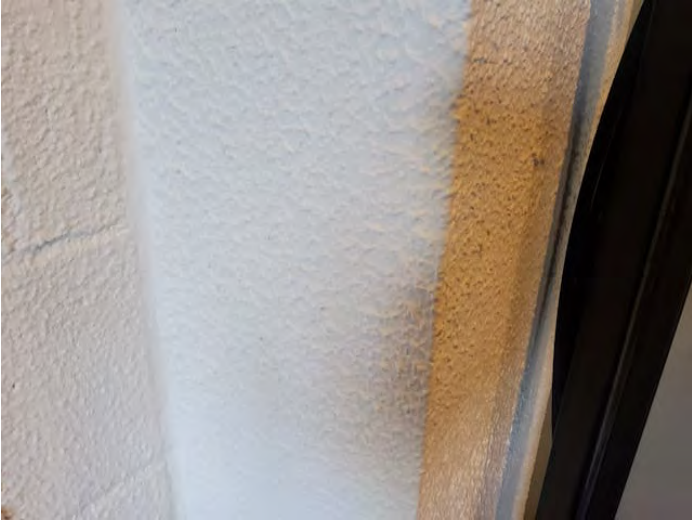
| Location | 101 | Item | 11 |

| Material | Textured Coating | Extent | <100 sq. m. |
| Strategy / Sample Id | Sample / S010 | Fibre Type | NADIS |
| General Comments | Textured coating | | |

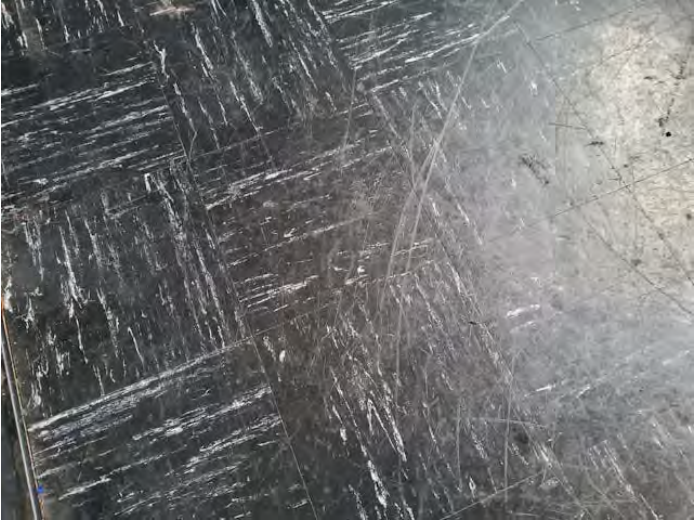
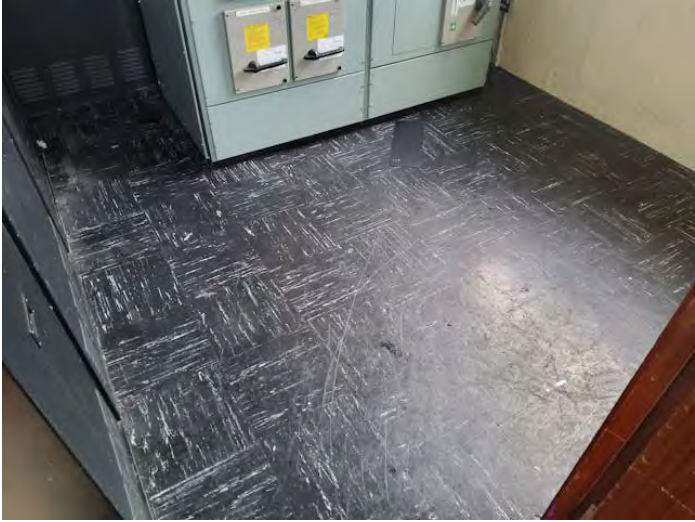
| Location | 103 | Item | 13 |

| Material | Vinyl Tile | Extent | <10m |
| Strategy / Sample Id | Sample / S012 | Fibre Type | NADIS |
| General Comments | Vinyl Floor tiles | | |

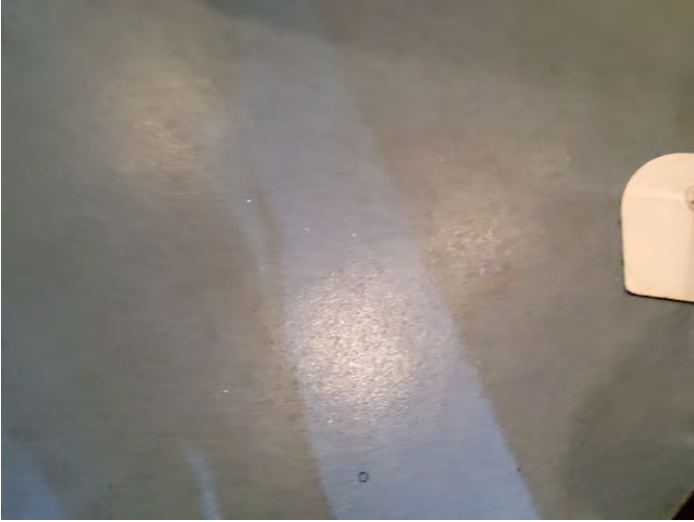
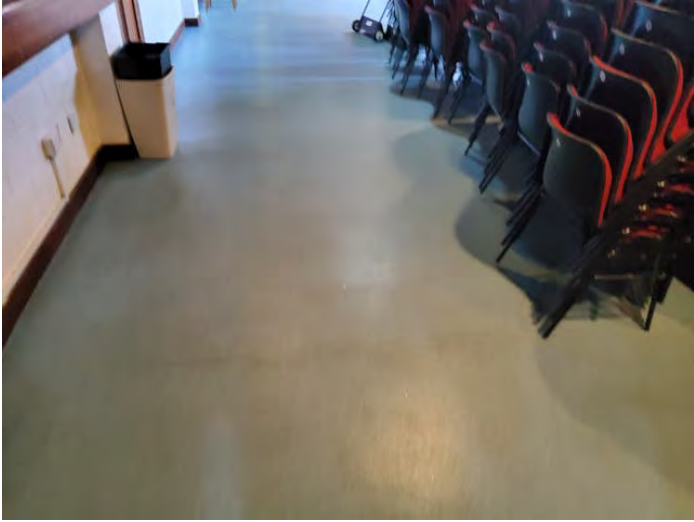
| Location | 104 | Item | 15 |

| Material | Modern Linoleum | Extent | <50m |
| Strategy / Sample Id | Sample / S013 | Fibre Type | NADIS |
| General Comments | Modern lino | | |

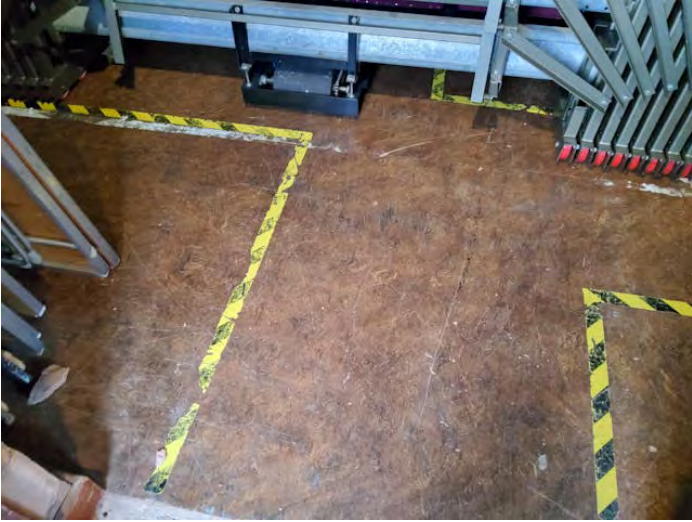
| Location | 105 | Item | 12 |

| Material | Linoleum | Extent | 16m. sq |
| Strategy / Sample Id | Sample / S011 | Fibre Type | NADIS |
| General Comments | Modern lino | | |

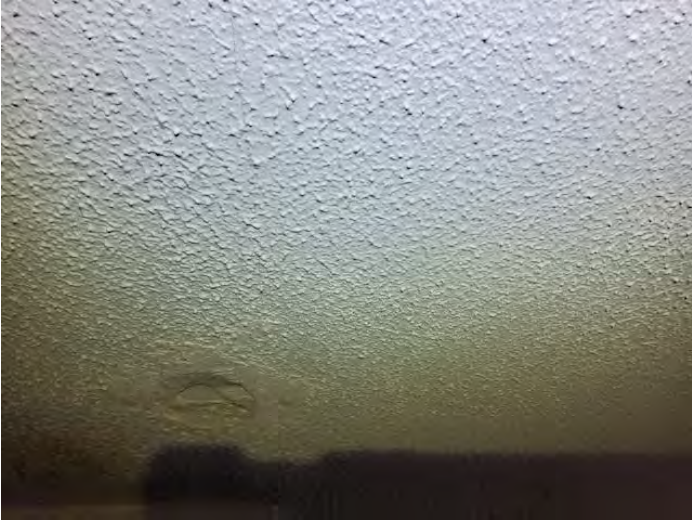
| Location | 106 | Item | 17 |

| Material | Textured Coating | Extent | 10m |
| Strategy / Sample Id | Sample / S014 | Fibre Type | NADIS |
| General Comments | Textured coating | | |

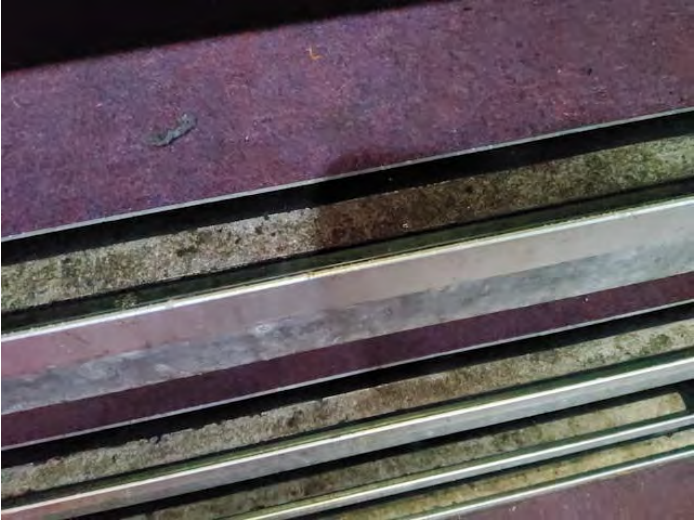
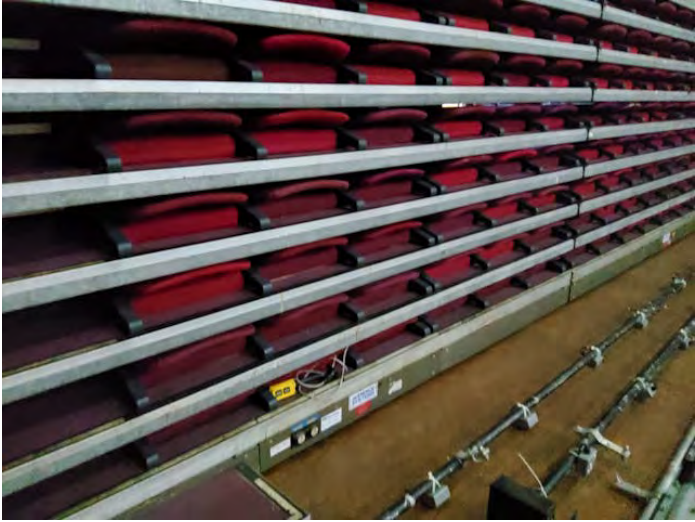
| Location | 109 | Item | 22 |

| Material | Stair nosing | Extent | > 100LM |
| Strategy / Sample Id | Sample / S019 | Fibre Type | NADIS |
| General Comments | Stair Noses | | |

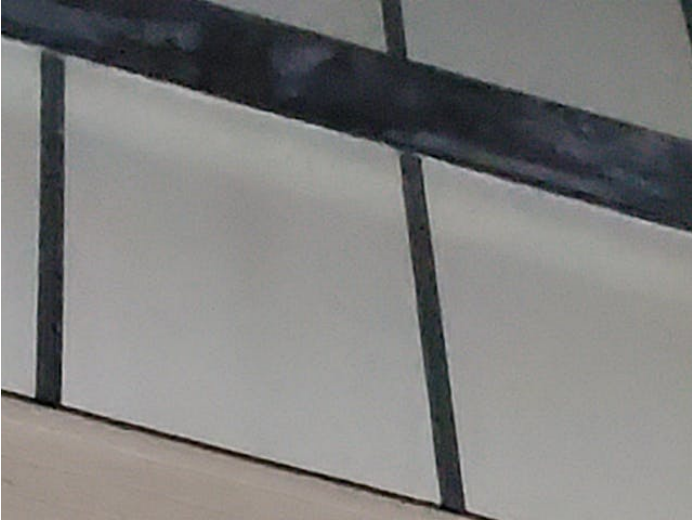
| Location | 110 | Item | 18 |

| Material | Insulating Board | Extent | <250 sqm |
| Strategy / Sample Id | Sample / S015 | Fibre Type | NADIS |
| General Comments | High level insulation Board | | |

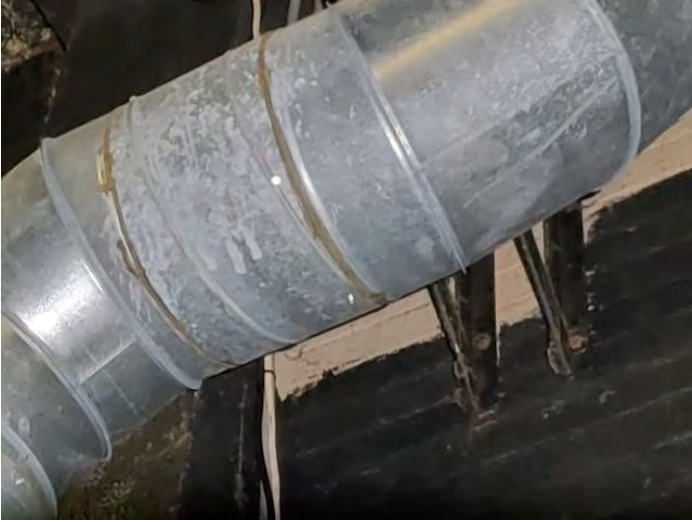
| Location | 110 | Item | 19 |

| Material | Mastic | Extent | Throughout |
| Strategy / Sample Id | Sample / S016 | Fibre Type | NADIS |
| General Comments | Mastic to ventilation | | |

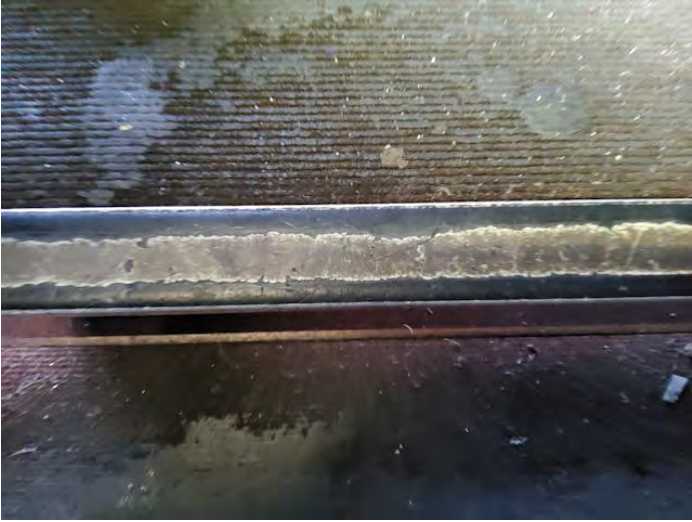
| Location | 110 | Item | 20 |

| Material | Stair nosing | Extent | 12 No. |
| Strategy / Sample Id | Sample / S017 | Fibre Type | NADIS |
| General Comments | Stair Noses | | |

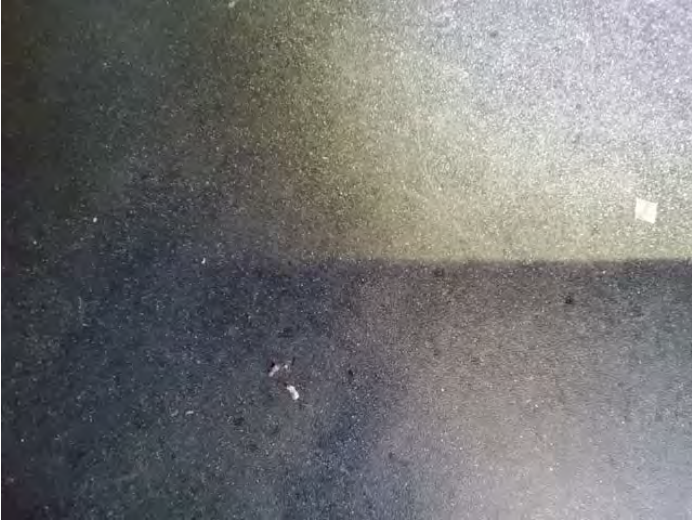
| Location | 110 | Item | 21 |

| Material | Modern Linoleum | Extent | 200 sqm |
| Strategy / Sample Id | Sample / S018 | Fibre Type | NADIS |
| General Comments | Modern lino | | |

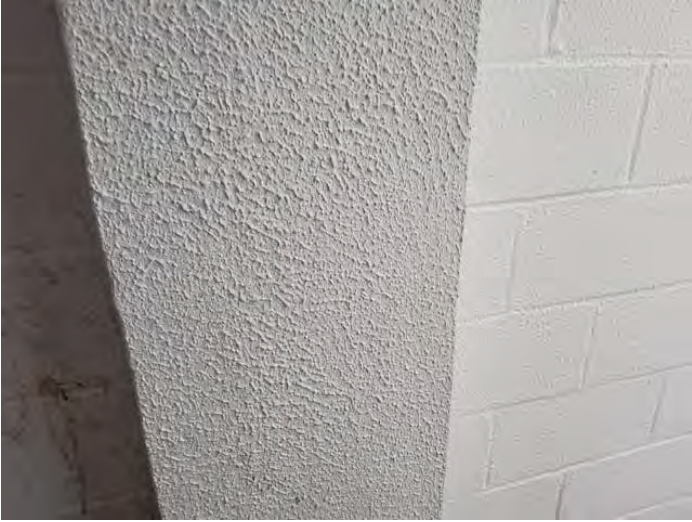
| Location | 201 | Item | 1 |

| Material | Textured Coating | Extent | <200 sqm |
| Strategy / Sample Id | Sample / S001 | Fibre Type | NADIS |
| General Comments | Textured coating to walls and ceiling | | |

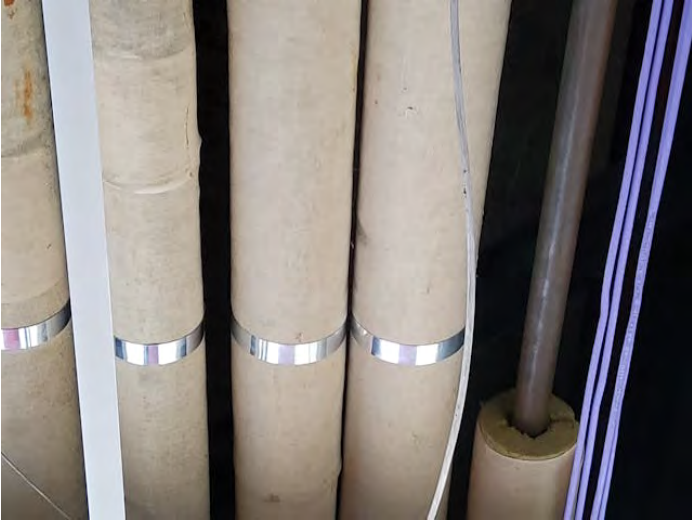
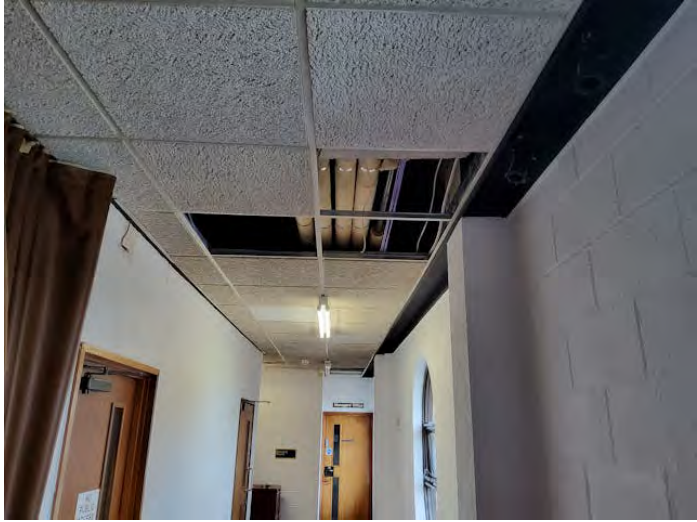
| Location | 201 | Item | 3 |

| Material | Man Made Mineral Fibre | Extent | >500LM |
| Strategy / Sample Id | Sample / S003 | Fibre Type | NADIS |
| General Comments | MMMF lagging to pipework | | |

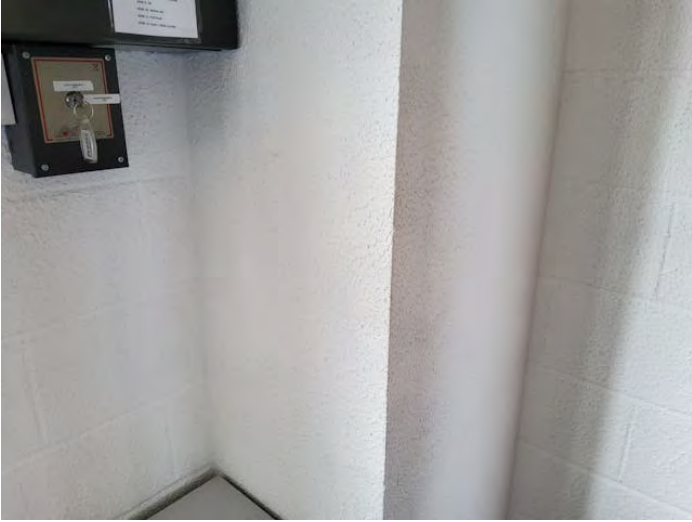
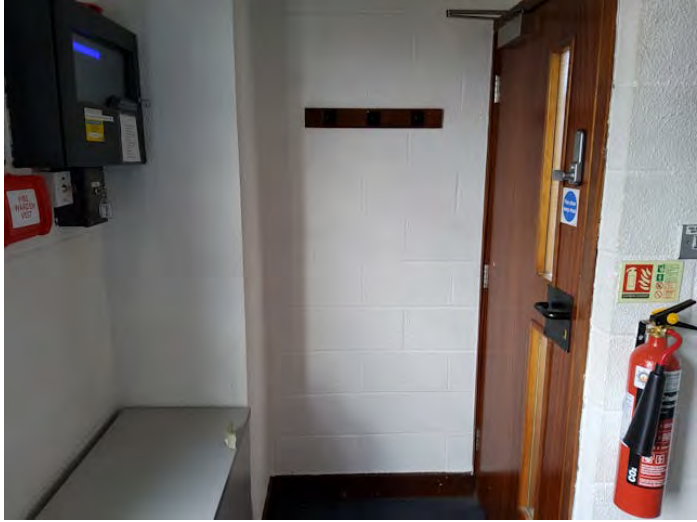
## Main Building > 2 > 206 > 4

| Material | Textured Coating | Extent | <50 sqm |
| Strategy / Sample Id | Sample / S004 | Fibre Type | NADIS |
| General Comments | Textured coating | | |

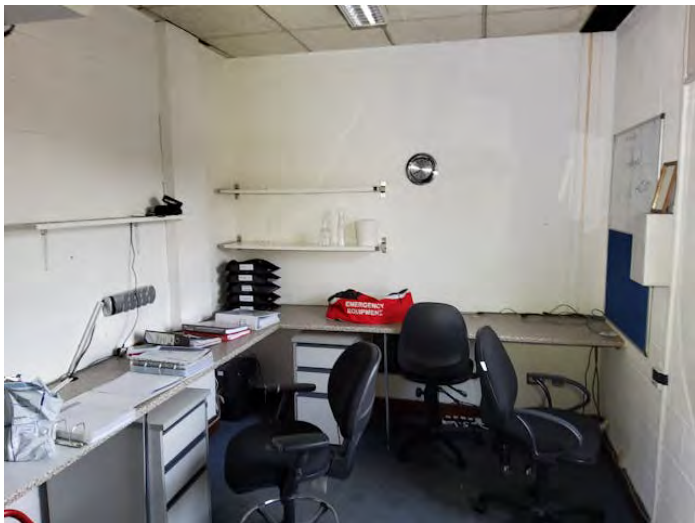
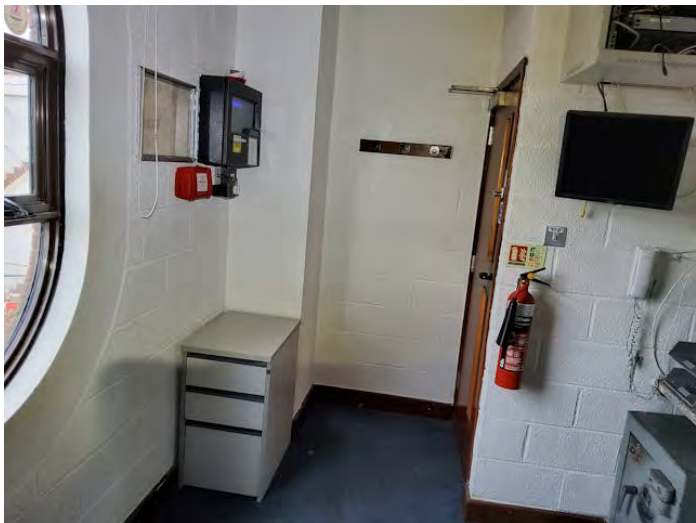
Main Building > 2 > 206 > Location Notes

| Location Notes | MMMF Suspended ceiling tile grid system.<br>Concrete in void to surfaces above<br>Modern floor covering over concrete<br>Modern windows and doors and frames. | | |

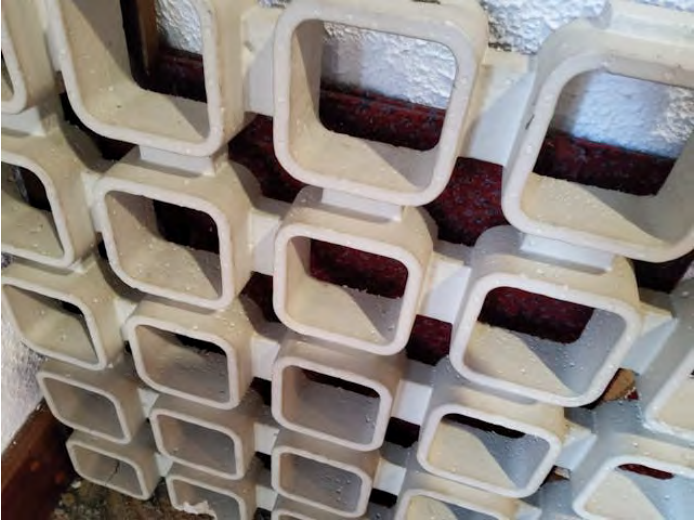
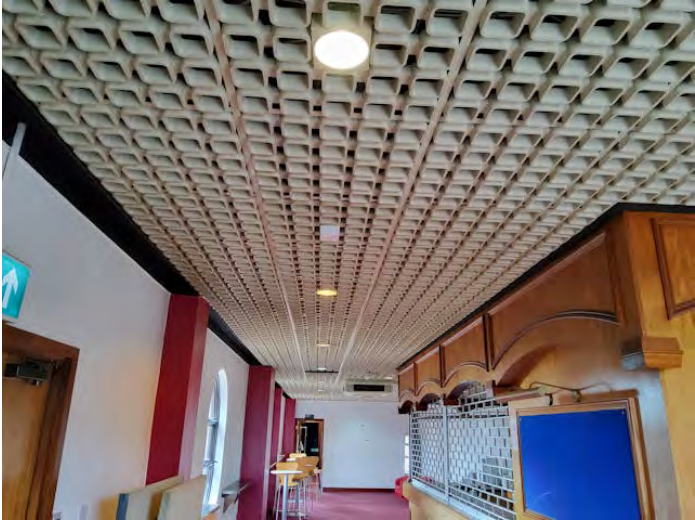
Main Building > 2 > 213 > 2

| Material | Ceramic Tile | Extent | 300 sqm |
| Strategy / Sample Id | Sample / S002 | Fibre Type | NADIS |
| General Comments | Suspended Ceiling tiles | | |

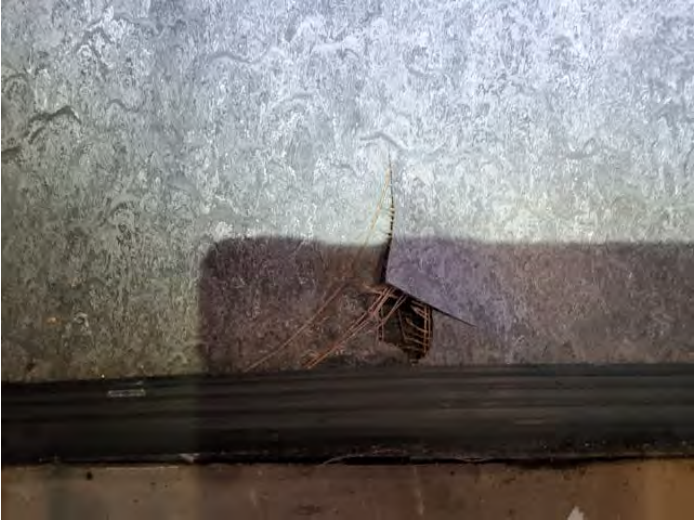
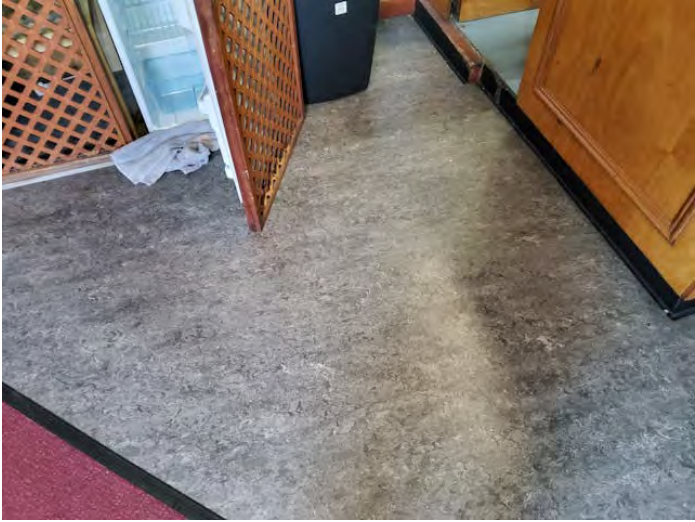
Main Building > 2 > 213 > 7

| Material | Linoleum | Extent | 10m |
| Strategy / Sample Id | Sample / S006 | Fibre Type | NADIS |
| General Comments | Modern lino | | |

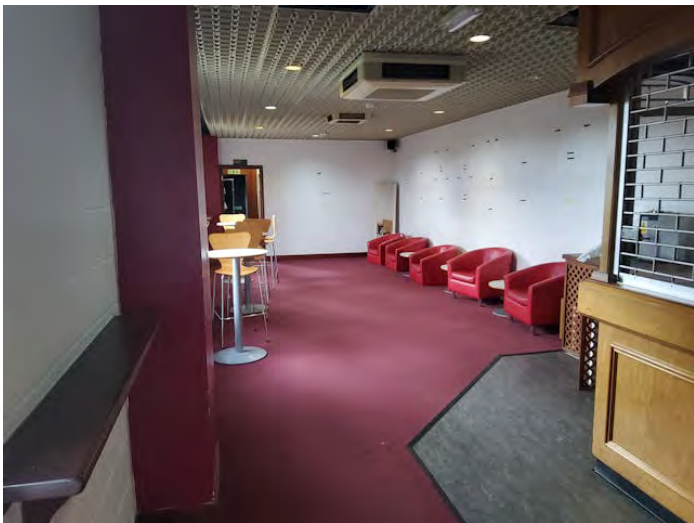
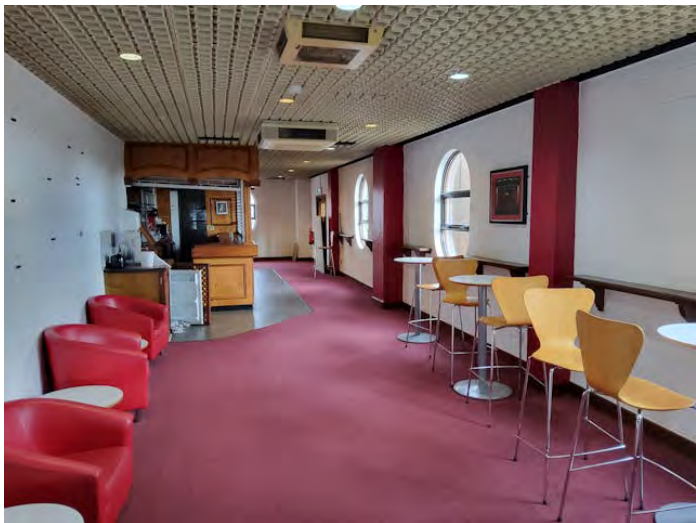
Main Building > 2 > 213 > Location Notes

| Location Notes | <p>Modern Floor covering over concrete screed. Solid walls with modern plaster Finish. Wood Box work.</p> <p>Plaster Ceiling grid tiles with Concrete to surfaces in Void above. Plaster Fire Break panels. Modern Window frame construction. Modern Fire Doors and frame construction. MMMF lagged copper pipes in ceiling void</p> | | |

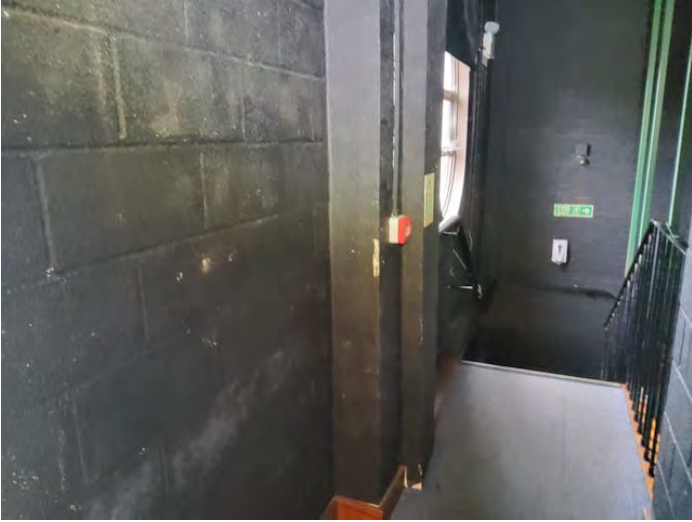
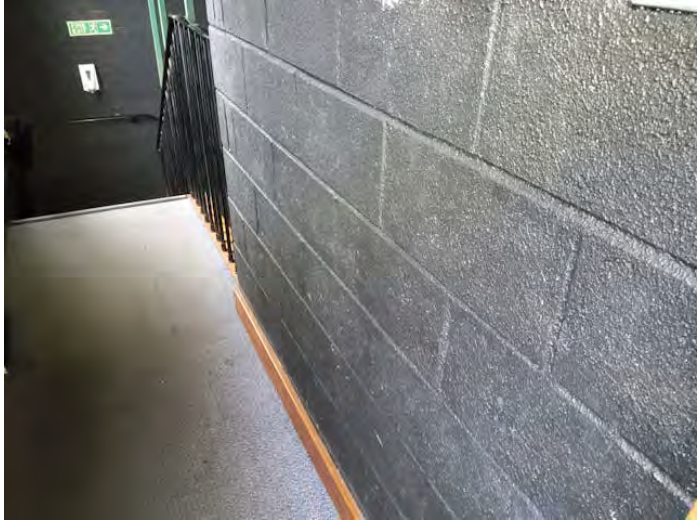
## Main Building > 2 > 217 > 8

| Material | Textured Coating | Extent | < 100 sqm |
| Strategy / Sample Id | Sample / S007 | Fibre Type | NADIS |
| General Comments | Textured coating | | |

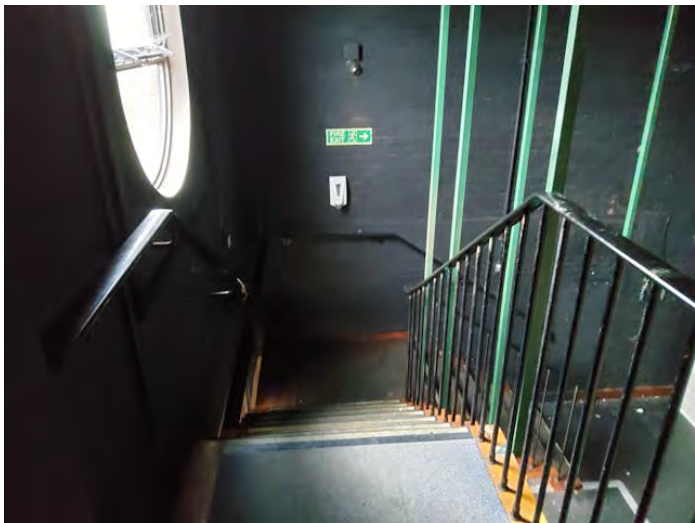
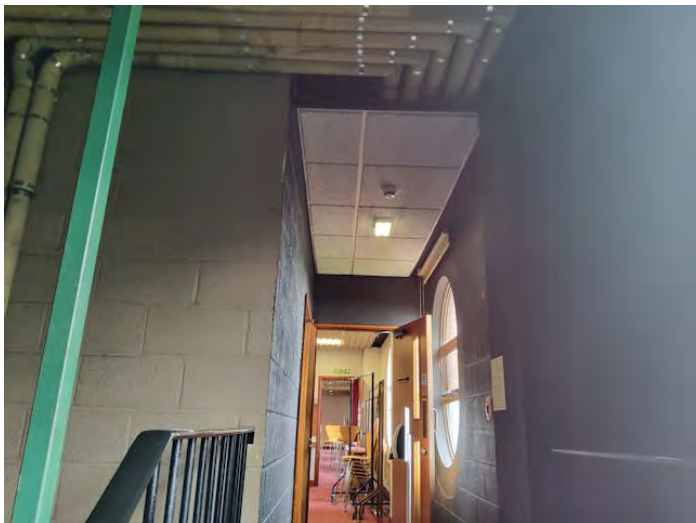
Main Building > 2 > 217 > Location Notes

| Location Notes | Modern suspended ceiling tiles. MMMF lagging over copper pipework. Modern floor coverings. Brick block work to walls | | |

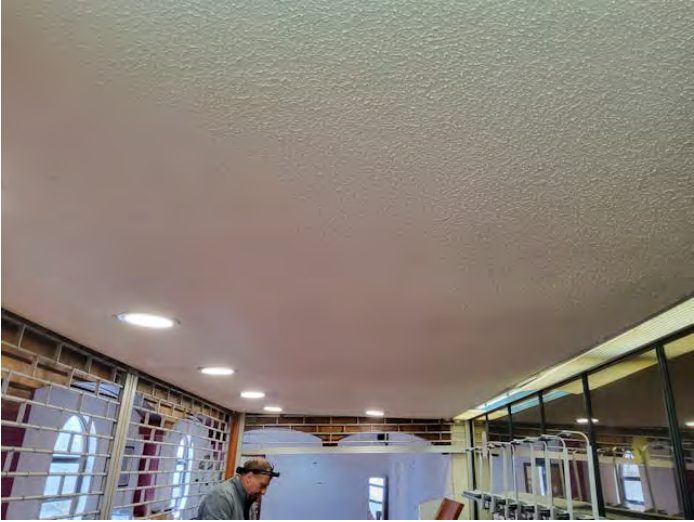
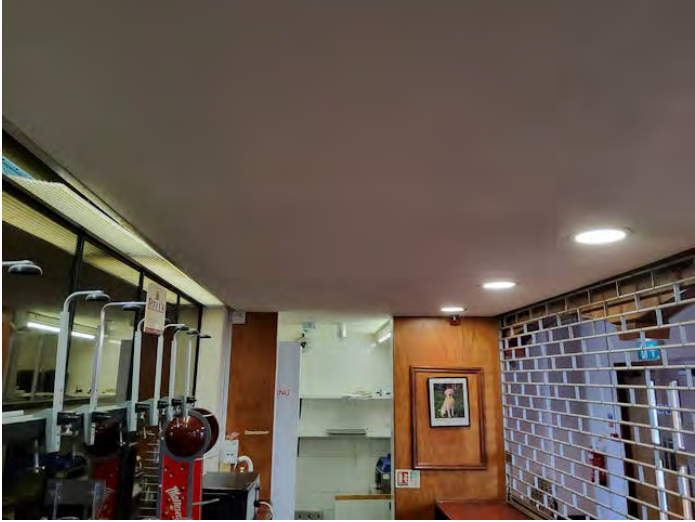
Main Building > 2 > 218 > 6

| Material | Textured Coating | Extent | 12m |
| Strategy / Sample Id | Sample / S005 | Fibre Type | NADIS |
| General Comments | Textured Coating to ceiling | | |

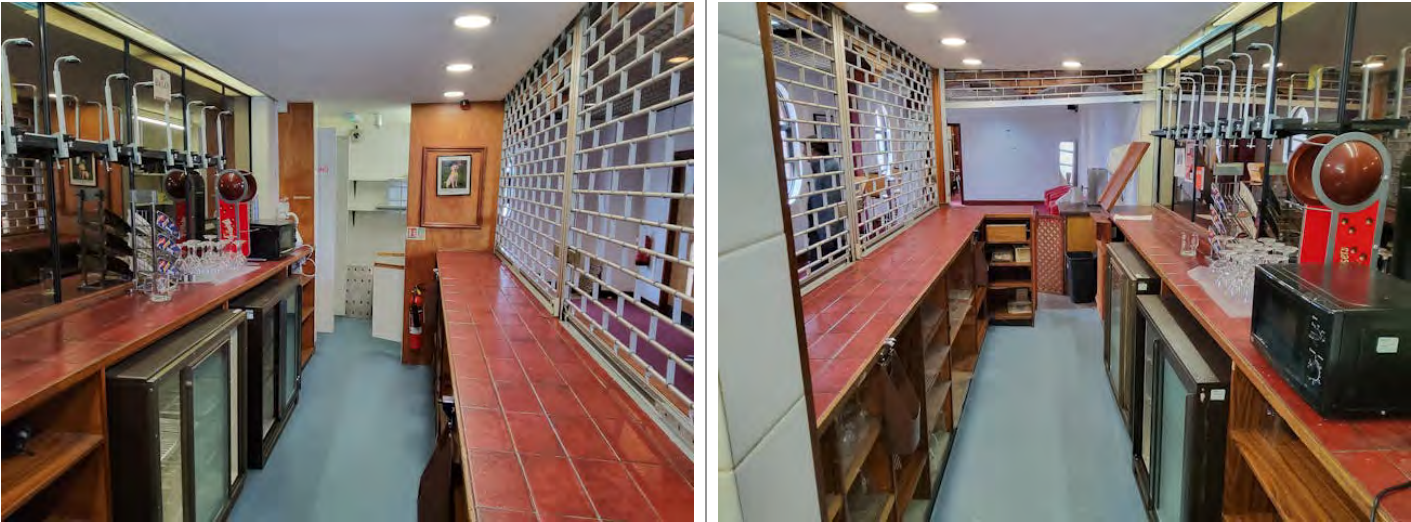
Main Building > 2 > 218 > Location Notes

| | | <p>Location Notes</p> <p>Plasterboard ceiling with textured coating.<br/>Wooden panelling and framework<br/>Modern floor covering over concrete</p> | |

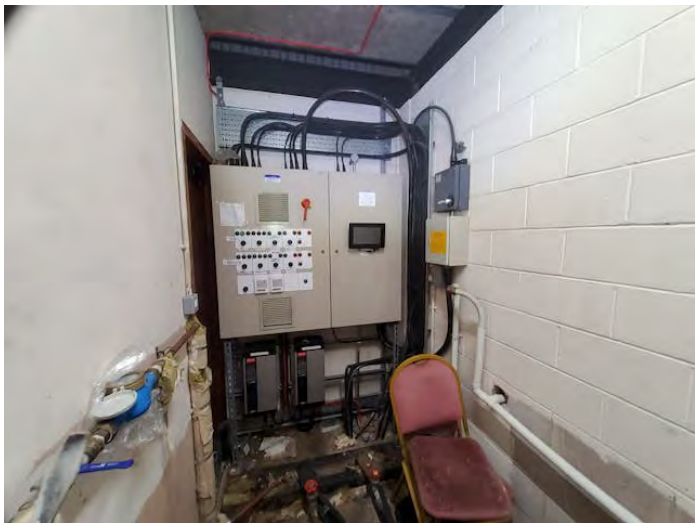
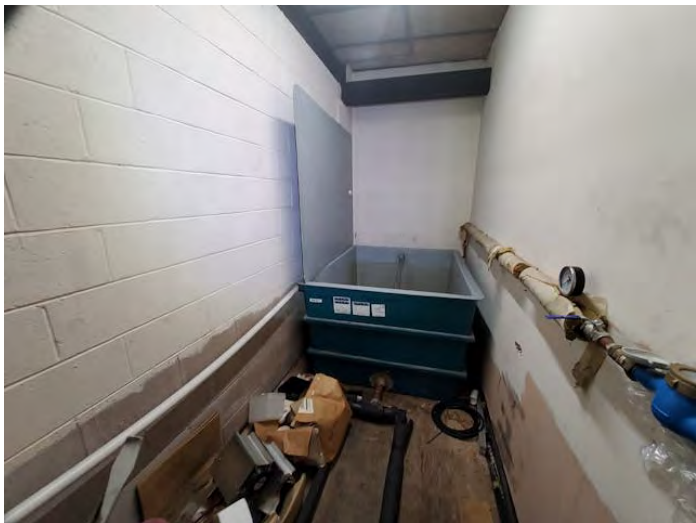
Main Building > 3 > 301 > Location Notes

| Location Notes | Strammit Board ceiling. Block work to walls<br>Modern Electrical system<br>MMMF lagging on pipework | | |

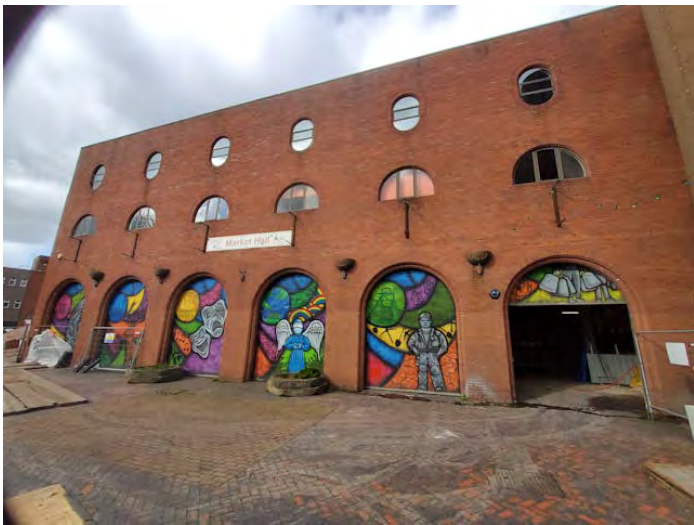
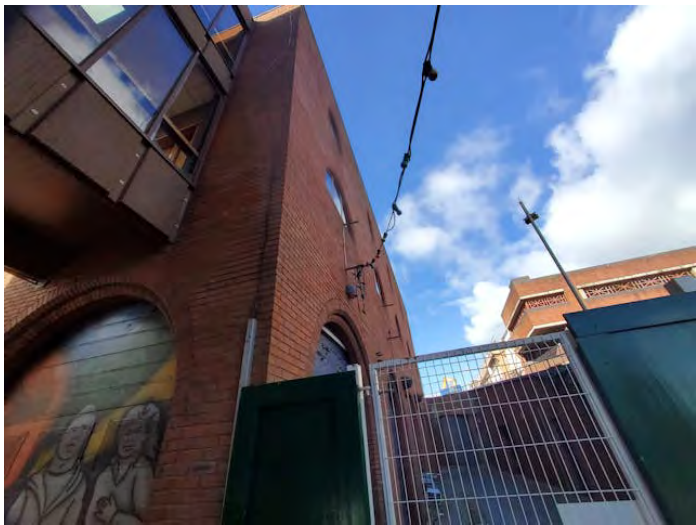
| Location | EX002 | Item | |

| Location Notes | Modern Exposed brick construction.<br>Modern window frames<br>Galvanised rainwater goods | | |

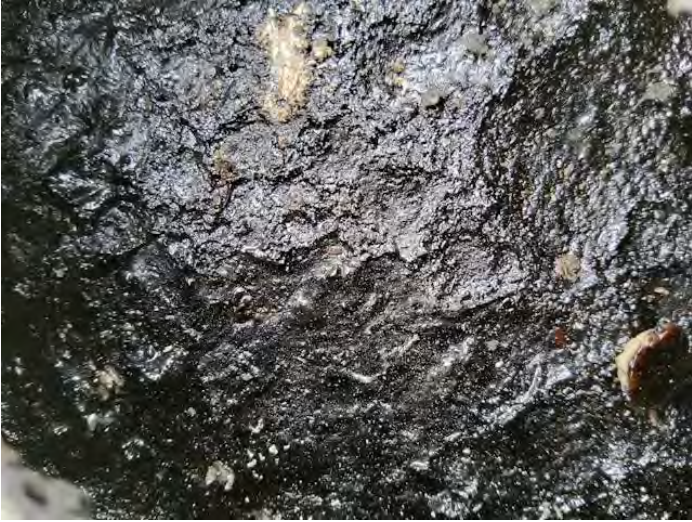
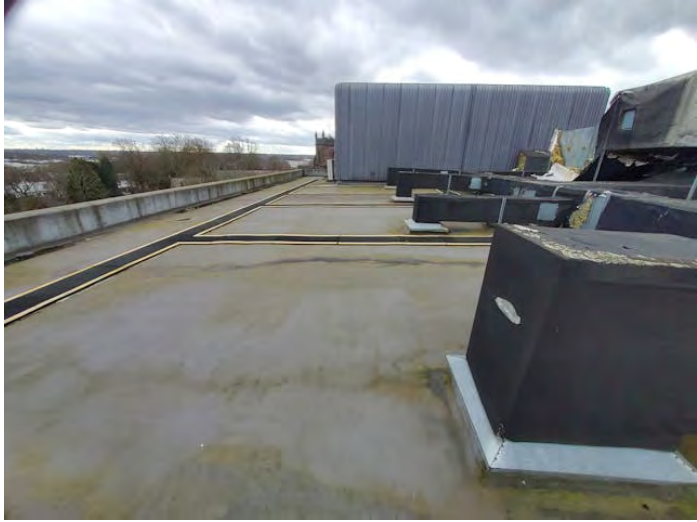
| Location | 999 - External | Item | 10 |

| Material | Bitumen | Extent | >500 sqm |
| Strategy / Sample Id | Sample / S009 | Fibre Type | NADIS |
| General Comments | Bitumen to roof surface | | |

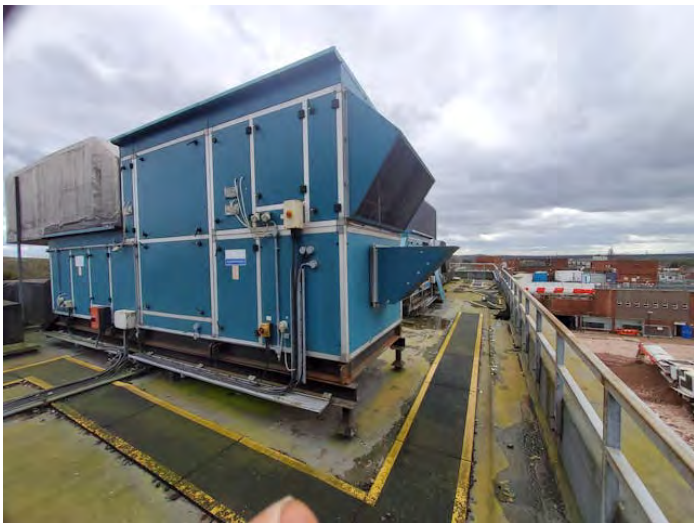
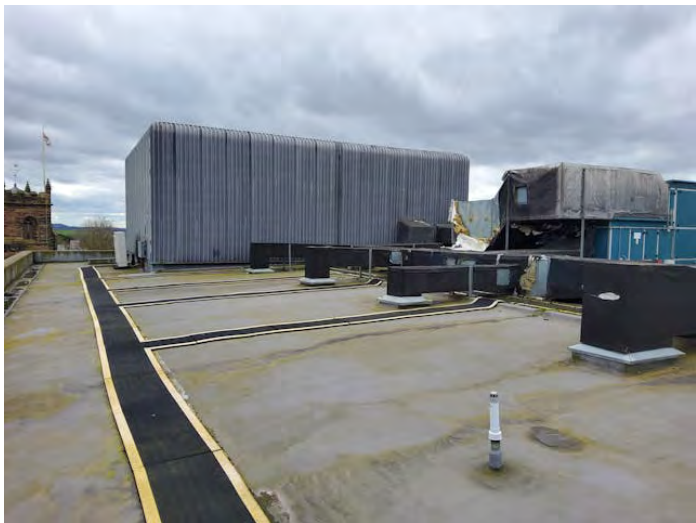
| Location | 999 - External | Item | |

| Location Notes | Metal Fabricated panels.<br>Bitumen roof surface<br>Metal/fibreglass panels and frame to ventilation system. | | |

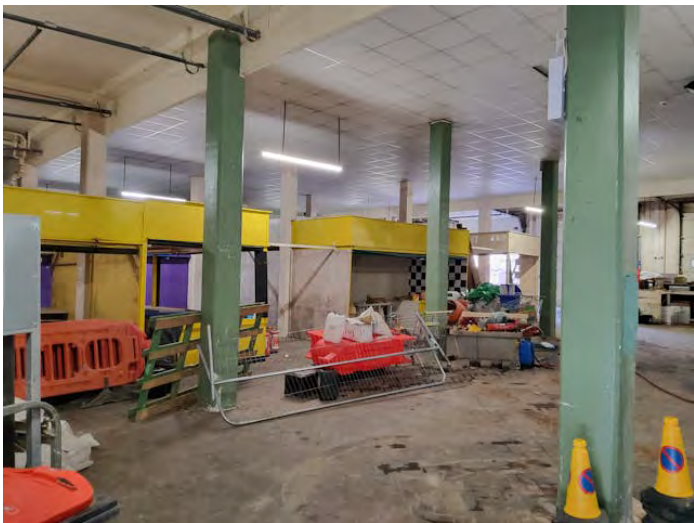
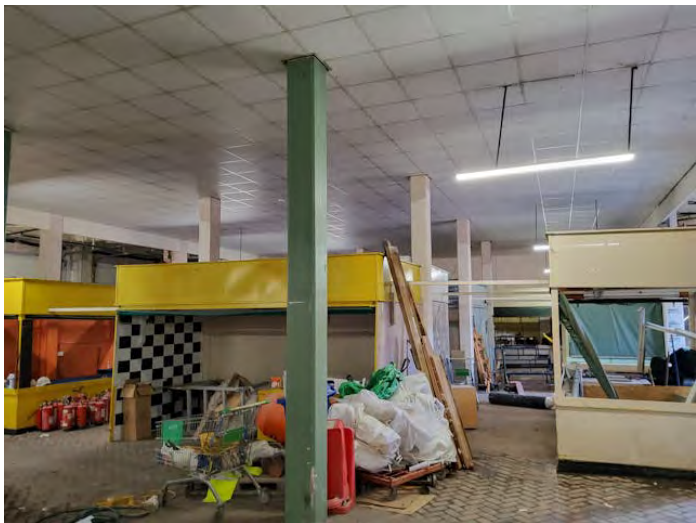
| Location Notes | <p>Solid concrete floor with wishbone brick finish</p> <p>Concrete columns</p> <p>Solid concrete ceiling and beams with fibreglass insulation and modern grid ceiling tile finish</p> <p>Wooden panels cross beam sections between concrete columns</p> <p>Plywood risers. Modern construction roller shutters</p> <p>Cast iron rainwater pipe</p> | | |

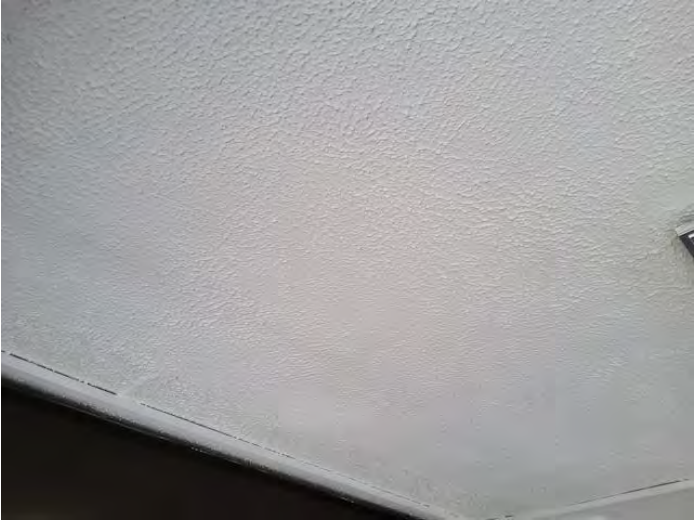
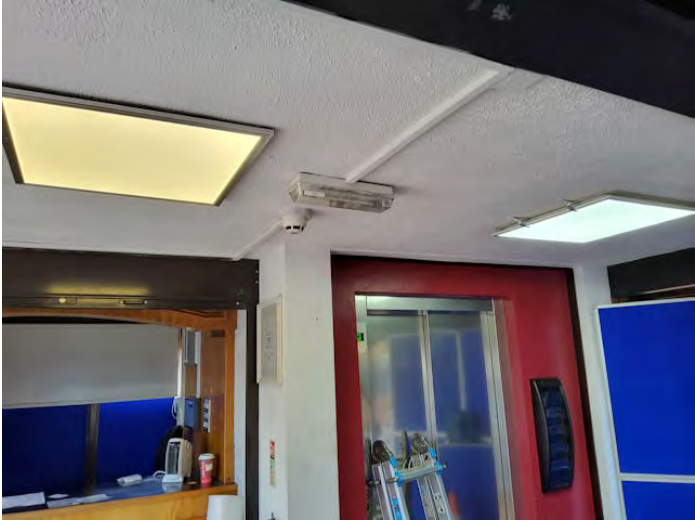
| Location | T003 | Item | 33 |

| Material | Textured Coating | Extent | 10m |
| Strategy / Sample Id | Sample / S028 | Fibre Type | NADIS |
| General Comments | Textured coating to walls and ceiling | | |

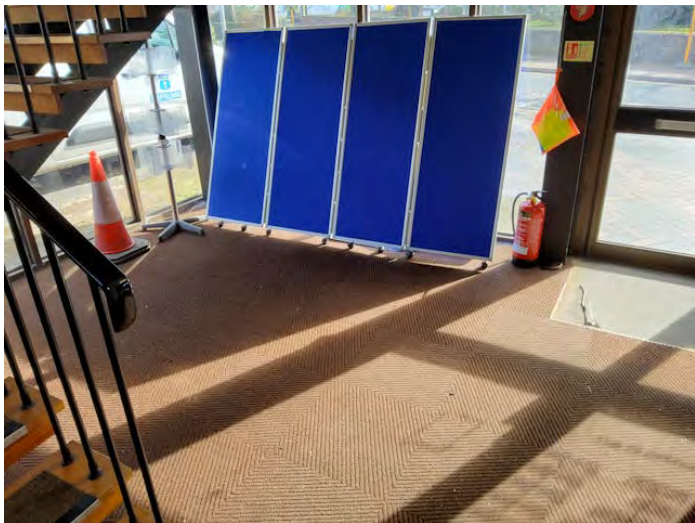
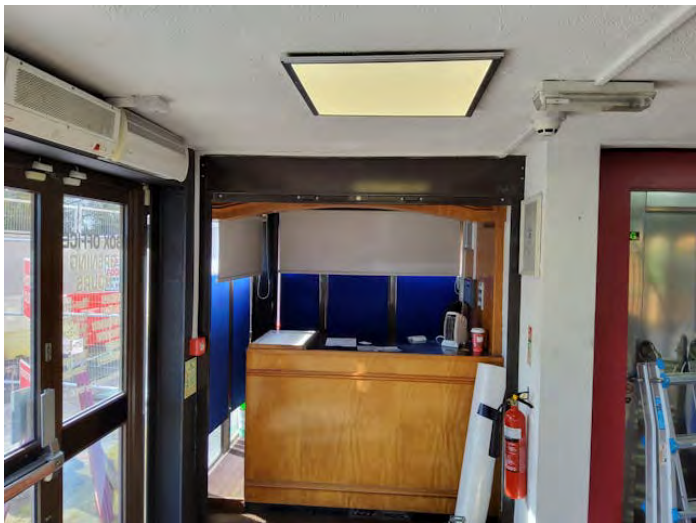
| Location Notes | Concrete/Timber Floor with Modern Floor covering.<br>concrete and plasterboard to ceiling surfaces.<br>Wooden Framed windows. Wooden panels to office/reception areas | | |

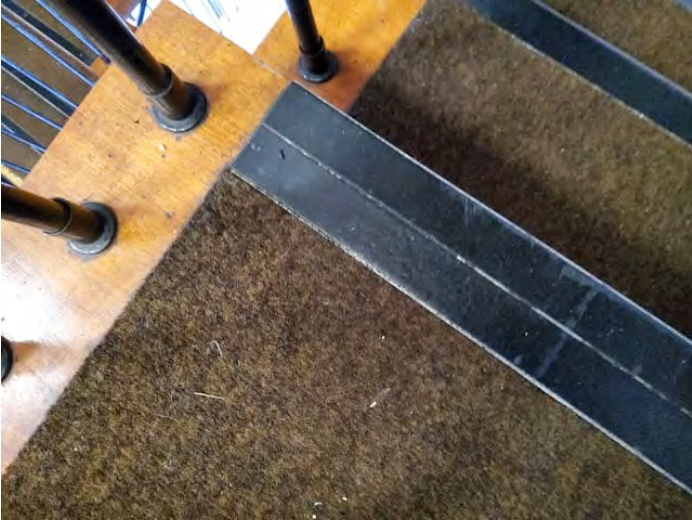
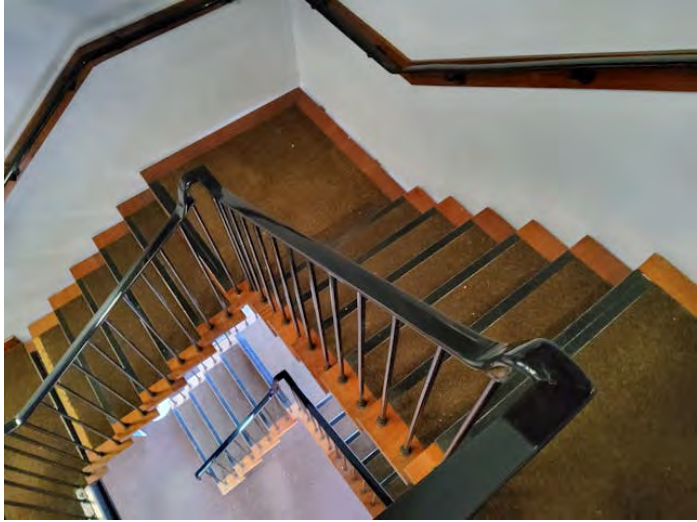
| Location | T101 | Item | 29 |

| Material | Stair nosing | Extent | x15 |
| Strategy / Sample Id | Strongly Presume / S022 | Presumed Fibre Type | NADIS |
| General Comments | Stair Noses | | |

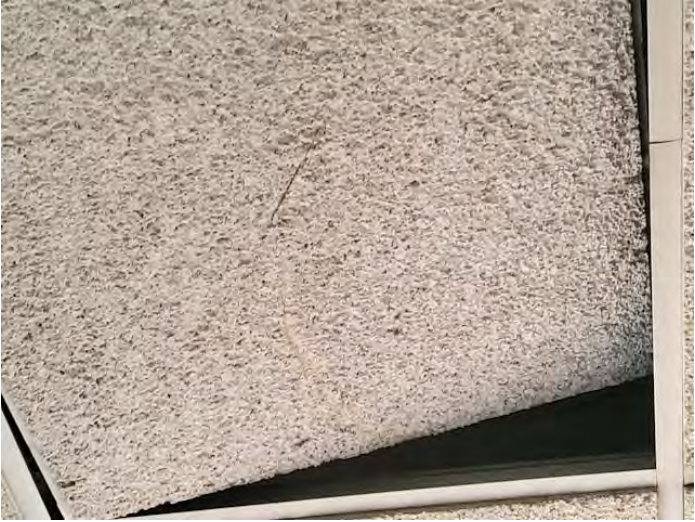
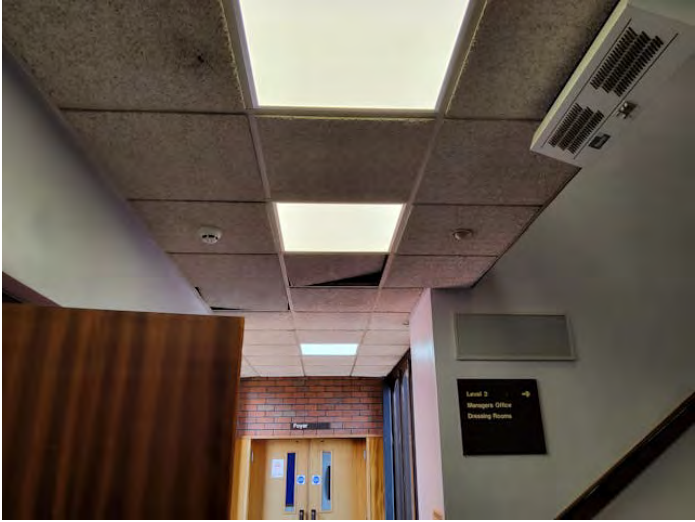
| Location | T101 | Item | 26 |

| Material | Ceiling tile | Extent | 12 sqm |
| Strategy / Sample Id | Sample / S023 | Fibre Type | NADIS |
| General Comments | Suspended Ceiling tiles | | |

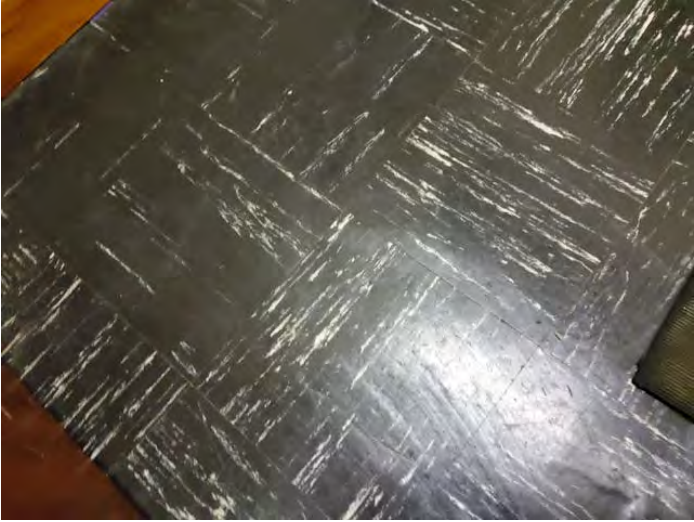
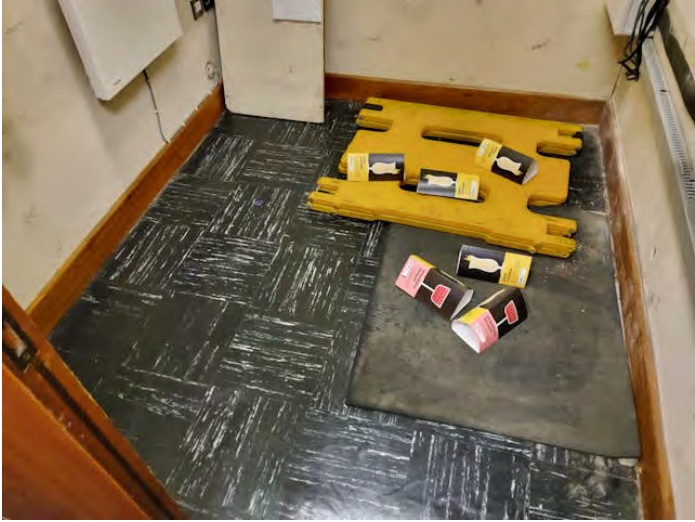
| Location | T101 | Item | 28 |

| Material | Vinyl Tile | Extent | 6m |
| Strategy / Sample Id | Sample / S025 | Fibre Type | NADIS |
| General Comments | Vinyl Floor tiles | | |

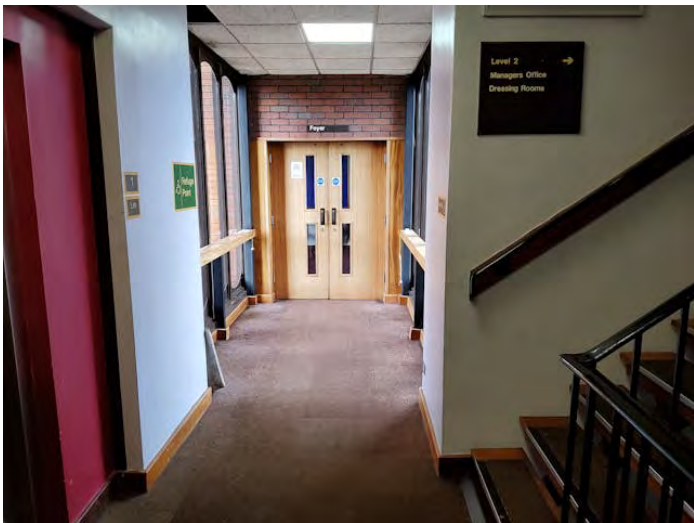
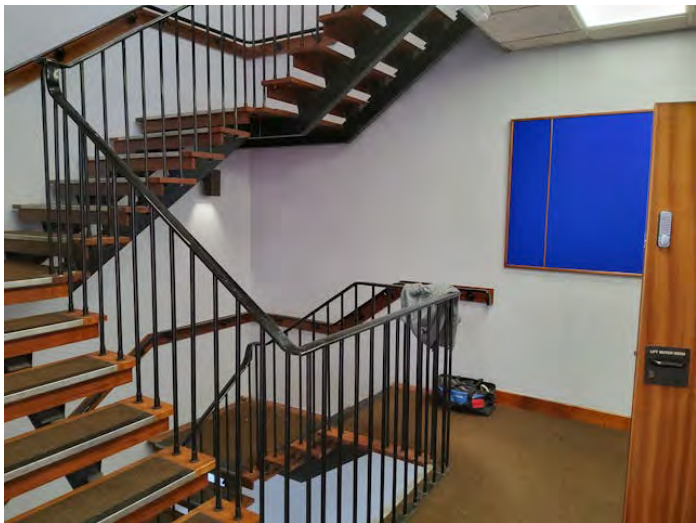
| Location | T101 | Item | |

| Location Notes | MMMF suspended Ceiling tiles. Plasterboard walls over brick construction Carpet over wood | | |

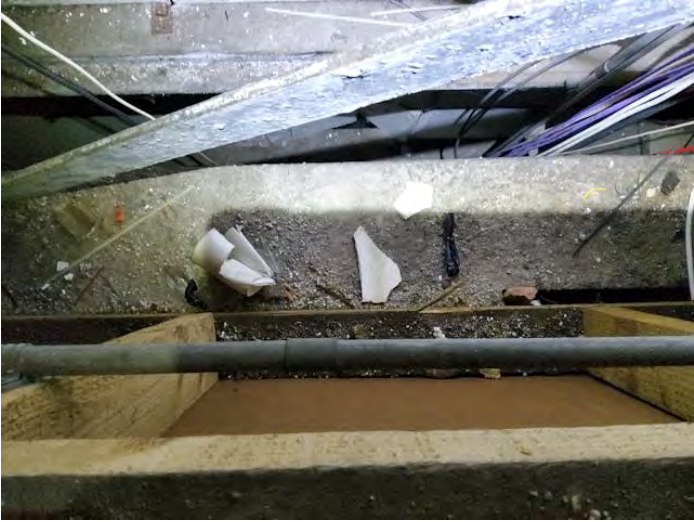
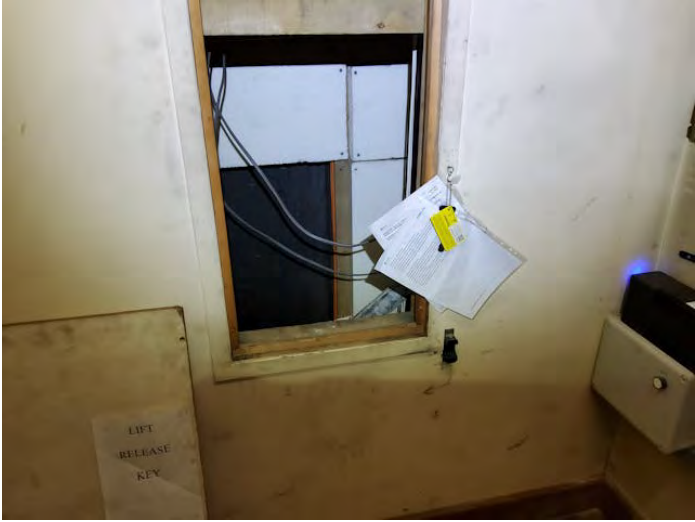
| Location | T102 | Item | 27 |

| Material | Supalux | Extent | Small amounts |
| Strategy / Sample Id | Sample / S024 | Fibre Type | NADIS |
| General Comments | Supalux debris in void | | |
