# Prince of Wales Theatre Refurbishment & Demolition Survey

Prepared for: Cannock Chase District  
Council

Report Number:  
Cannock/Theatre/260417

# Asbestos Demolition Survey

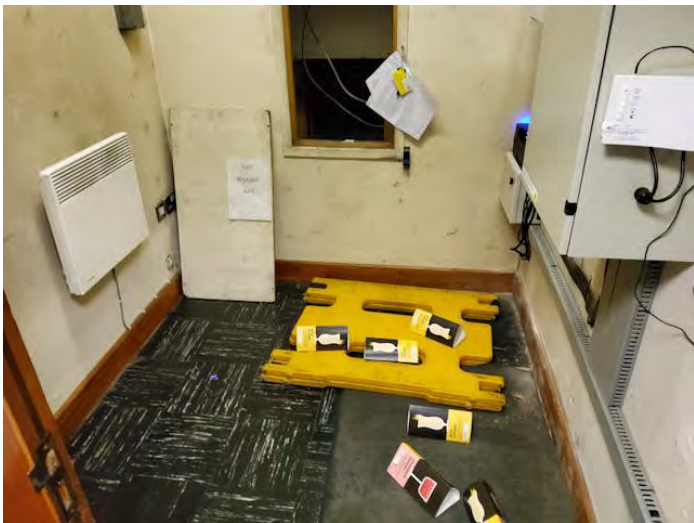
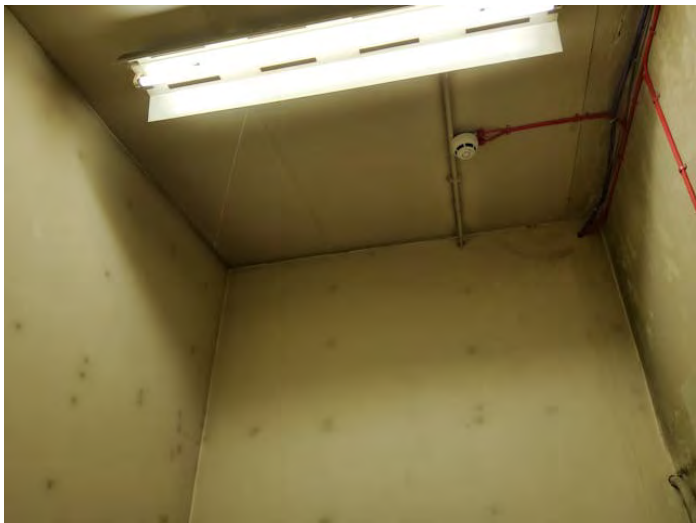
| Location Notes | Solid walls and ceiling.<br>Void to rear of room consists of wooden framework with polystyrene insulation panels.<br>Vinyl tile over wood | | |

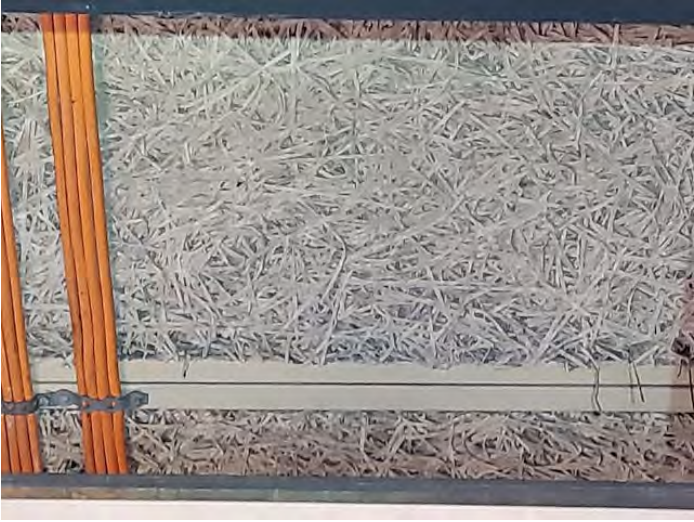
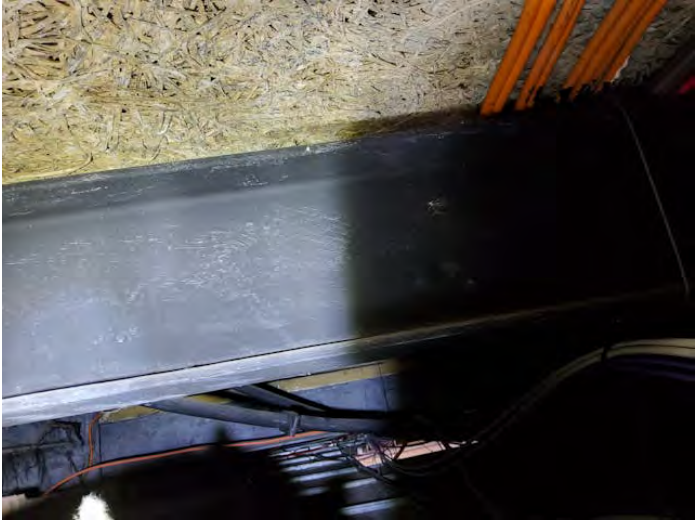
| Location | T201 | Item | 23 |

| Material | Straw board | Extent | > 500 sqm |
| Strategy / Sample Id | Sample / S020 | Fibre Type | NADIS |
| General Comments | Straw board ceiling panels | | |

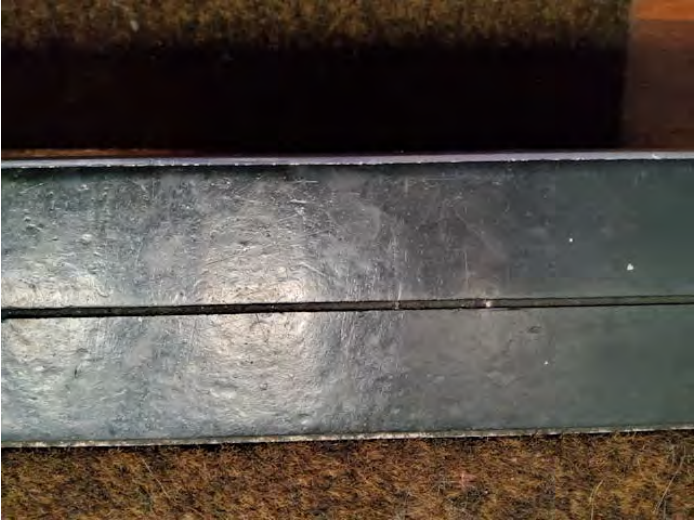
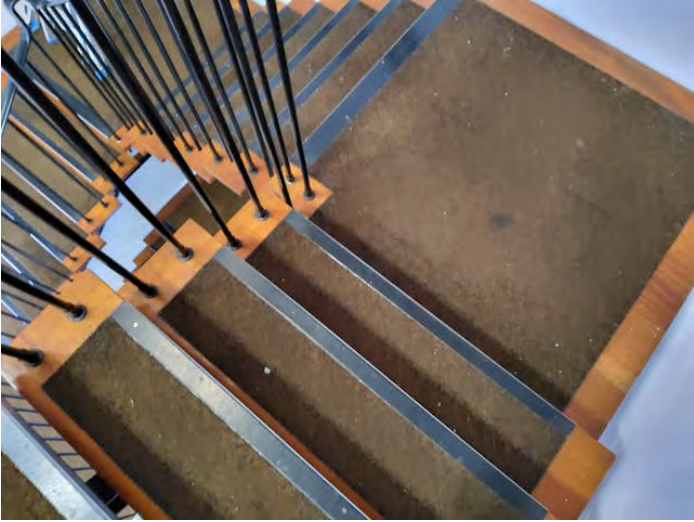
| Location | T201 | Item | 25 |

| Material | Stair nosing | Extent | 18 |
| Strategy / Sample Id | Sample / S022 | Fibre Type | NADIS |
| General Comments | Stair Noses | | |

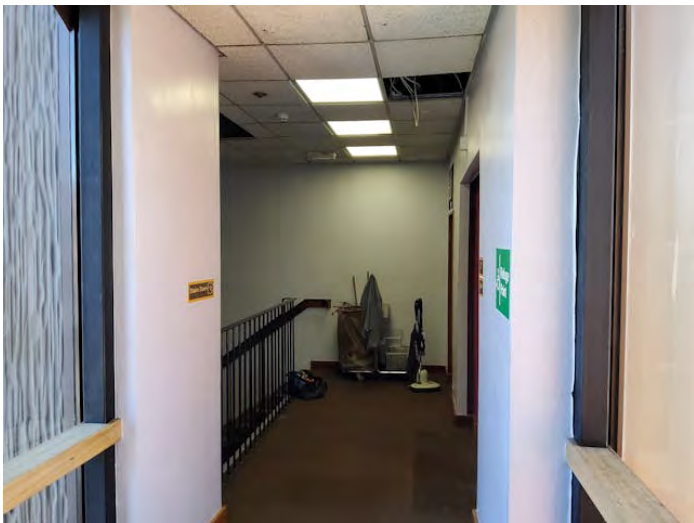
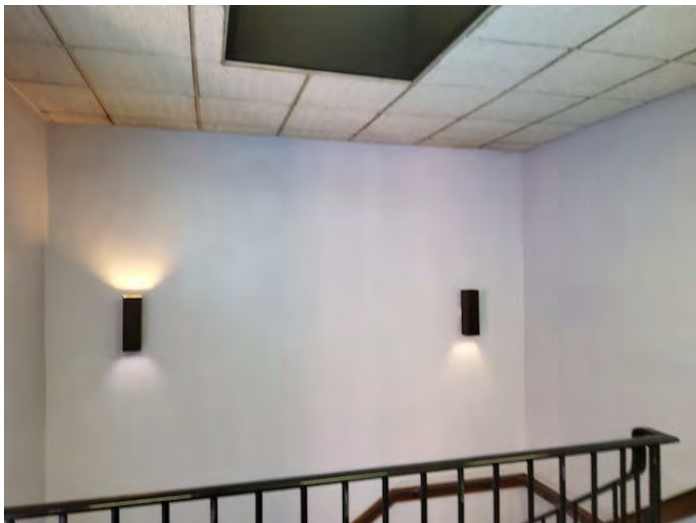
| Location Notes | MMMF Suspended ceiling tiles with strammit board above<br>Modern floor covering over wood<br>Skylight has wooden surround | | |
| General Comments | Modern suspended ceiling tiles construction with straw board ceiling construction above in void<br>Plasterboard walls with foam insulation to void behind<br>Carpet tiles over timber to floor | | |

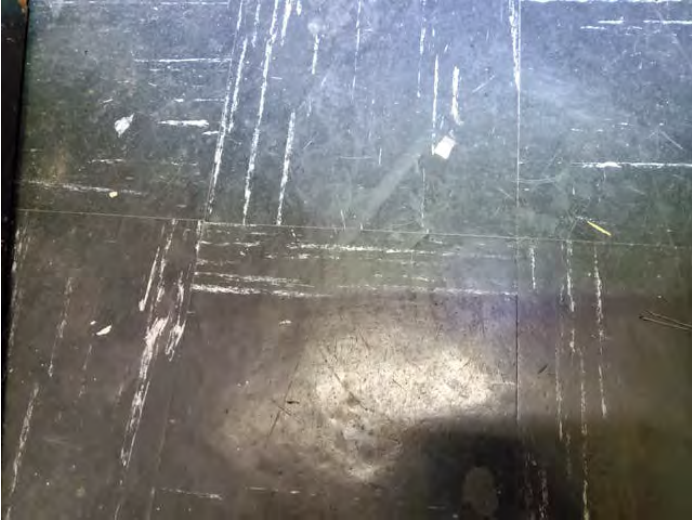
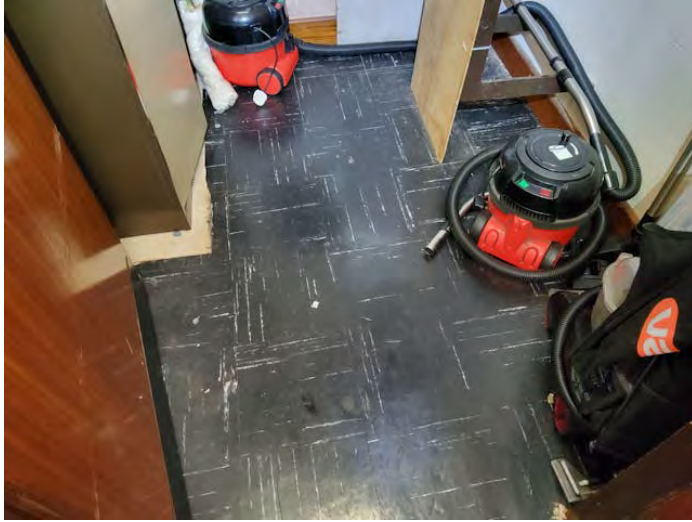
| Location | T202 | Item | 24 |

| Material | Vinyl Tile | Extent | 6m |
| Strategy / Sample Id | Sample / S021 | Fibre Type | NADIS |
| General Comments | Vinyl tile | | |

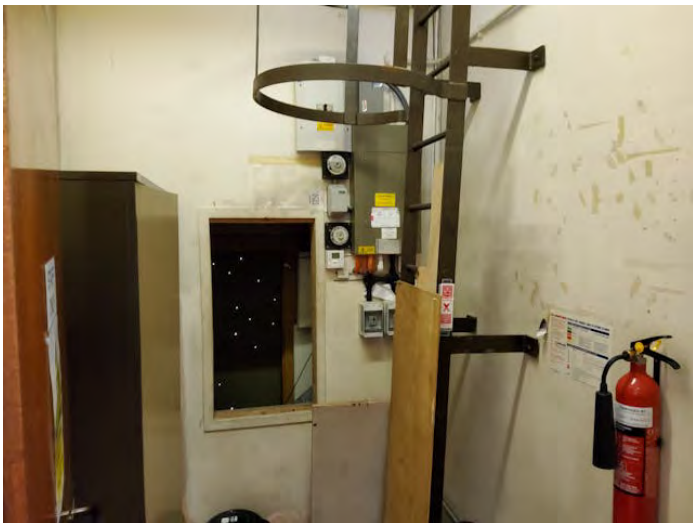
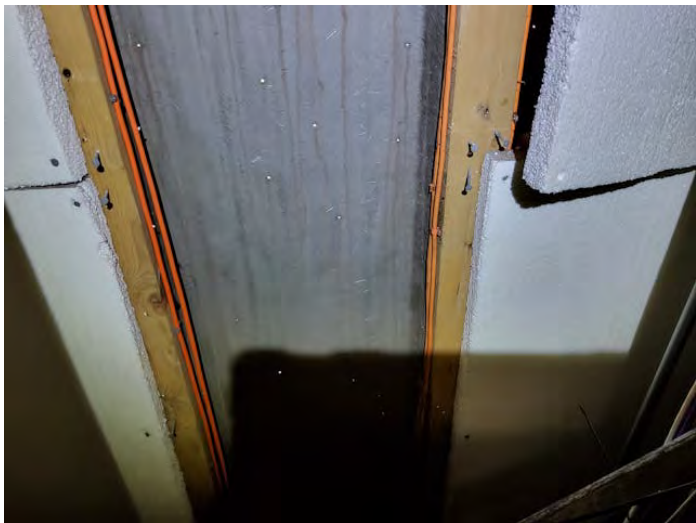
| Location Notes | Solid walls and ceiling.<br>Void to rear of room consists of wooden framework with polystyrene insulation panels.<br>Vinyl tile over wood | | |

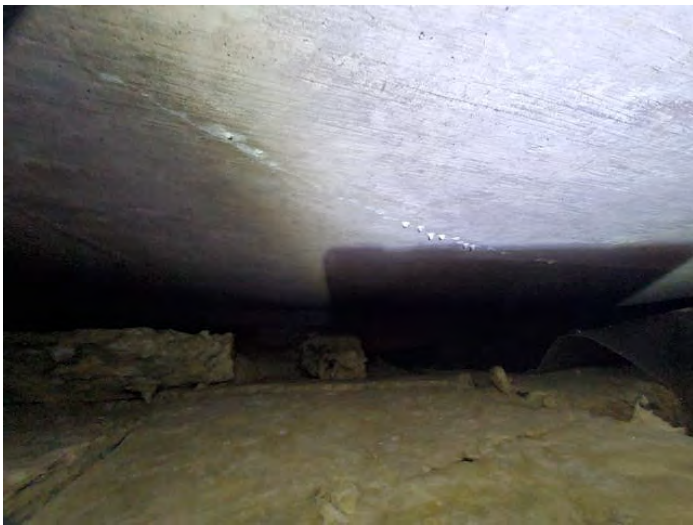
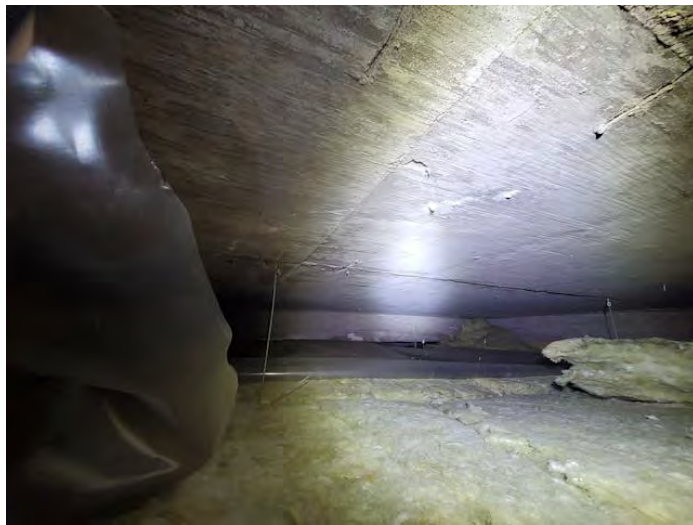
| Location | T203 | Item | |

| Strong evidence location does not contain asbestos | | | |
| Location Notes | Visible concrete surfaces present<br>Lift system is modern and has been recently installed | | |

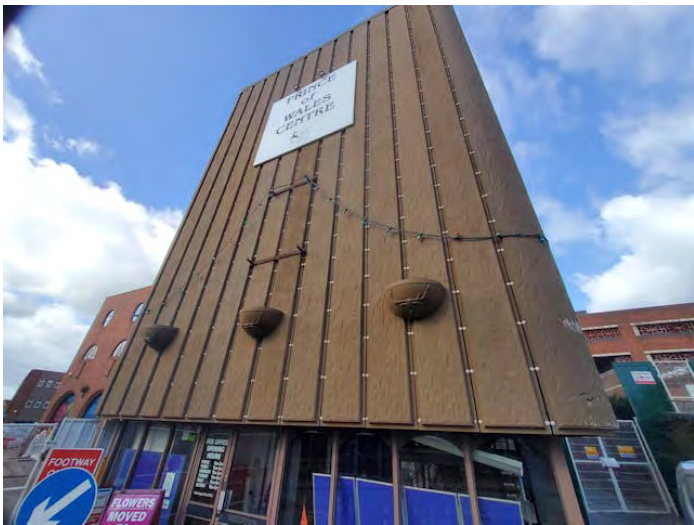
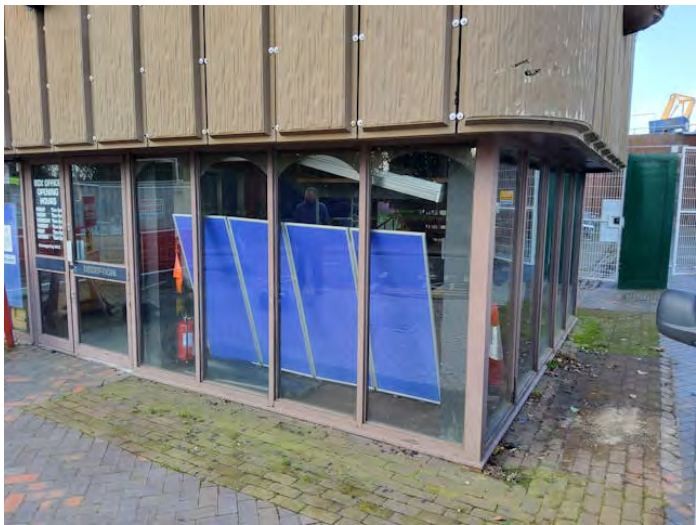
| Location | EX001 | Item | |

| Location Notes | GRP Panels with polystyrene panels behind. | | |

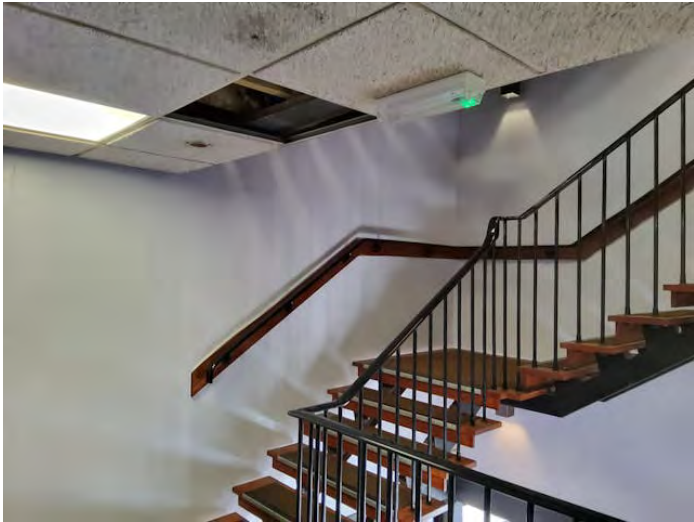
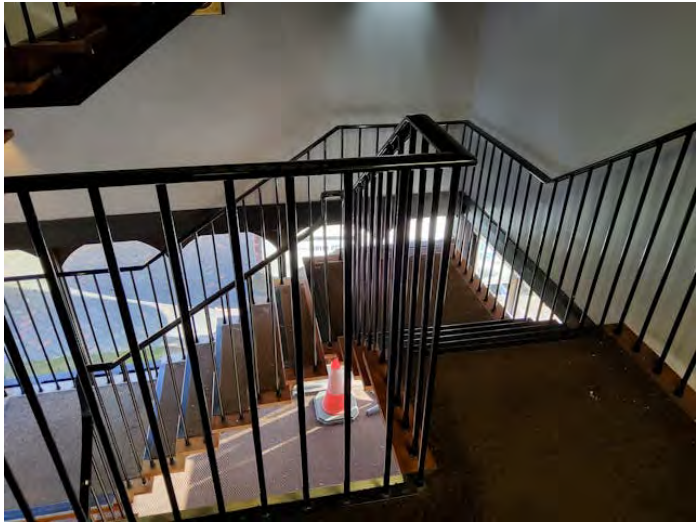
| Location | T001 | Item | |

| Location Notes | MMMF suspended Ceiling tiles. Plasterboard walls over brick construction Carpet over wood | | |

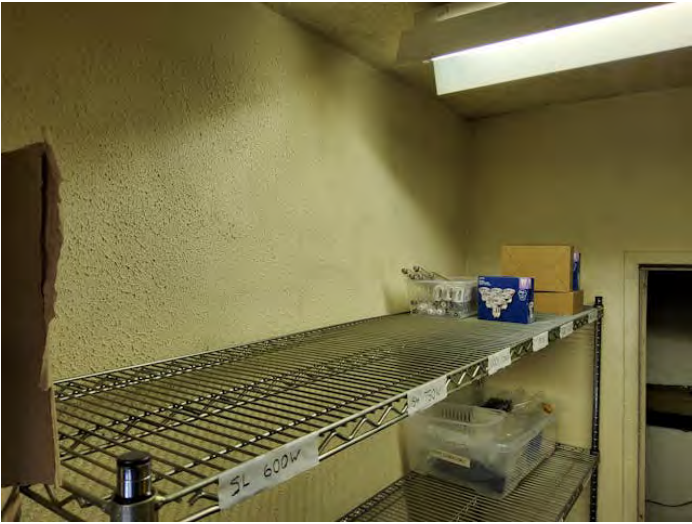
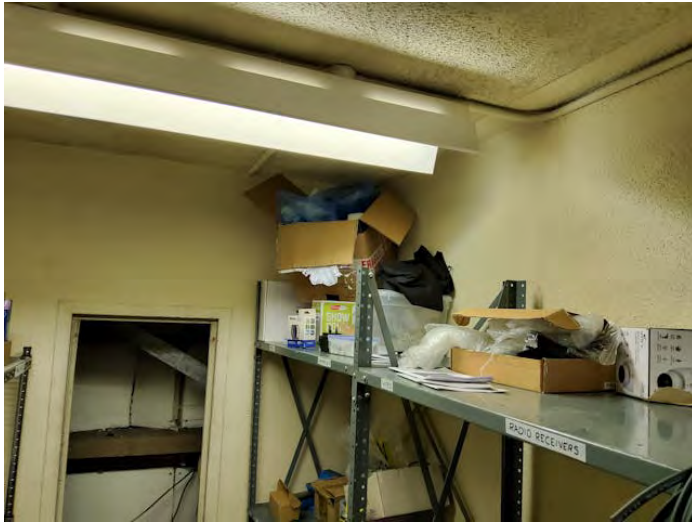
| Location | T002 | Item | 30 |

| Material | Textured Coating | Extent | 15 |
| Strategy / Sample Id | Sample / S026 | Fibre Type | NADIS |
| General Comments | Textured coating to walls and ceiling | | |

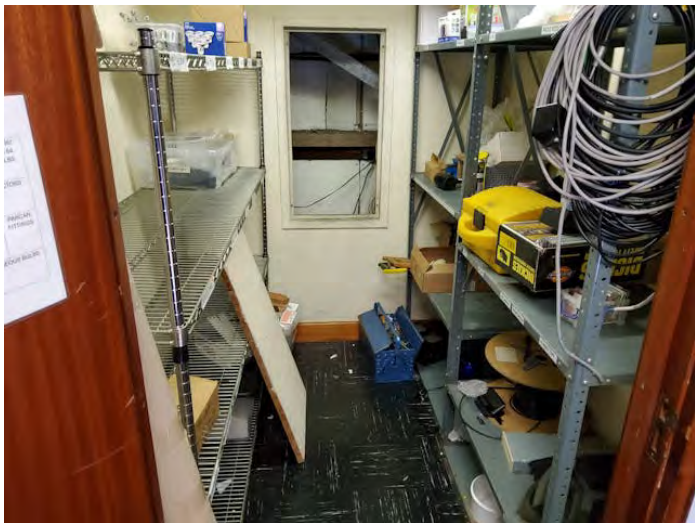
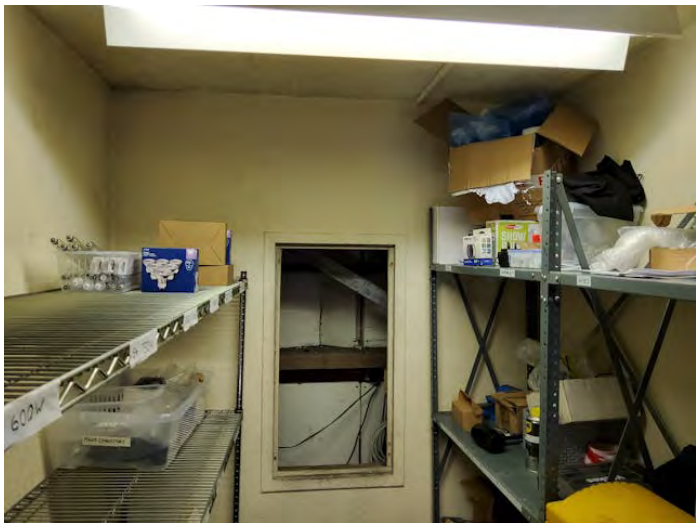
| Location Notes | Solid walls and ceiling.<br>Void to rear of room consists of wooden framework with polystyrene insulation panels.<br>Vinyl tile over wood | | |

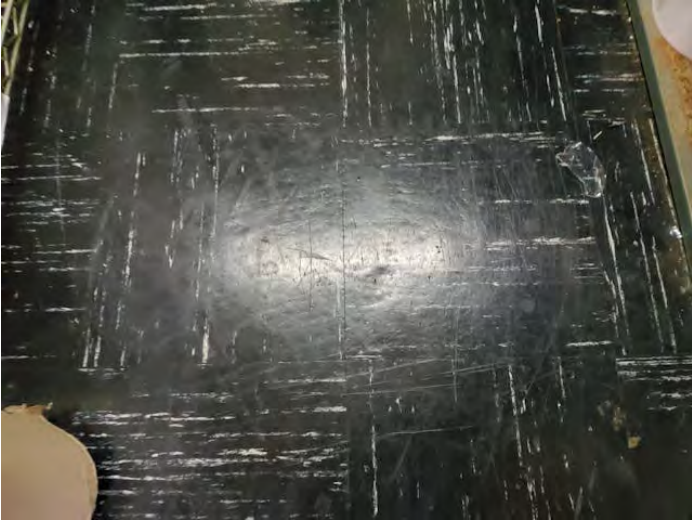
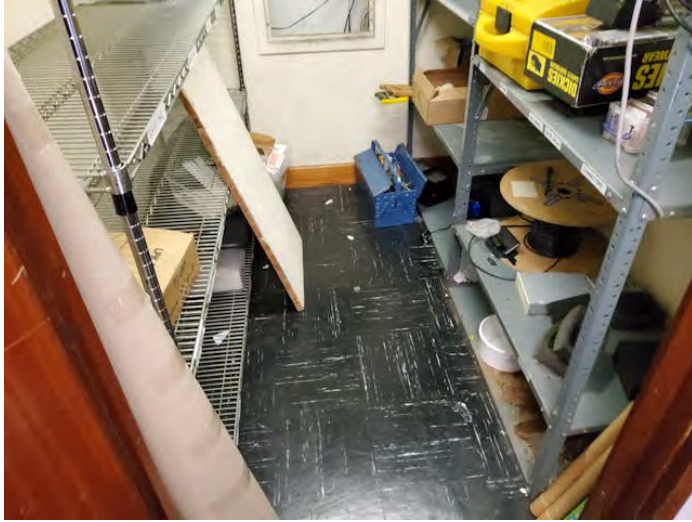
| Location | T002 | Item | 31 |

| Material | Vinyl Tile | Extent | 6m |
| Strategy / Sample Id | Sample / S027 | Fibre Type | NADIS |
| General Comments | Vinyl Floor tiles | | |
